**Report: TAB Report**  
**Function: Test, Adjust, & Balance**  
**Date: 11/26/2024**  
**Completed By: National TAB**

**PROJECT**  
**11-25-24 CULVERS LABELLE, FL**

Project: 11-25-24 CULVERS LABELLE, FL

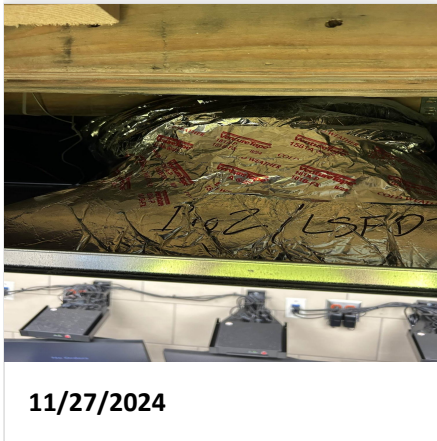
Project Issue File Details

**Issue Name :** RTU 1 - Low Flow Diffusers  
**Description :** Diffusers 1-18, 1-23, 1-24, and 1-26 are below design (46%, 87%, 80%, and 82% of design respectively). Respective dampers are fully open. Duct for 1-18 is severely crushed, restricting airflow. Not expected to cause comfort issues in the open dining space.  
**Created By :** National TAB                      **Assigned To :** National TAB - Dan Hertenstein  
**Status :** Open  
**Priority :** Medium                                      **Asset Tag :** RTU1  
**Originated Date :** 11/27/2024 - Mark Johnson - National TAB

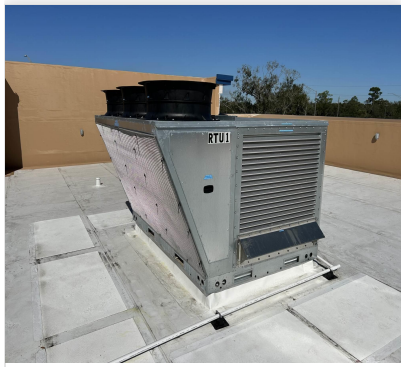
RTU-1

Test Data		
	Design	Actual
SF CFM	6150	5667
SF RPM	-	1580
RA CFM	4400	3885
OA CFM	1750	1782
RL Voltage	-	158 VFD
RL Amperage	-	23.8 VFD
SF Rotation	-	CCW
SF System SetPt	-	54 HZ
RA Damper Position	-	5.8 V
Min OA Damper Position	-	4.2 V
Min OA Damper Type	-	ECONOMIZER

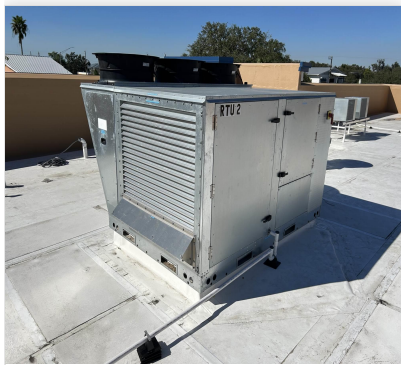
**RTU-2**

**Issue Name :** RTU 2 - Low Flow  
**Description :** RTU 2 is currently outputting 5233 CFM (84% design). Unit cannot be sped up further without causing the motor to overamp. Several diffusers remain below design (2-1, 2-2, 2-12, 2-13, 2-15) but the cookline and surrounding food prep area is within design flow. Recommend contacting manufacturer if comfort issues arise.

Test Data		
	Design	Actual
SF CFM	6225	5233
SF RPM	-	1550
RA CFM	4525	3507
OA CFM	1700	1726
RL Voltage	-	158 VFD
RL Amperage	-	23.6 VFD
SF Rotation	-	CCW
SF System SetPt	-	53 HZ
RA Damper Position	-	4.8 V
Min OA Damper Position	-	5.2 V
Min OA Damper Type	-	ECONOMIZER

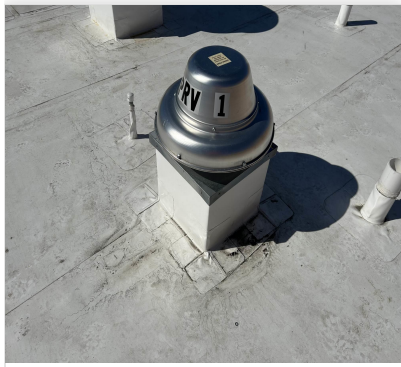
**PRV-1**

Test Data		
	Design	Actual
CFM	300	305
Fan RPM	1010	868
Fan Rotation	-	CCW
Motor RPM	-	868
System SetPt	-	46%
RL Voltage	-	120
RL Amperage	-	0.4
Total ESP	0.250"	0.117"
Fan Inlet SP	-	-0.117"
Fan Discharge SP	-	ATM

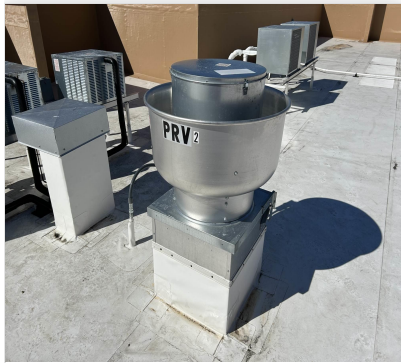
**PRV-2**

Test Data		
	Design	Actual
CFM	1500	1497
Fan RPM	1406	1206
Fan Rotation	-	CCW
Motor RPM	-	1206
System SetPt	-	60%
RL Voltage	-	121
RL Amperage	-	5.8
Total ESP	1.412'	0.598"
Fan Inlet SP	-	-0.598"
Fan Discharge SP	-	ATM

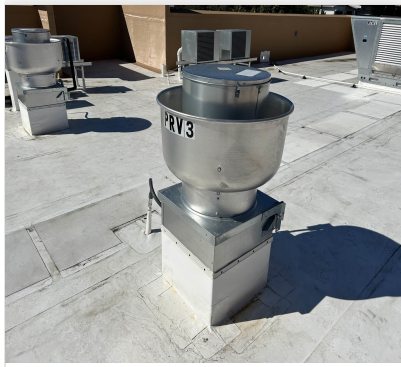
**PRV-3**

Test Data		
	Design	Actual
CFM	1500	1555
Fan RPM	1348	1142
Fan Rotation	-	CCW
Motor RPM	-	1142
System SetPt	-	57%
RL Voltage	-	121
RL Amperage	-	4.8
Total ESP	1.250"	0.413"
Fan Inlet SP	-	-0.413"
Fan Discharge SP	-	ATM

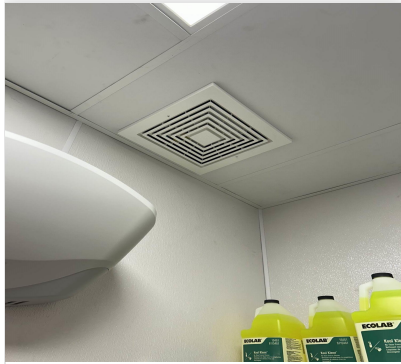
**EF-1A**

MOP ROOM

Test Data		
	Design	Actual
CFM	75	74
Fan RPM	493	HIGH
Fan Rotation	-	CCW
Motor RPM	-	HIGH
System SetPt	-	SPEED CONTROLLER (MARKED)
RL Voltage	-	119
RL Amperage	-	0.4

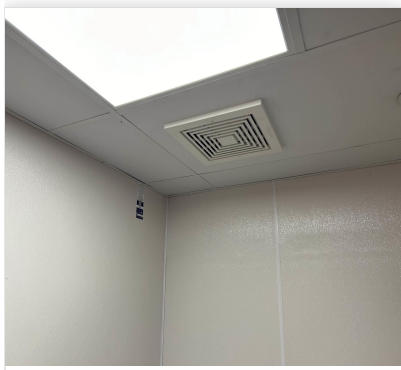
**EF-1B**

EMPLOYEE RESTROOM

Test Data		
	Design	Actual
CFM	75	75
Fan RPM	-	HIGH
Fan Rotation	-	CCW
Motor RPM	-	HIGH
System SetPt	-	SPEED CONTROLLER (MARKED)
RL Voltage	-	120
RL Amperage	-	0.4

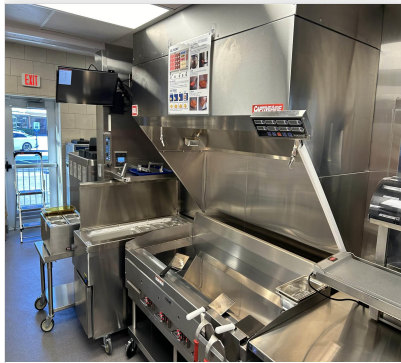
**HOOD 1**

100%

Test Data Exhaust		
	Design	Actual
Filter Type	CAPTRATE SOLO	CAPTRATE SOLO
Filter Size 1	16x16	16x16
Filter Qty 1	4	4
Filter AK factor size 1	1.62	1.62
Filter Total AK Area	6.48	6.48
Filter1 FPM	-	229
Filter2 FPM	-	233
Filter3 FPM	-	230
Filter4 FPM	-	234
Filter Ave FPM(corr)	-	231
CFM	1500	1497

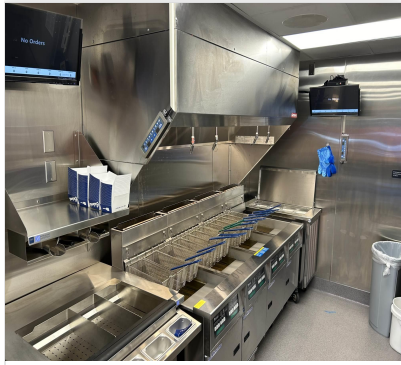
**HOOD 2**

100%

Test Data Exhaust		
	Design	Actual
Filter Type	CAPTRATE SOLO	CAPTRATE SOLO
Filter Size 1	16x16	16x16
Filter Qty 1	5	5
Filter AK factor size 1	1.62	1.62
Filter Total AK Area	8.10	8.10
Filter1 FPM	-	189
Filter2 FPM	-	190
Filter3 FPM	-	198
Filter4 FPM	-	184
Filter5 FPM	-	201
Filter Ave FPM(corr)	-	192
CFM	1500	1555

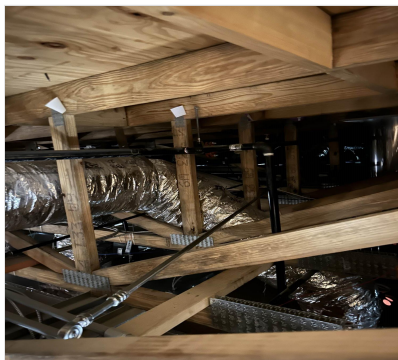
Cookline diffusers have at 12-18" of straight duct out of the top of the diffusers and a rigid 90 degree fitting? Fail
