Report: TAB Report
Function: Test, Adjust, & Balance
Date: 11/26/2024
Completed By: National TAB

PROJECT
11-25-24 CULVERS LABELLE, FL

Project: 11-25-24 CULVERS LABELLE, FL

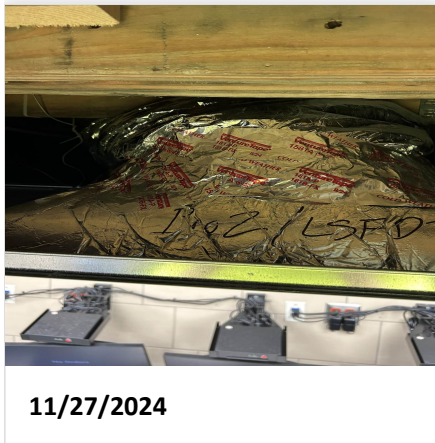
Project Issue File Details

Issue Name : RTU 1 - Low Flow Diffusers
Description : Diffusers 1-18, 1-23, 1-24, and 1-26 are below design (46%, 87%, 80%, and 82% of design respectively). Respective dampers are fully open. Duct for 1-18 is severely crushed, restricting airflow. Not expected to cause comfort issues in the open dining space.
Created By : National TAB **Assigned To :** National TAB - Dan Hertenstein
Status : Open
Priority : Medium **Asset Tag :** RTU1
Originated Date : 11/27/2024 - Mark Johnson - National TAB

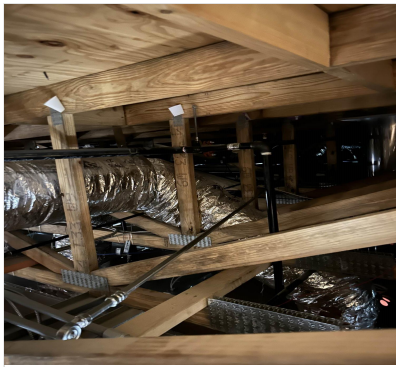
Cookline diffusers have at 12-18" of straight duct out of the top of the diffusers and a rigid 90 degree fitting? Fail
