Report: Renew

Date: 2/2/2022

FREDDY'S EPOCH - HASTINGS, NE - RENEW 3F (2)

3400 OSBORNE DRIVE WEST
HASTINGS, NE 68901

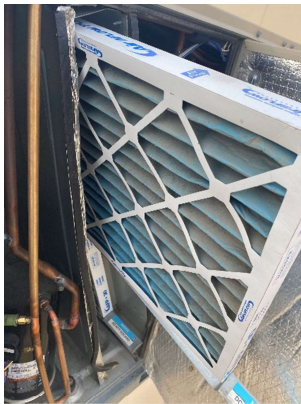
RTU-1 (DINING)
DIRTY EVAPORATOR FILTERS

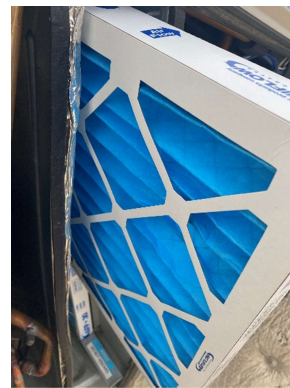
RTU-1 (DINING)
CLEAN EVAPORATOR FILTERS

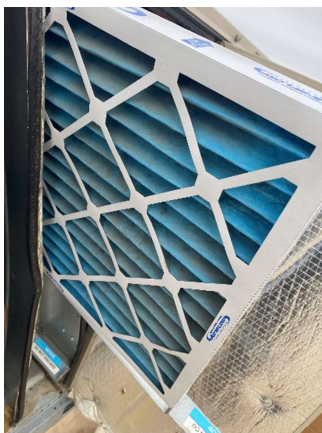
RTU-2 (FRONT KITCHEN/DINING)
DIRTY EVAPORATOR FILTERS

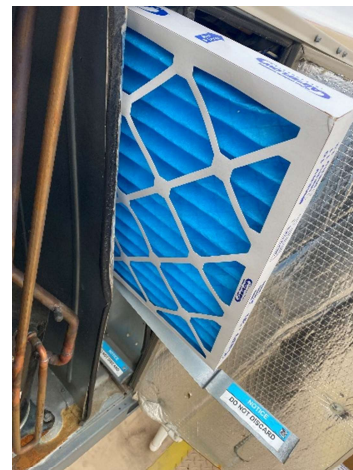
RTU-2 (FRONT KITCHEN/DINING)
CLEAN EVAPORATOR FILTERS

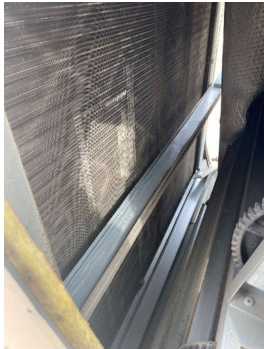
RTU-1 (DINING)
DIRTY EVAPORATOR

RTUs: There evaporator coil was rinsed off and cleaned. During warmer months a self-cleaning chemical is sprayed on the evaporator. The outside air filters were rinsed off to remove any dirty, so the unit stays at the designated outside air set point. Based on static pressures, amps, and fan rpm it shows that the total supply has not changed since the last test and balance.

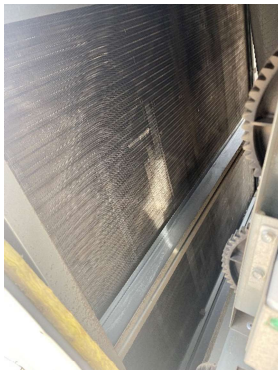
RTU-2 (FRONT KITCHEN/DINING)
DIRTY EVAPORATOR

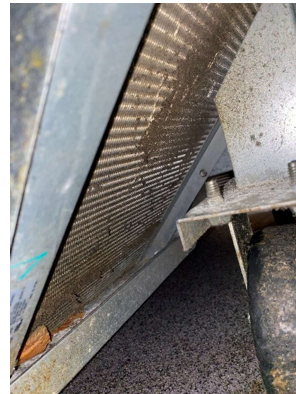
DXC-3 (MEAT COOLER 1)
CLEAN CONDENSOR

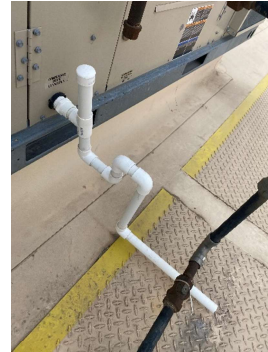
RTU-1 (DINING)
P-TRAP

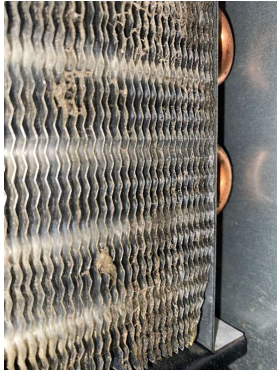
DXC-5 (PREP TABLE 1)
DIRTY CONDENSER

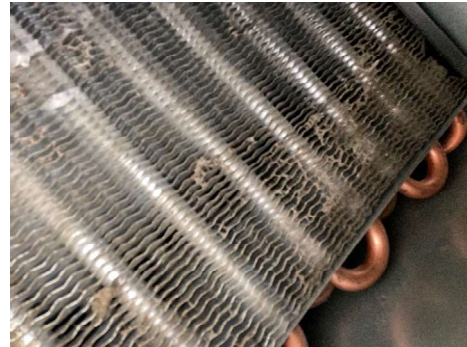
DXC-5 (PREP TABLE 1)
CLEAN CONDENSER

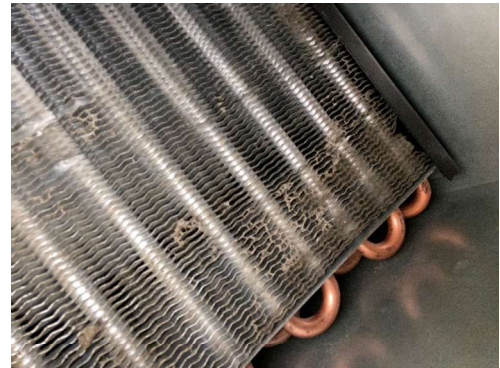
DXC-6 (PREP TABLE 2)
CLEAN CONDENSER

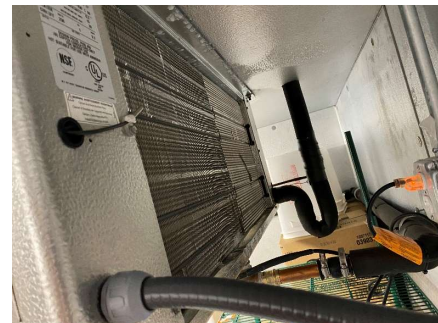
DXC-2 (WALK-IN FREEZER)
CLEAN EVAPORATOR

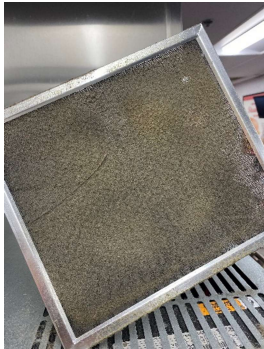
**DXC-7 (FRYER FREEZER)
DIRTY CONDENSER**

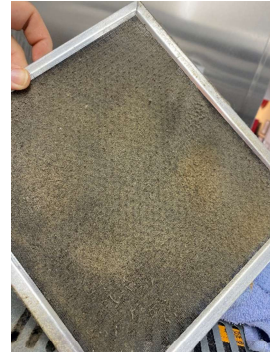
**DXC-7 (FRYER FREEZER)
CLEAN CONDENSER**

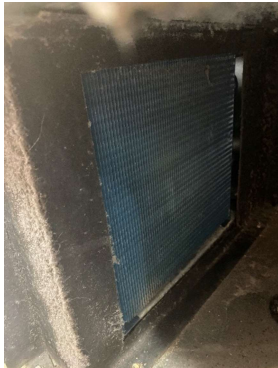
**DXC-8 (SUNDAE PREP)
DIRTY CONDENSER**

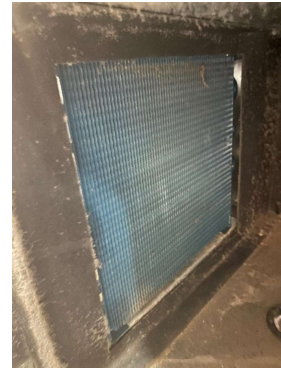
**DXC-8 (SUNDAE PREP)
CLEAN CONDENSER**

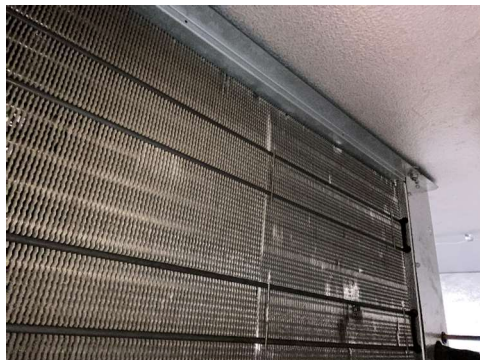
**DXC-1 (WALK-IN COOLER)
DIRTY EVAPORATOR**

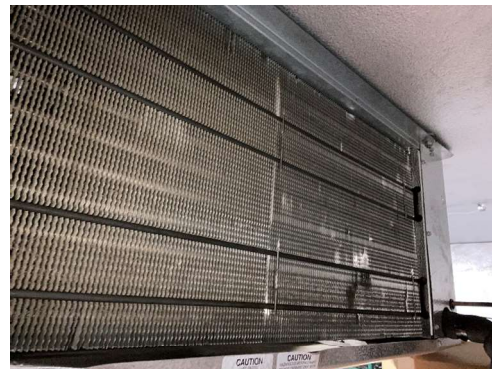
**DXC-1 (WALK-IN COOLER)
CLEAN EVAPORATOR**
