Report: TAB Report
Function: Test, Adjust, & Balance
Date: 12/17/2025
Completed By: National TAB

12-08-25 WHATABURGER #1667 LARGO, FL

Whataburger Restaurants
300 Concord Plaza Dr
San Antonio, TX 78216

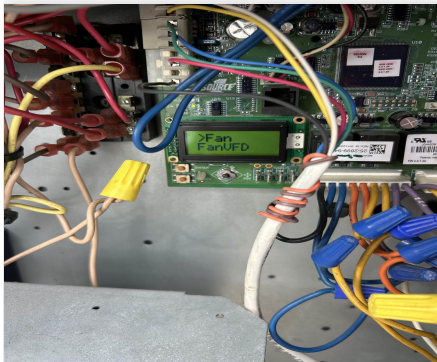
Issue Name : Economizers Not Operational
Description : All RTU economizers are not functional. For RTUs 1 and 2, the damper does not respond to setpoint changes. RTUs 3 and 4 do not have economizer setpoints enabled on the controller. All economizers must be functional to complete TAB.
Created By : National TAB **Assigned To :** National TAB - Will Turnbough
Status : Open
Priority : Urgent **Asset Tag :**
Originated Date : 12/08/2025 - Mark Johnson - National TAB

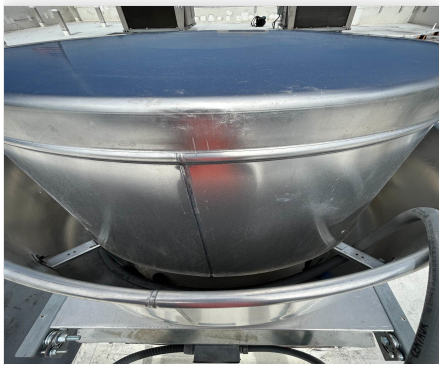
Issue Name : EFs 1, 2 - Conduit Placement
Description : The conduit for both hood exhaust fans is routed around the inside of the fan, with risk of damage from grease over time.
Created By : National TAB **Assigned To :** National TAB - Will Turnbough
Status : Open
Priority : High **Asset Tag :**
Originated Date : 12/12/2025 - Mark Johnson - National TAB

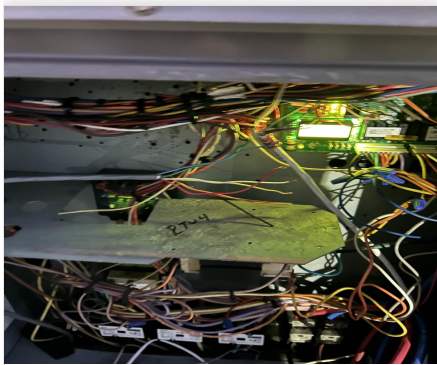
Issue Name : RTUs - Loose Wires
Description : All RTUs have loose sensor wires inside their controls cabinet. Recommend installation.
Created By : National TAB **Assigned To :** National TAB - Will Turnbough
Status : Open
Priority : High **Asset Tag :**
Originated Date : 12/12/2025 - Mark Johnson - National TAB

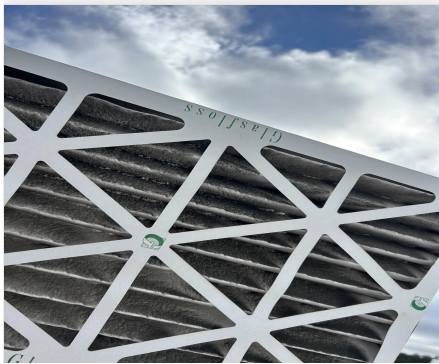
Issue Name : RTUs 1, 2 - Filters Dirty
Description : Final filters are dirty in RTUs 1 and 2 and will need replaced soon.
Created By : National TAB **Assigned To :** National TAB - Will Turnbough
Status : Open
Priority : Medium **Asset Tag :**
Originated Date : 12/12/2025 - Mark Johnson - National TAB

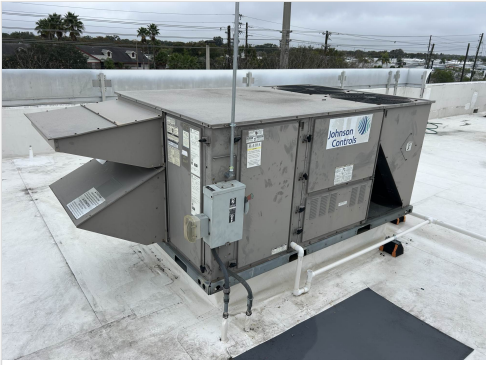
Unit Data - PHOTO LOG

Asset: RTU1

General	
	Actual
Unit free of Damage	NO
Fan Rotation Correct	YES
Unit Filters Clean	HALF LOADED
Condensate Drain Installed	YES

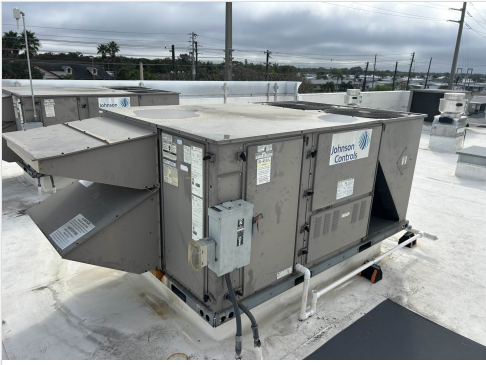
Unit Data - PHOTO LOG

Asset: RTU2

General	
	Actual
Unit free of Damage	NO
Fan Rotation Correct	YES
Unit Filters Clean	HALF LOADED
Condensate Drain Installed	YES

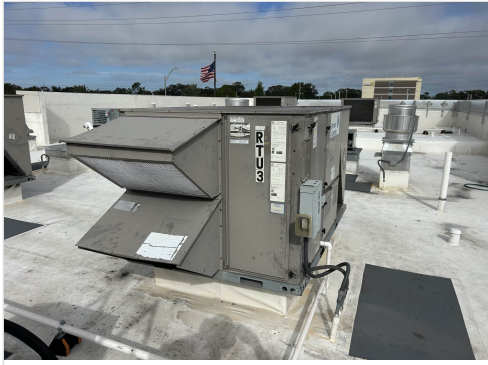
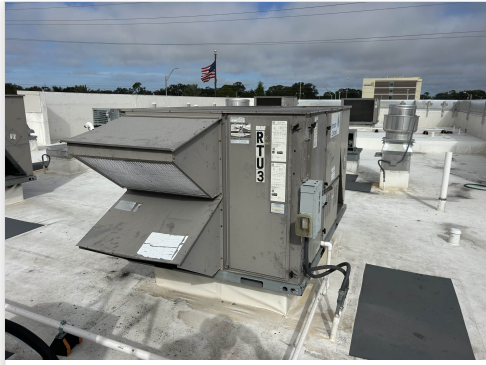
Unit Data - PHOTO LOG

Asset: RTU3

General	
	Actual
Unit free of Damage	NO
Fan Rotation Correct	YES
Unit Filters Clean	YES
Condensate Drain Installed	YES

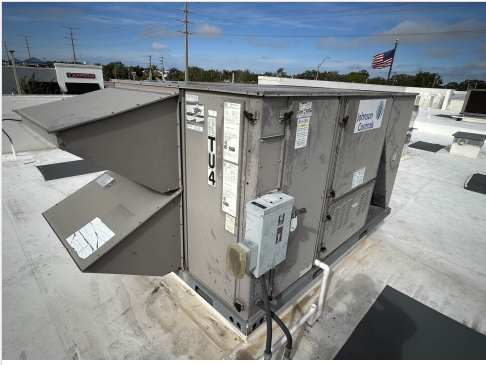
Unit Data - PHOTO LOG

Asset: RTU4

General	
	Actual
Unit free of Damage	NO
Fan Rotation Correct	YES
Unit Filters Clean	YES
Condensate Drain Installed	YES

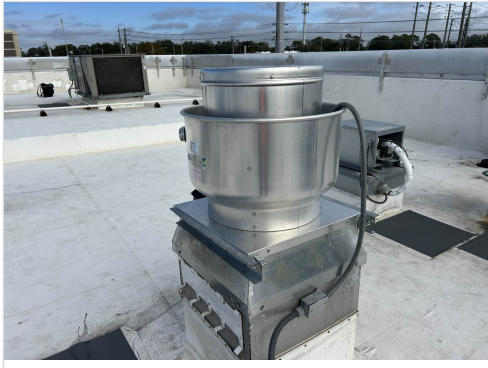
Unit Data - PHOTO LOG

Asset: EF1

Test Data		
	Design	Actual
CFM	1995	2052
Fan RPM	1517	DD
Fan Rotation	-	CW
Motor RPM	-	DD
System SetPt	-	SPEED CONTROLLER (MARKED)
RL Voltage	-	123
RL Amperage	-	2.6
Total ESP	1.00"	0.39"
Fan Inlet SP	-	-0.39"
Fan Discharge SP	-	ATM

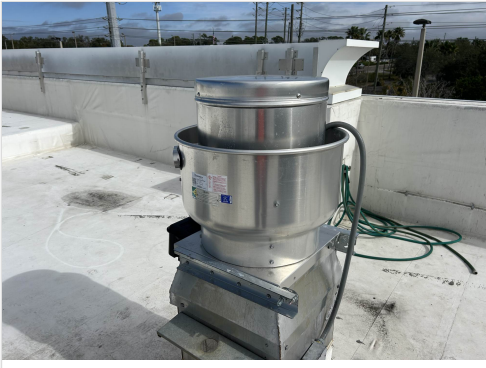
Unit Data - PHOTO LOG

Asset: EF2

Test Data		
	Design	Actual
CFM	1216	1260
Fan RPM	1415	DD
Fan Rotation	-	CW
Motor RPM	-	DD
System SetPt	-	SPEED CONTROLLER (MARKED)
RL Voltage	-	122
RL Amperage	-	2.0
Total ESP	0.75"	0.56"
Fan Inlet SP	-	-0.56"
Fan Discharge SP	-	ATM

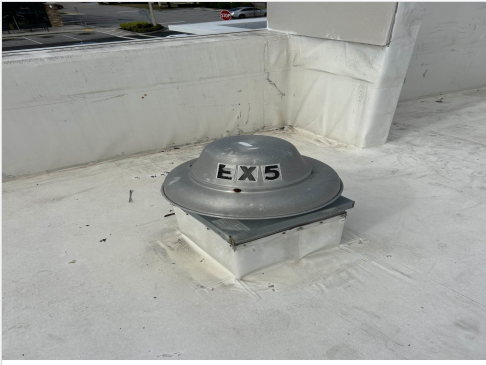
Unit Data - PHOTO LOG

Asset: EF6

Test Data		
	Design	Actual
CFM	300	307
Fan RPM	-	DD
Fan Rotation	-	CCW
Motor RPM	-	DD
RL Voltage	-	86
RL Amperage	-	1.2
Suction ESP	-	-0.17"
Discharge ESP	-	ATM
Total ESP	-	0.17"

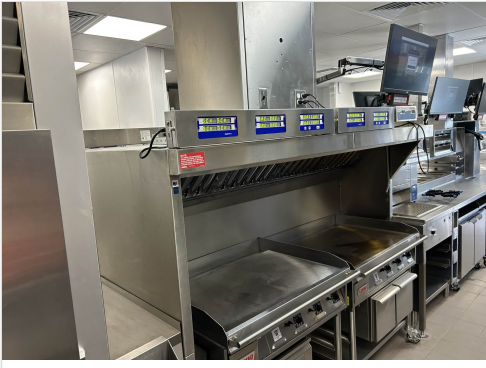
Unit Data - PHOTO LOG

Asset: HD1

Test Data Exhaust		
	Design	Actual
Filter Type	BAFFLE	BAFFLE
Filter Size 1	12X20	12X20
Filter Qty 1	8	8
Filter AK factor size 1	1.50	1.50
Filter Total AK Area	12.00	12.00
Filter1 FPM	-	166
Filter2 FPM	-	190
Filter3 FPM	-	185
Filter4 FPM	-	140
Filter5 FPM	-	170
Filter6 FPM	-	190
Filter7 FPM	-	180
Filter8 FPM	-	149
Filter Ave FPM(corr)	-	171
CFM	1995	2052

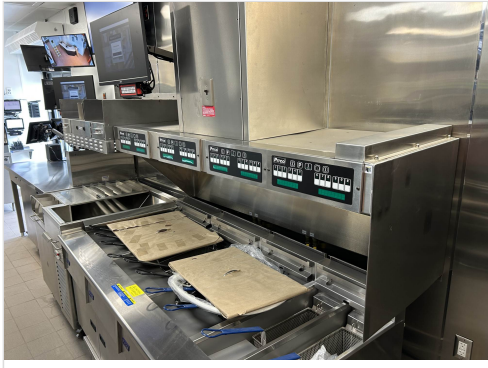
Unit Data - PHOTO LOG

Asset: HD2

Test Data Exhaust		
	Design	Actual
Filter Type	-	BAFFLE
Filter Size 1	-	12X20
Filter Size 2	-	12X16
Filter Qty 1	-	1
Filter Qty 2	-	3
Filter AK factor size 1	-	1.50
Filters AK factor size 2	-	1.16
Filter Total AK Area	-	4.98
Filter1 FPM	-	242
Filter2 FPM	-	276
Filter3 FPM	-	273
Filter4 FPM	-	222
Filter Ave FPM(corr)	-	253
CFM	1216	1260
