Report: TAB Report
Function: Test, Adjust, & Balance
Date: 12/17/2025
Completed By: National TAB

12-08-25 WHATABURGER #1667 LARGO, FL

Whataburger Restaurants
300 Concord Plaza Dr
San Antonio, TX 78216

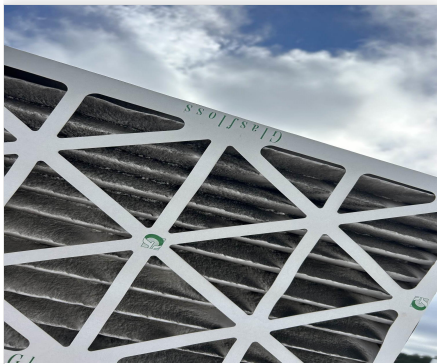
Issue Name : RTUs 1, 2 - Filters Dirty
Description : Final filters are dirty in RTUs 1 and 2 and will need replaced soon.
Created By : National TAB **Assigned To :** National TAB - Will Turnbough
Status : Open
Priority : Medium **Asset Tag :**
Originated Date : 12/12/2025 - Mark Johnson - National TAB

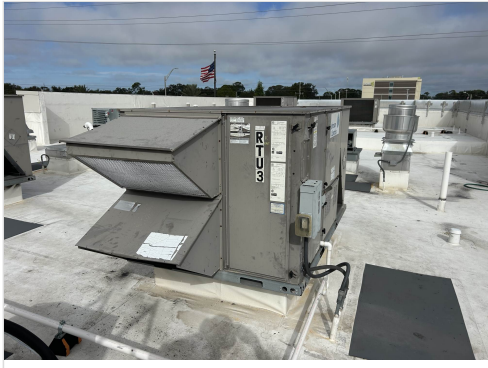
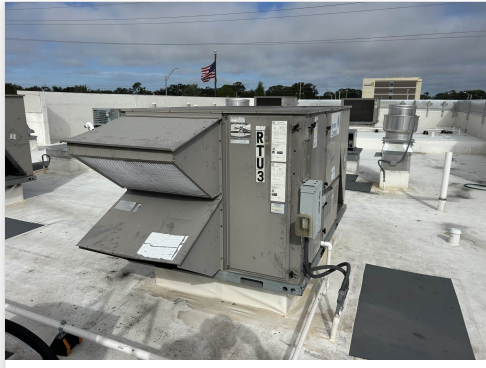
Unit Data - PHOTO LOG

Asset: RTU3

General	
	Actual
Unit free of Damage	NO
Fan Rotation Correct	YES
Unit Filters Clean	YES
Condensate Drain Installed	YES
