Report: TAB Report
Function: Test, Adjust, & Balance
Date: 12/17/2025
Completed By: National TAB

12-08-25 WHATABURGER #1667 LARGO, FL

10150 ULMRETON ROAD

Whataburger Restaurants
300 Concord Plaza Dr
San Antonio, TX 78216

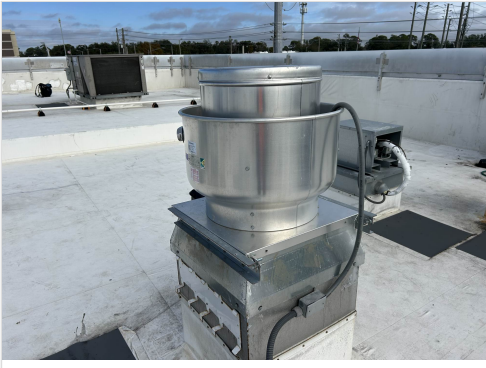
Asset: EF1

Unit Data		
	Design	Actual
MFG	GREENHECK	GREENHECK
Model Num	CUE-140-VG	CUE-140-7-VG-1-26-G
Serial Num	-	27765134
Type	UPBLAST	UPBLAST
Configuration	VERTICAL	VERTICAL

Test Data		
	Design	Actual
CFM	1995	2052
Fan RPM	1517	DD
Fan Rotation	-	CW
Motor RPM	-	DD
System SetPt	-	SPEED CONTROLLER (MARKED)
RL Voltage	-	123
RL Amperage	-	2.6
Total ESP	1.00"	0.39"
Fan Inlet SP	-	-0.39"
Fan Discharge SP	-	ATM

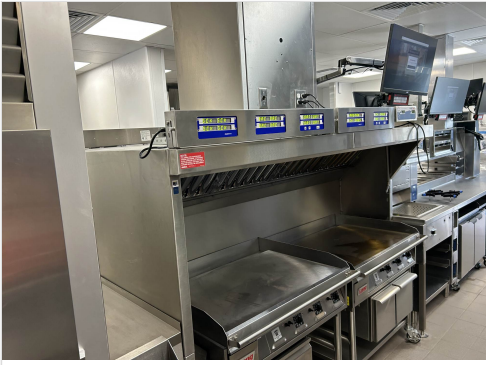
Asset: HD1

Unit Data		
	Design	Actual
MFG	H&K DALLAS	H&K INTERNATIONAL
Model Num	HKD027	HKD027
Job / Serial Num	-	8157757-001
Type	TYPE 1 CANOPY	TYPE I LOW PROXIMITY
Hood length	86.78"	86.78"
Hood Width	55.63"	55.88"

Test Data Exhaust		
	Design	Actual
Filter Type	BAFFLE	BAFFLE
Filter Size 1	12X20	12X20
Filter Qty 1	8	8
Filter AK factor size 1	1.50	1.50
Filter Total AK Area	12.00	12.00
Filter1 FPM	-	166
Filter2 FPM	-	190
Filter3 FPM	-	185
Filter4 FPM	-	140
Filter5 FPM	-	170
Filter6 FPM	-	190
Filter7 FPM	-	180
Filter8 FPM	-	149
Filter Ave FPM(corr)	-	171
CFM	1995	2052
