**Report: FINAL TAB REPORT**  
**Function: Test, Adjust, & Balance**  
**Date: 8/5/2022**

**PROJECT**  
**07-11 TACO BELL - O'FALLON, MO**

4231 STATE HWY K

O'FALLON, MO

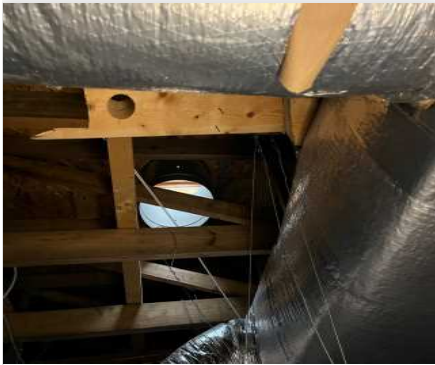
thumbnail\_image2.jpg

**Issue Name :** Building relief plenum

**Description :** Unit has bara metric relief damper, this allows this to be open at all times. Recommend installing a bara metric damper so it only opens when building is under positive pressure to ensure no airflow from outside gets into the ceiling (especially winter).

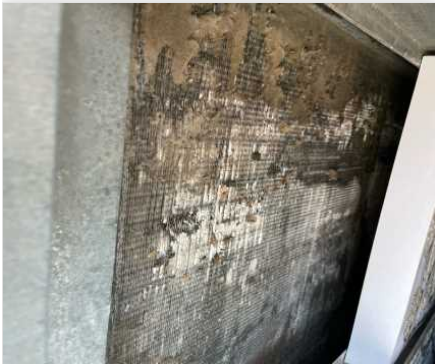
thumbnail\_image1.jpg

**Issue Name :** RTU2 Evap coil is dirty

**Description :** Coil is dirty, static pressure taken back up this observation. Coil needs to be cleaned, currently the unit is within design parameters.

Notes:[1] Unable to access fan sheave [2] Evap coil is dirty, unable to get it clean at time of balance [3] OA damper does not function, damper was manually set.

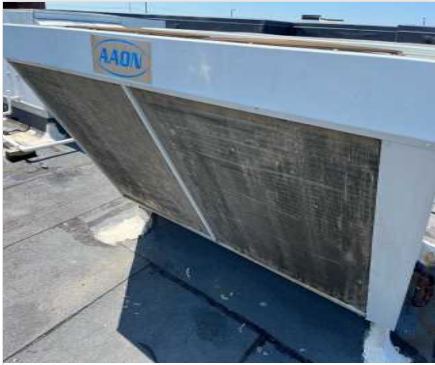
thumbnail\_image0.jpg

**Issue Name :** RTUs Condenser coils are dirty

**Description :** Condenser coils on both units are slightly dirty.

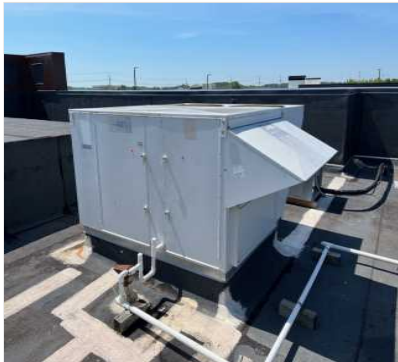
RTU-1

Unit Data		
	Design	Actual
MFG	AAON	AAON
Serial Num	-	200404-AMGL05827
Model Num	RK-15-2-FO-222	RM-015-8-0-AB02
Type	RTU	RTU
Configuration	VERTICAL	VERTICAL
Num OA Filters 1	-	1
OA Filter Size 1	-	39x19
Num Final Filter 1	-	6
Final Filter Size 1	-	16x20x2

Test Data		
	Design	Actual
SF CFM	4800	4602
SF RPM	-	[1]
RA CFM	3800	3563
OA CFM	1000	1039
RL Voltage	-	209/209/209
RL Amperage	-	10.1/10.1/10.1
SF Rotation	-	CCW, CORRECT
RA Damper Position	-	3.5" OPEN
Min OA Damper Position	-	0.5" OPEN
Min OA Damper Type	-	ECONOMIZER

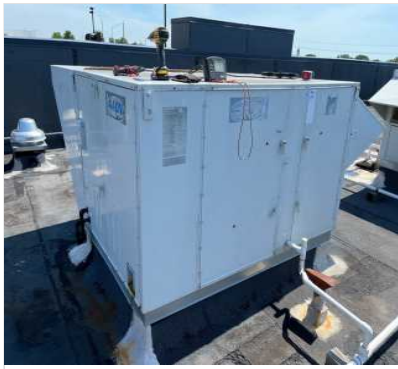
RTU-2

Unit Data		
	Design	Actual
MFG	AAON	AAON
Serial Num	-	200404-AMGL05828
Model Num	RK-15-2-FO-222	RM-015-8-0-AB02
Type	RTU	RTU
Configuration	VERTICAL	VERTICAL
Num OA Filters 1	-	1
OA Filter Size 1	-	39x19
Num Final Filter 1	-	6
Final Filter Size 1	-	16x20x2

Test Data		
	Design	Actual
SF CFM	4000	3868
SF RPM	-	[1]
RA CFM	3200	3117
OA CFM	800	751
RL Voltage	-	210/210/210
RL Amperage	-	8.2/8.2/8.2
SF Rotation	-	CCW, CORRECT
RA Damper Position	-	0.25" OPEN
Min OA Damper Position	-	3" OPEN
Min OA Damper Type	-	ECONOMIZER [3]

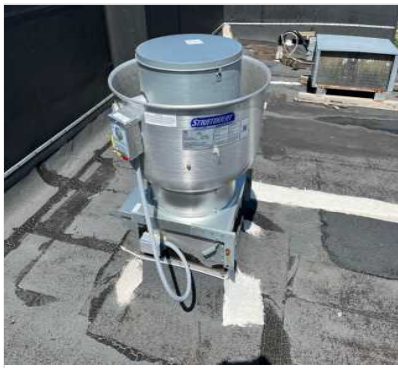
EF-1

Unit Data		
	Design	Actual
<b>MFG</b>	STRATOVENT	STRATOVENT
<b>Model Num</b>	SV-DU50HFA	SV-DU50HFA
<b>Serial Num</b>	-	5134613
<b>Type</b>	UPBLAST	UPBLAST
<b>Configuration</b>	VERTICAL	VERTICAL

Test Data		
	Design	Actual
<b>CFM</b>	1050	991
<b>Fan RPM</b>	1344	DD
<b>Fan Rotation</b>	-	CCW, CORRECT
<b>Motor RPM</b>	-	DD
<b>System SetPt</b>	-	LOW
<b>RL Voltage</b>	-	71
<b>RL Amperage</b>	-	4.1
<b>Total ESP</b>	0.9"	0.24"
<b>Fan Inlet SP</b>	-	-0.24"
<b>Fan Discharge SP</b>	-	ATM

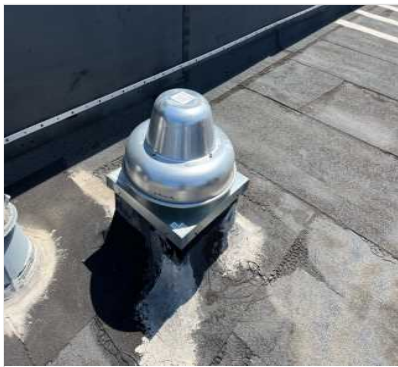
EF-2

Unit Data		
	Design	Actual
MFG	STRATOVENT	STRATOVENT
Model Num	SV-DR10HFA	SV-DR10HFA
Serial Num	-	5134613
Type	DOWNBLAST	DOWNBLAST
Configuration	HORIZONTAL	VERTICAL

Test Data		
	Design	Actual
CFM	150	150
Fan RPM	1095	706
Fan Rotation	-	CCW, CORRECT
Motor RPM	-	706
System SetPt	-	41%
RL Voltage	-	120
RL Amperage	-	0.25
Total ESP	0.25"	0.19"
Fan Inlet SP	-	-0.19"
Fan Discharge SP	-	ATM

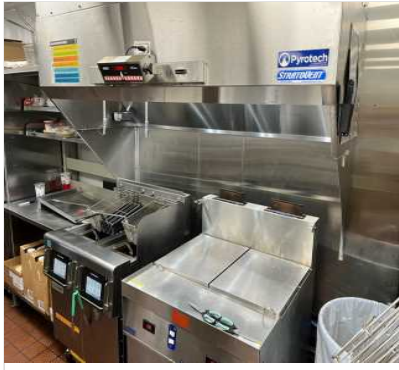
HOOD-1

Unit Data		
	Design	Actual
MFG	STRATOVENT	STRATOVENT
Model Num	SVBD2	3650 SV-BD-2
Job / Serial Num	-	5134613
Type	TYPE I LOW PROXIMITY	TYPE I LOW PROX
Hood length	75"	75"
Hood Width	36"	36"

Performance Data		
	Design	Actual
Smoke Generation Type	-	SMOKE EMITTER
Hood Capture %	-	100%
End Panels Installed (Y/N)	-	YES

Test Data Exhaust		
	Design	Actual
Filter Type	STAINLESS BAFFLE	BAFFLE
Filter Size 1	16X16	16X16
Filter Qty 1	4	4
Filter AK factor size 1	1.62	1.62
Filter Total AK Area	6.48	6.48
Filter1 FPM	-	150
Filter2 FPM	-	159
Filter3 FPM	-	153
Filter4 FPM	-	152
Filter Ave FPM(corr)	-	153
CFM	-	991
