**Report: TAB Report**  
**Function: Test, Adjust, & Balance**  
**Date: 10/15/2025**  
**Completed By: National TAB**

**PROJECT**  
**09-29-25 QT #1107 ANDERSON, SC**

QUIKTRIP  
4705 SOUTH 129TH EAST AVENUE  
TULSA, OK 74134

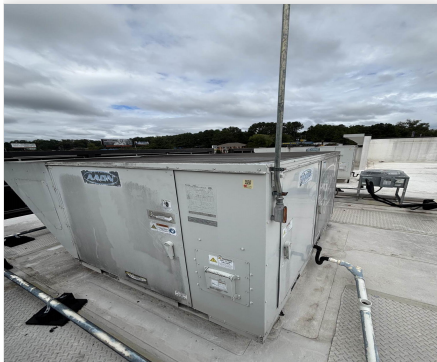
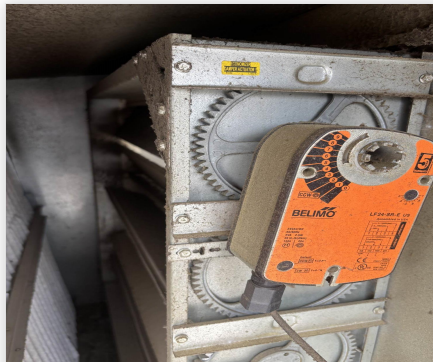
**Issue Name :** RTU-3 economizer doesn't close all the way  
**Description :** The economizer on RTU 3 does not close more than 0.75". This is enough for 807 CFM of OA but does not close enough to find a set point for the 350CFM of OA also required. (Picture shows lowest set point)  
**Created By :** National TAB                      **Assigned To :** National TAB - Brianna Biggs  
**Status :** Open  
**Priority :** Medium                                      **Asset Tag :** RT-3  
**Originated Date :** 09/30/2025 - Christian Moller - National TAB

Economizer will not shut enough to get 350CFM, even with it on 0V.

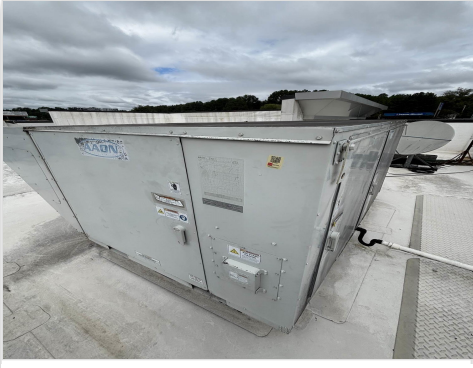
## Unit Data - PHOTO LOG

Unit Data		
	Design	Actual
MFG	NA	AAON
Serial Num	-	201107-ANEK05242
Model Num	NA	RN-013-8-0-EA0A-152
Num OA Filters 1	-	1
OA Filter Size 1	-	45X25

Test Data		
	Design	Actual
SF CFM	4200	4464
OA CFM (Hoods On)	800	825
OA CFM (Hoods Off)	350	335
RL Voltage	-	206/208/206
RL Amperage	-	6.9/6.1/5.8
VFD Max SetPt	-	37Hz
VFD Min SetPt	-	23Hz
OA Damper Position (Hoods On)	-	1"
OA Damper Position (Hoods Off)	-	0.1"

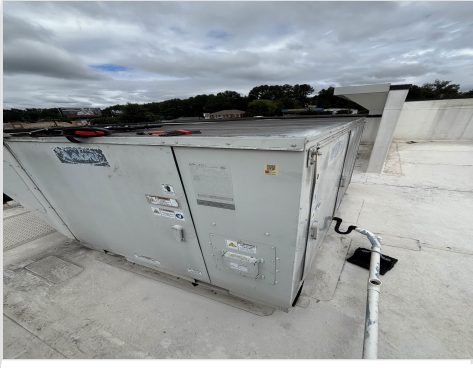
**Unit Data - PHOTO LOG**

Unit Data		
	Design	Actual
MFG	NA	AAON
Serial Num	-	201107-ANEK05243
Model Num	NA	RN-013-8-0-EA0A-152
Num OA Filters 1	-	1
OA Filter Size 1	-	45X25

Test Data		
	Design	Actual
SF CFM	4200	4346
OA CFM (Hoods On)	800	806
OA CFM (Hoods Off)	350	348
RL Voltage	-	207/207/208
RL Amperage	-	5.9/6.8/5.6
VFD Max SetPt	-	37Hz
VFD Min SetPt	-	23Hz
OA Damper Position (Hoods On)	-	1"
OA Damper Position (Hoods Off)	-	0.25"

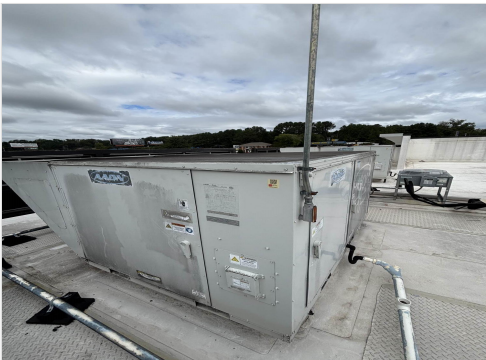
### Unit Data - PHOTO LOG

Unit Data		
	Design	Actual
MFG	NA	AAON
Serial Num	-	201107-ANEK05244
Model Num	NA	RN-013-8-0-EA0A-152
Num OA Filters 1	-	1
OA Filter Size 1	-	45X25

Test Data		
	Design	Actual
SF CFM	4200	4311
OA CFM (Hoods On)	800	807
OA CFM (Hoods Off)	350	807
RL Voltage	-	206/208/206
RL Amperage	-	4.6/5.3/4.8
VFD Max SetPt	-	34Hz
VFD Min SetPt	-	23Hz
OA Damper Position (Hoods On)	-	0.75"
OA Damper Position (Hoods Off)	-	0.75"

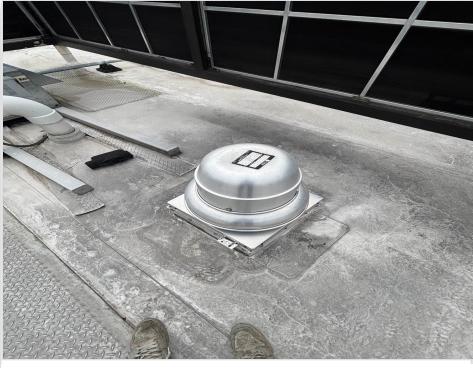
**Unit Data - PHOTO LOG**

Unit Data		
	Design	Actual
MFG	NA	COOK
Model Num	NA	90 ACEH 90C15DH
Serial Num	-	418SD68271- 00/0000701
Type	-	UPBLAST
Configuration	-	VERTICAL

Test Data		
	Design	Actual
CFM	225	324
Fan Rotation	-	CCW
System SetPt	-	SPEED CONTROLLER / HIGH
RL Voltage	-	110
RL Amperage	-	0.98
Total ESP	-	0.46"
Fan Inlet SP	-	-0.46"
Fan Discharge SP	-	ATM

Notes:  
[1] SPEED CONTROL NOT FUNCTIONAL; UNABLE TO REDUCE TO DESIGN AIRFLOW

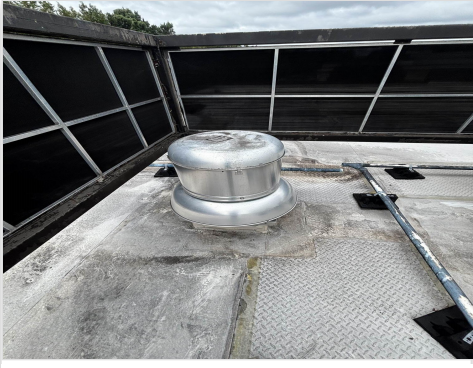
**Unit Data - PHOTO LOG**

Unit Data		
	Design	Actual
MFG	NA	COOK
Model Num	NA	120 ACE 120C13D
Serial Num	-	418SD68271- 00/00002201
Type	-	UPBLAST
Configuration	-	VERTICAL

Test Data		
	Design	Actual
CFM	525	483
Fan Rotation	-	CCW
System SetPt	-	SPEED CONTROLLER / HIGH
RL Voltage	-	110
RL Amperage	-	2.7
Total ESP	-	0.67"
Fan Inlet SP	-	-0.67"
Fan Discharge SP	-	ATM

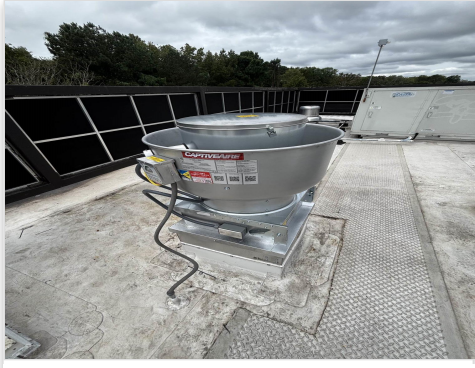
## Unit Data - PHOTO LOG

Unit Data		
	Design	Actual
MFG	NA	CAPTIVEAIRE
Model Num	NA	DU50HFA
Serial Num	-	7644874
Type	UPBLAST	UPBLAST
Configuration	VERTICAL	VERTICAL

Test Data		
	Design	Actual
CFM	1350	1385
Fan Rotation	-	CCW
System SetPt	-	HMI / 55.8Hz
RL Voltage	-	210
RL Amperage	-	3.1
Total ESP	-	NR
Fan Inlet SP	-	NR
Fan Discharge SP	-	ATM

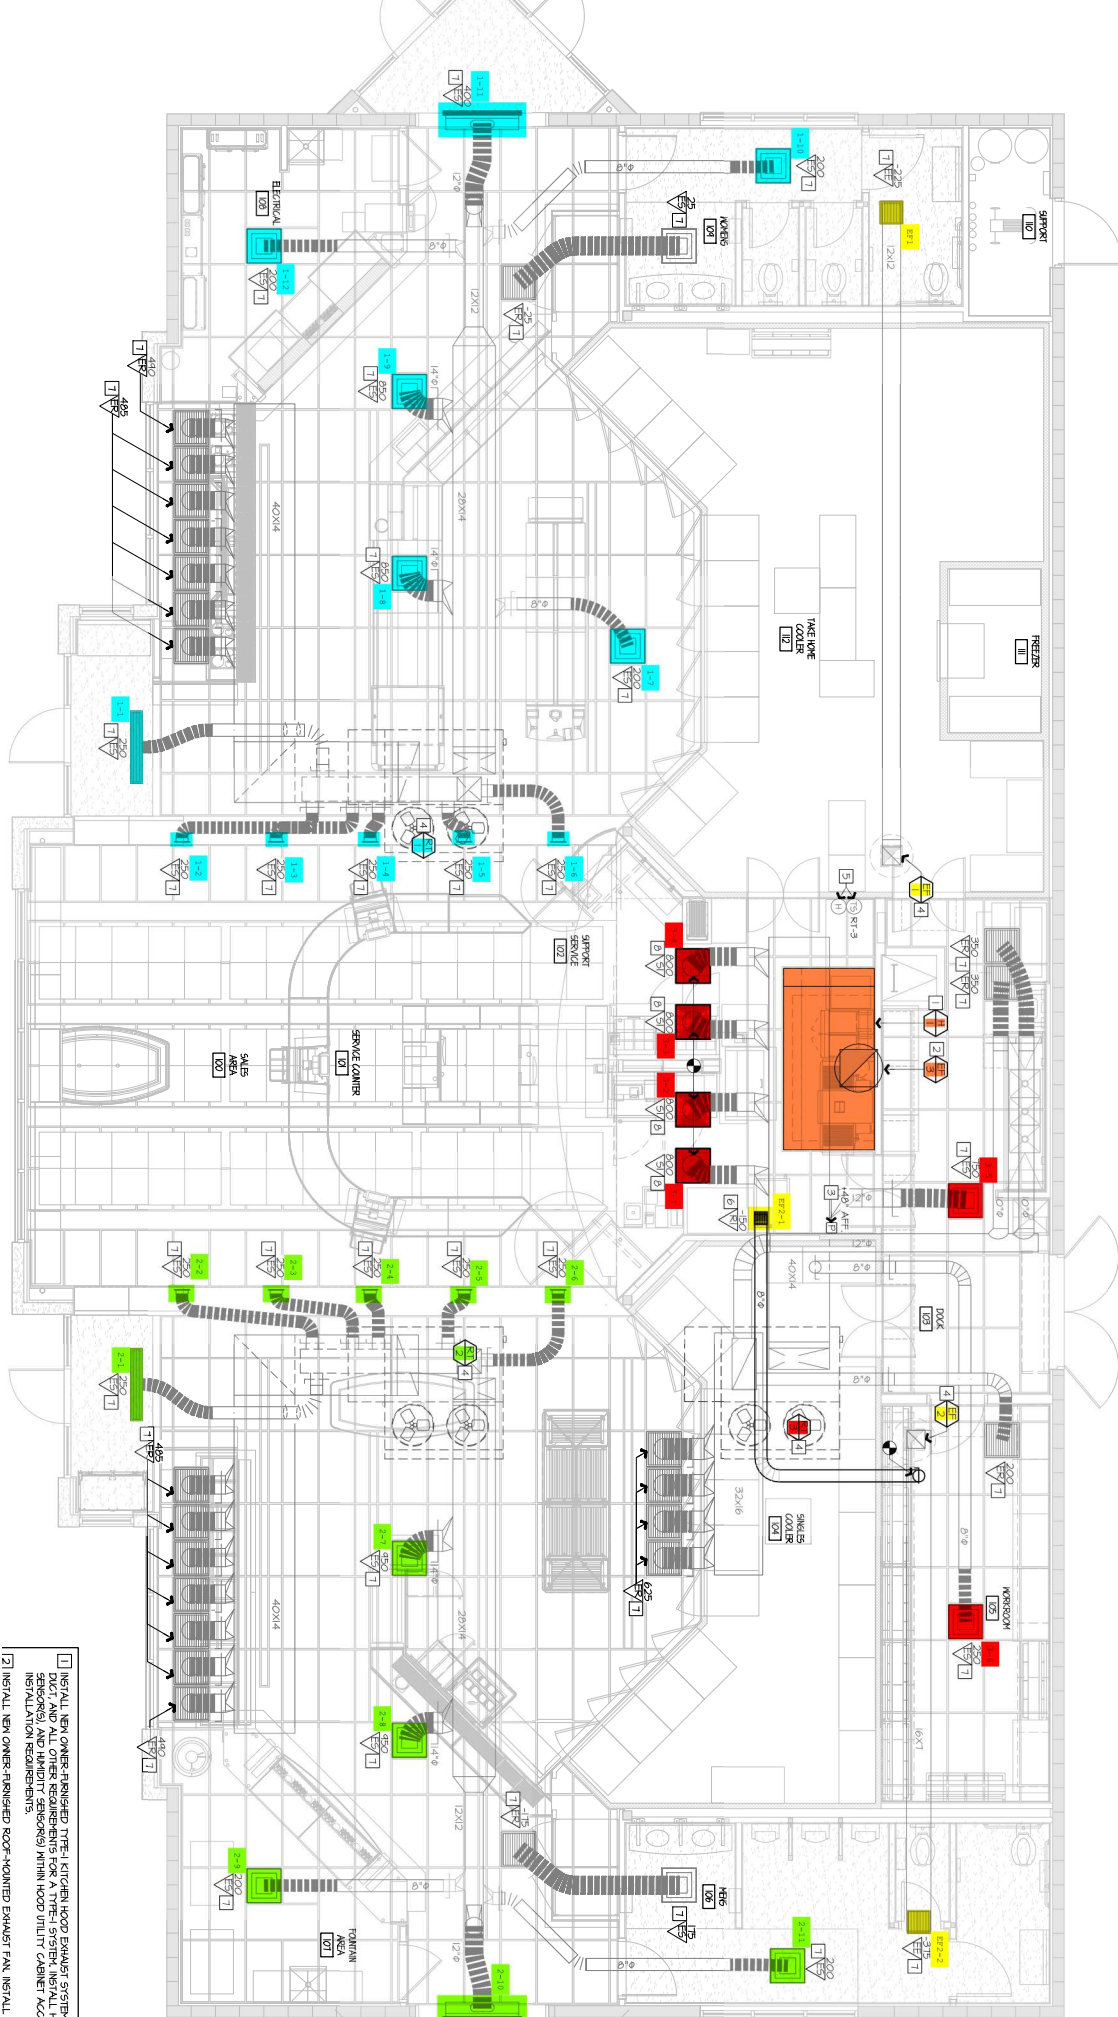
[1] INSTALL NEW OWNER-DESIGNED TYPICAL KITCHEN HOOD EXHAUST SYSTEM PER THE FOLLOWING SECTION (SENSORS, AND HEAVY-DUTY SENSORS) WITHIN HOOD UTILITY CABINET ACCORDING TO MANUFACTURER'S INSTALLATION REQUIREMENTS.  
 [2] INSTALL NEW OWNER-DESIGNED ROOF-MOUNTED EXHAUST FAN. INSTALL 12" Ø.
