**Report: TAB Report**  
**Function: Test, Adjust, & Balance**  
**Date: 05/06/2025**  
**Completed By: National TAB**

## 05-05-25 CHIPOTLE #5558 OWATONNA, MN

# National TAB

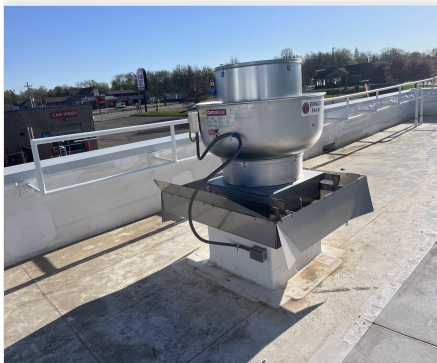
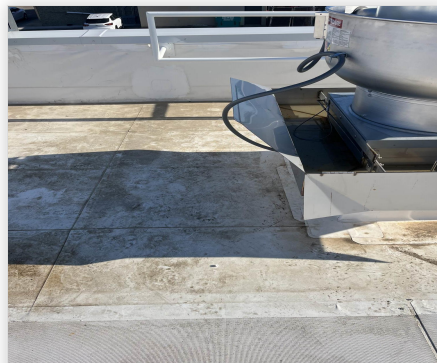
**Issue Name :** EF-1: Electrical Conduit  
**Description :** Electrical conduit for EF-1 is restricted by viroguard when fan is hinged back for cleaning or guard is opened This may lead to wear or damage during future duct cleaning. Recommend conduit is lengthened or reconfigured.  
**Created By :** National TAB                      **Assigned To :** National TAB - Brianna Biggs  
**Status :** Open  
**Priority :** Low                                      **Asset Tag :**  
**Originated Date :** 05/06/2025 - Michael McDonnell - National TAB

However, conduit being caught on viroguard, recommend addressing.

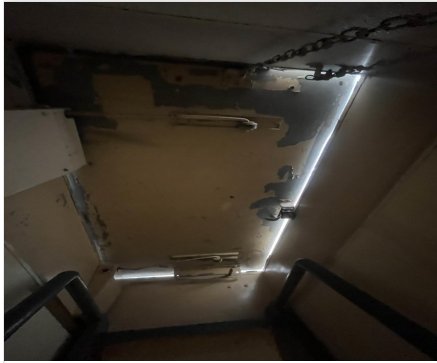
**Issue Name :** Roof Hatch Not Sealed.  
**Description :** Appears roof Hatch is existing. Does not fully close and seal.  
**Created By :** National TAB                      **Assigned To :** National TAB - Brianna Biggs  
**Status :** Open  
**Priority :** Low                                      **Asset Tag :**  
**Originated Date :** 05/06/2025 - Michael McDonnell - National TAB

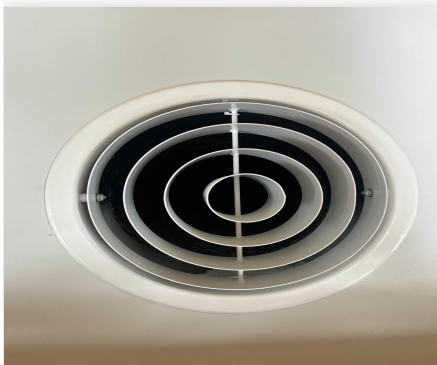
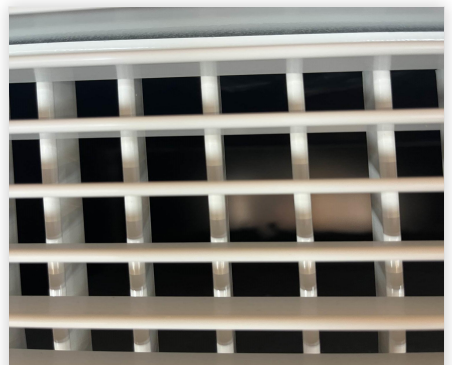
**Issue Name :** RTU-2: Accessible Dampers Not Installed  
**Description :** Per grille schedule, installed SR1 and SR2 grilles to have face accessible OBDs. None are installed. It appears dampers were installed closer to the takeoffs for several Grilles, but these are not accessible due to ceiling obstructions. Total airflow for the unit is at design and unit serves large space, not anticipated to cause issue.

[1] FACE ACCESSIBLE OBDs NOT INSTALLED PER DIFFUSER SCHEDULE, UNABLE TO INDIVIDUALLY BALANCE DIFFUSERS. TOTAL IS AT DESIGN AIRFLOW, NOT ANTICIPATED TO CAUSE ANY ISSUE AS UNIT SERVES SINGLE LARGE OPEN SPACE.

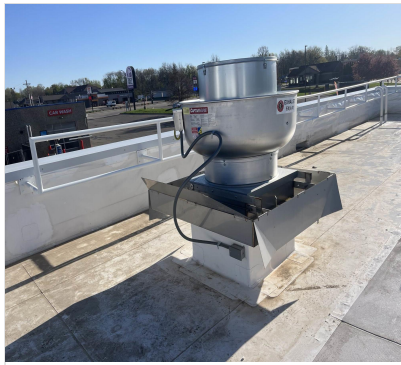
<b>Flex conduit is long enough so that fan can be completely tilted back?</b>	Yes
---	-----
