Report: TAB REPORT
Function: Test, Adjust, & Balance
Date: 10/17/2023

10-16-23 TRUE FOOD - SANTA MONICA, CA

The purpose of the visit to True Food in Santa Monica was to address hood capture issues.

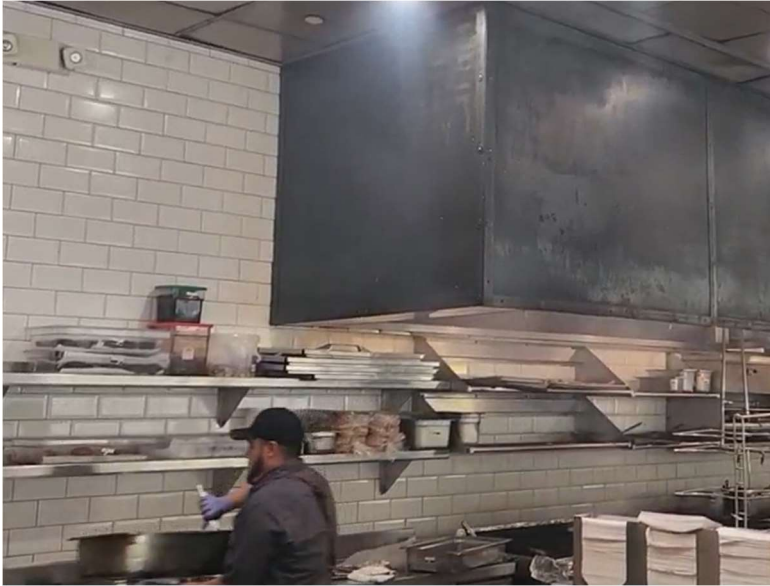
4. The shelving and salamander above the equipment creates more adverse effects on hood performance at the cooking surface. Especially the shelving that is over equipment then continues to the left to go outside the hood. All smoke under shelving will travel left, continue out of the hood and then into space. The shelving needs to stop 12" from left end of hood and then at least partial end panel-30" wide & down 6" below the shelving in hood.

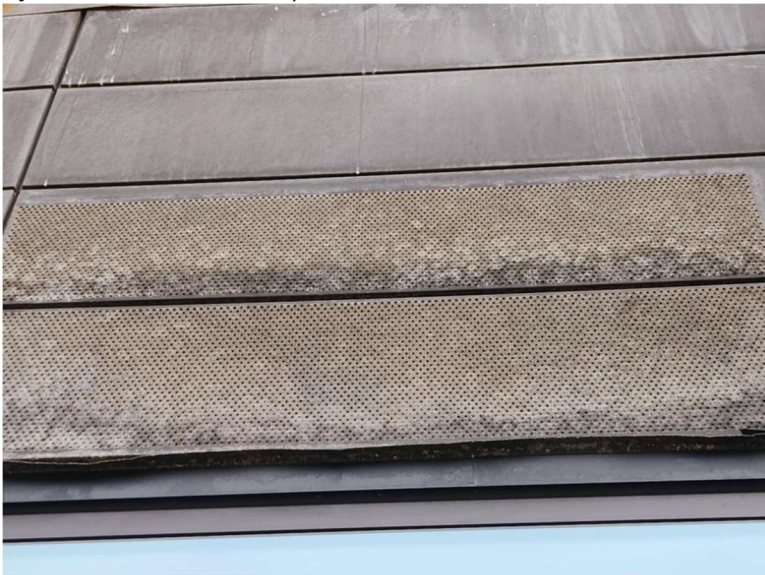
6. MUA airflow is 3487 CFM (68% of design). Part of the reason is that the intake louver appears to be clogged. Recommend cleaning (wait until after changes to exhaust

system are addressed)

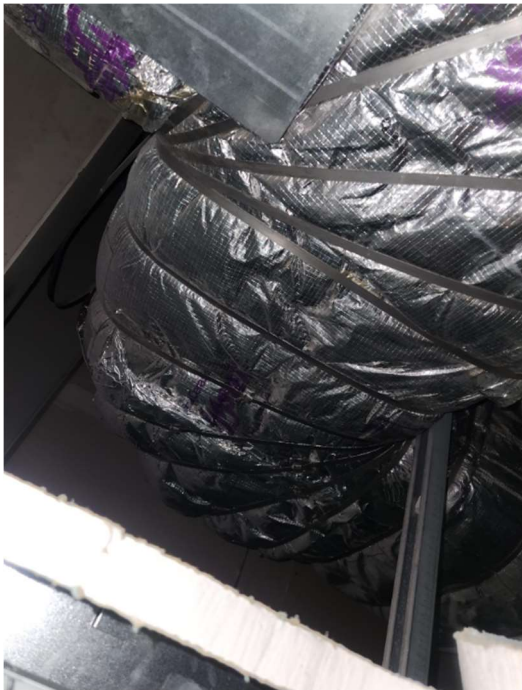
3rd floor back to back 90's:

1. The main hood EF is 4144 CFM out of original design of 6400 CFM. The airflow is low primarily due to pressure losses from multiple 90 degree transitions (some back to back) and system effect losses. A new larger fan will likely be required, however the pressure would have to double based on fan law to achieve the original design (7" @ 6400 CFM). This pressure may not be realistic. Also the more you increase velocity in the duct, the higher the impact due to system losses is. This means that airflow may not increase as much as predicted due to these transitions. Either way, it looks like a larger fan is needed. But there may be a need to have some of the ductwork modified if we cannot overcome the back to back 90 degree transitions to get optimum performance. Recommend consulting an OEM to discuss options.

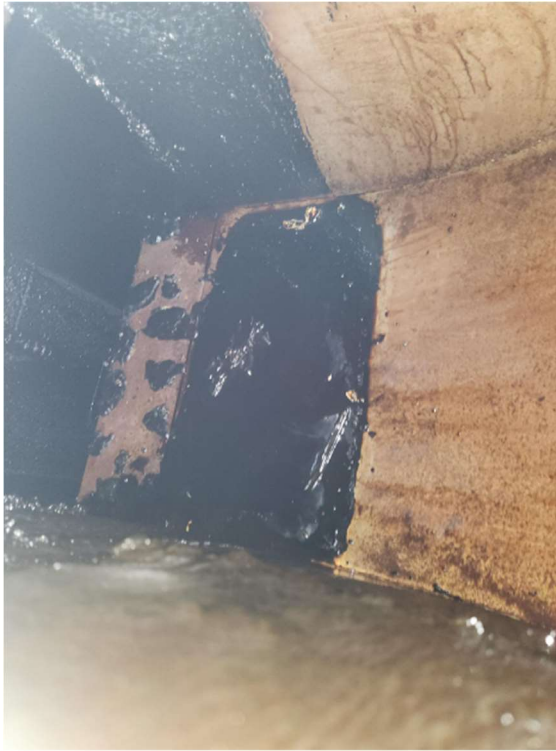
3rd floor inside the 90's

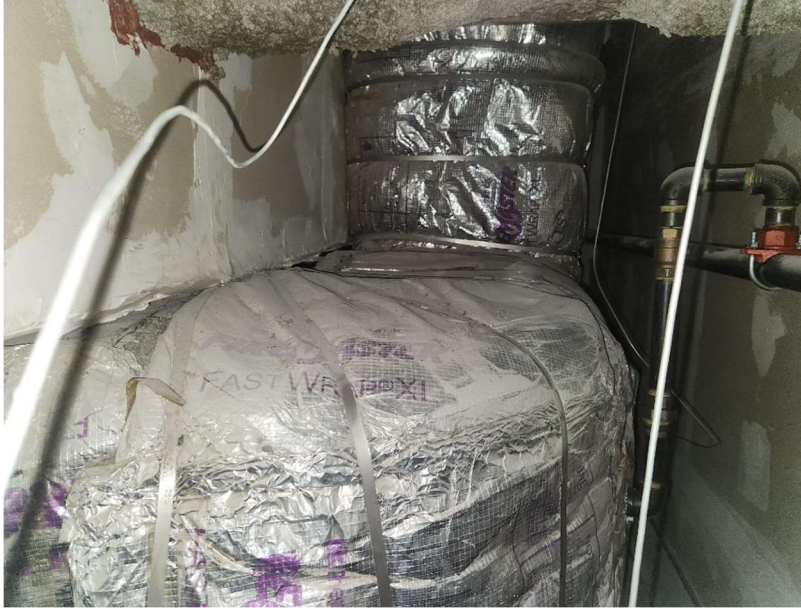
1st floor back to back 90's

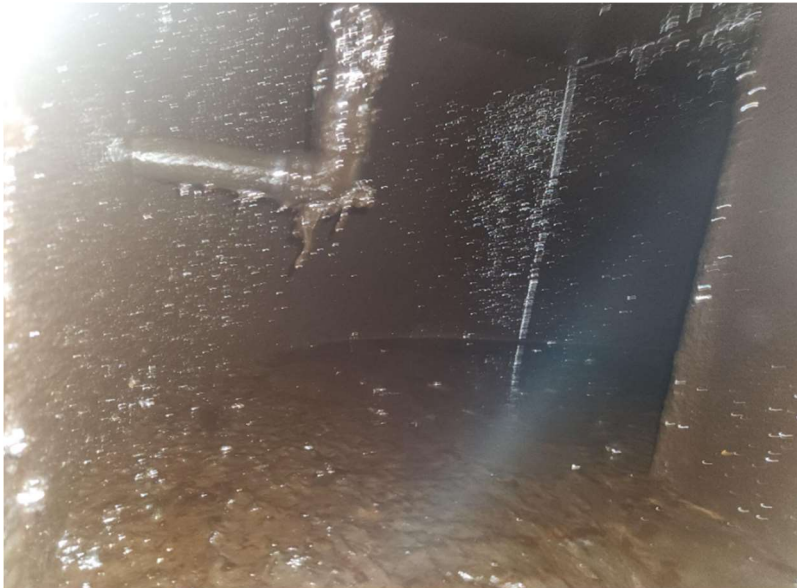
1st floor inside the duct. Pools of grease

2. Grease duct is extremely dirty both in True Food space and out side of it. Recommend the ductwork be thoroughly cleaned. This buildup could be having an impact on airflow, so cleaning thoroughly may increase flow some.

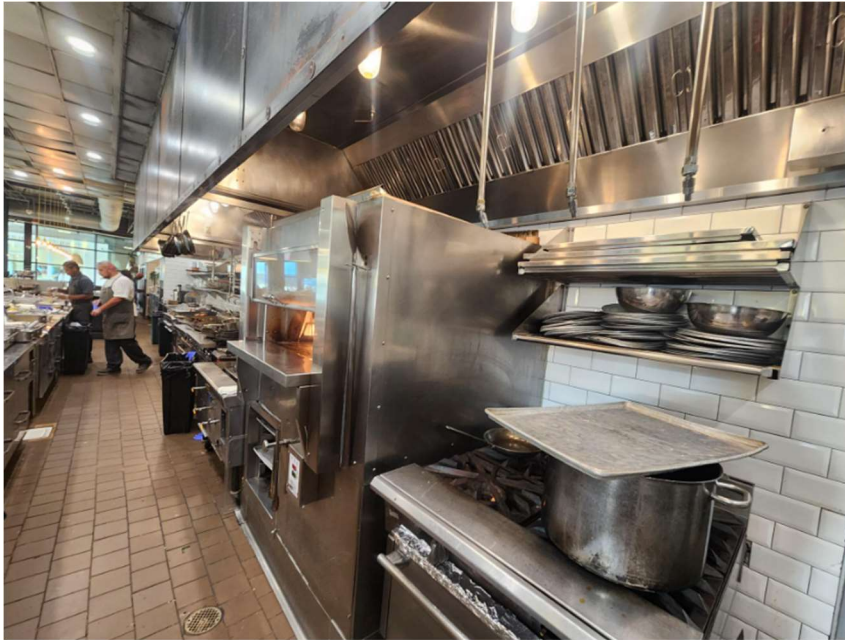
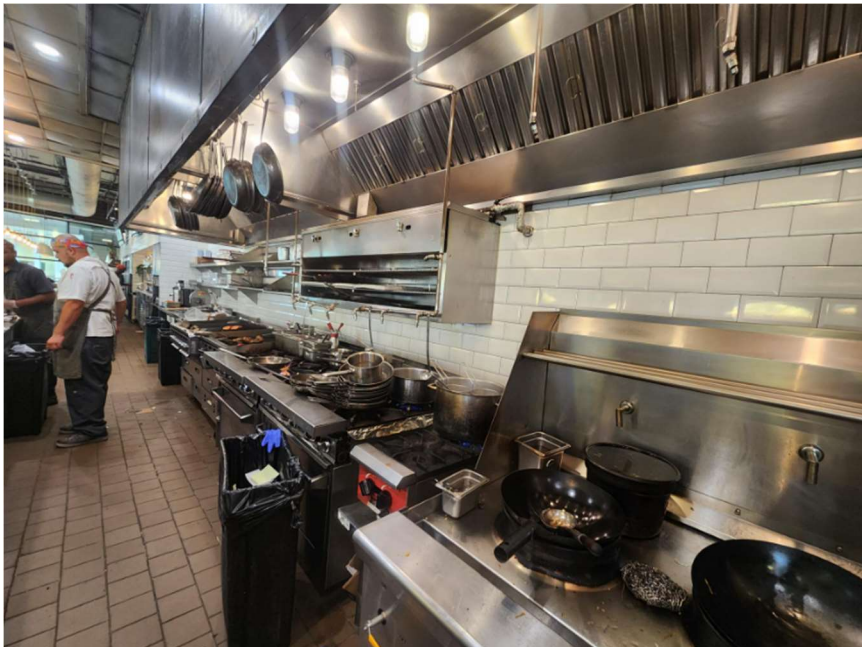
Hood pictures:

While cooking was occurring hood capture was observed to be around 60-70%. A smoke test with a smoke emitter was also used and similar capture observed. The smoke primarily escapes once entering the canopy and then billows out on all sides. The airflow was read out with a velocity matrix which totaled out to 4144 CFM of exhaust which is 69% of design. There are dampers installed at the hood risers and it was confirmed that these were fully open. It was also confirmed that the riser sizes matched design.

3. Vertical end panels need to be installed on both ends of the hood. Mocked up cardboard to temporarily test and this improved capture.

7. The MUA perforated discharge at the hood is an old style and has fairly uneven velocities. Increasing the airflow will cause velocities to get more uneven and more turbulent which could worsen hood capture issues. Recommend installing a new PSP and widening to reduce the velocities and creating a more even curtain of air. Recommend contacting a hood OEM.
