Report: TAB REPORT
Function: Test, Adjust, & Balance
Date: 01/16/2023

**01-09-23 WALGREENS #03606 -
SARASOTA, FL**

6465 S TAMIAMI TRL

SARASOTA, FL 34231

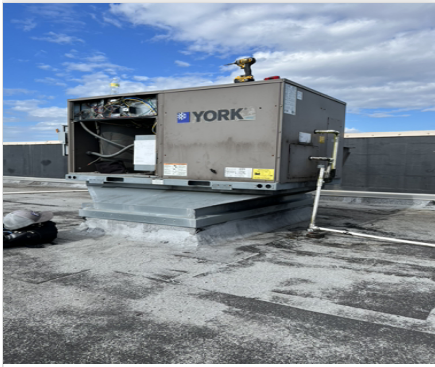
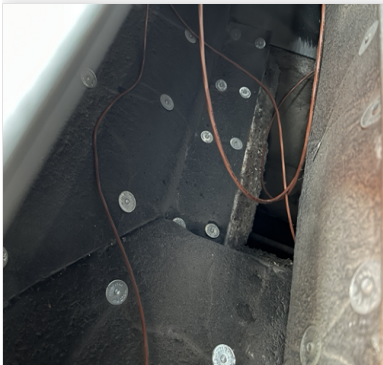
Issue Name : RTU-3 Airflow

Description : RTU-3 (Pharmacy) is a 5 ton unit that is operating at 1260 CFM out of design of 1750 CFM. The speed tap is set to the highest position. Airflow appears to be low due to severe curb transition (see pictures). Diffusers proportionally balanced.

- **02/23/2023** **National TAB - Ian Fuller**
 - Return duct opening is restricted and the air has to make a 90 degree turn inside the curb.

Notes: UNIT PROPOTIONALLY BALANCED TO 90% OF DESIGN. AIRFLOW IS ON LOW END OF TOLERANCE DUE TO TRANSITION IN CURB ADAPTER. MOTOR TAPS SET TO HIGH SPEED.

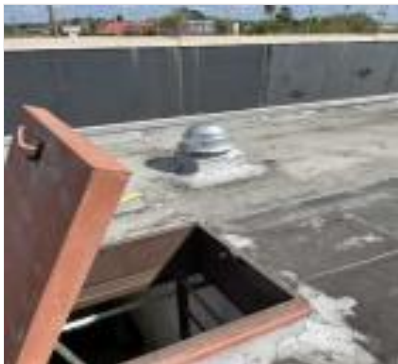
EF-3

Fan rotation is correct	Pass
Pulleys are aligned and belts are tensioned properly	N/A DIRECT DRIVE
Speed controller installed and functional (direct drive)	EMPLOYEE OFFICE SPEED CONTROLLER NOT FUNCTIONAL
Fan is secured to the curb	Pass
Back draft damper is installed and functional	Pass
No exterior damage to the fan	Pass
No unusual noise or vibration	Pass
Controls are functional	Fail
Additional Comments:	NOT ALL FANS ARE OPERATIONAL DUE TO CONTROLS
