Report: TAB REPORT
Function: Test, Adjust, & Balance
Date: 01/16/2023

**01-09-23 WALGREENS #03606 -
SARASOTA, FL**

6465 S TAMiami TRL

SARASOTA, FL 34231

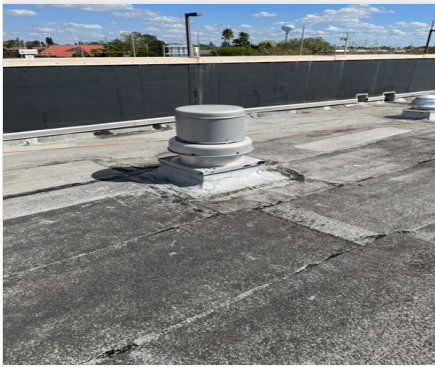
FuselT60e9118048c9418...

Issue Name : Existing EF-1 Not Functional

Description : EF-1 (Stock Room) is not running. No response from the fan when thermostat set point is changed within the stock room.

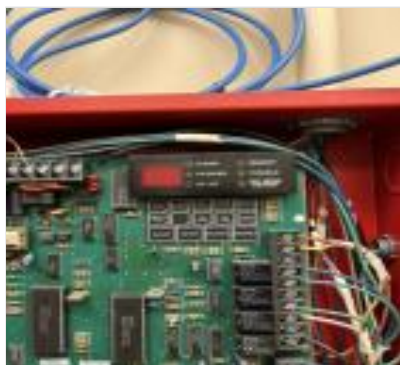
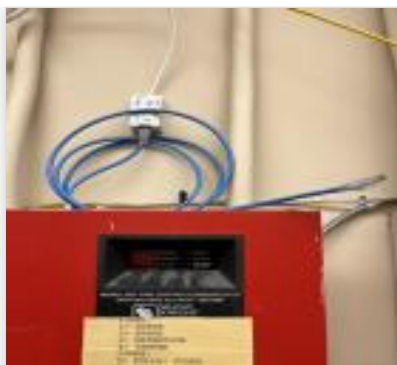
In duct smoke detectors are installed	Pass
Fire alarm panel status (visual inspection where possible)	NO MESSAGES DISPLAYED ON PANEL
