**Report: TAB REPORT**  
**Function: Test, Adjust, & Balance**  
**Date: 01/16/2023**

**01-09-23 WALGREENS #03606 -  
SARASOTA, FL**

Project: 01-09-23 WALGREENS #03606 - SARASOTA,FL

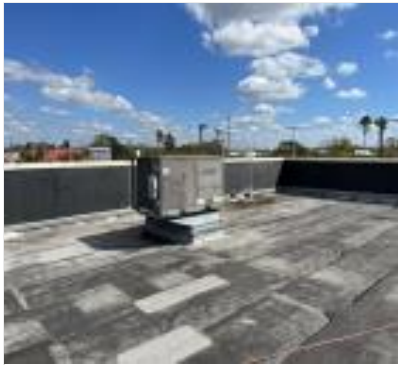
RTU-3

Notes: AIRFLOW IS ON LOW END OF TOLERANCE DUE TO TRANSITION IN CURB ADAPTER. MOTOR TAP SET TO HIGH SPEED.

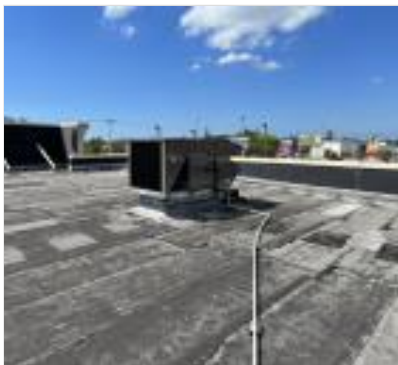
RTU-4

Notes: SERVICE DISCONNECT NOT FUNCTIONAL AT END OF BALANCING. UNIT WOULD NOT TURN ON TO COMPLETE TAB.

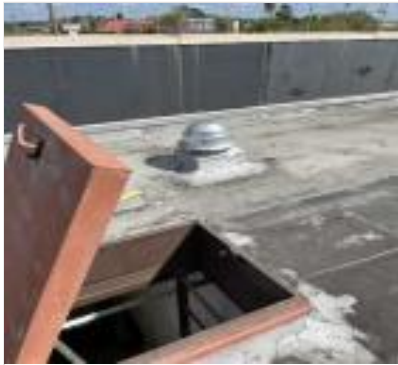
EF-3

Fan rotation is correct	Pass
Pulleys are aligned and belts are tensioned properly	N/A DIRECT DRIVE
Speed controller installed and functional (direct drive)	EMPLOYEE OFFICE SPEED CONTROLLER NOT FUNCTIONAL
Fan is secured to the curb	Pass
Back draft damper is installed and functional	Pass
No exterior damage to the fan	Pass
No unusual noise or vibration	Pass
Controls are functional	Fail
Additional Comments:	NOT ALL FANS ARE OPERATIONAL DUE TO CONTROLS
