Report: TAB REPORT
Function: Test, Adjust, & Balance
Date: 02/20/2023

PROJECT
02-13-23 PENN STATION - DALLAS, NC

Table Of Contents

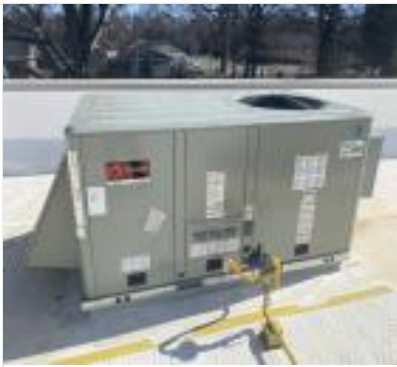
RTU1
02/13/2023

Test Data		
	Design	Actual
SF CFM	3000	2932
SF RPM	-	1045
RA CFM	2400	2310
OA CFM	600	622
RL Voltage	-	215.4/215.7/216.1
RL Amperage	-	2.9/3.1/2.7
SF Rotation	-	CW
RA Damper Position	-	79%
Min OA Damper Position	-	21%
Min OA Damper Type	-	ODB
OA Enthalpy Setpt	-	E

Notes: CONSTRUCTION FILTER//CLEAN

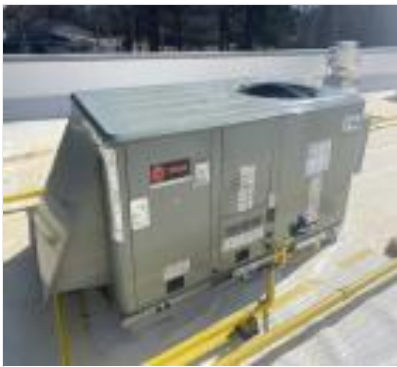
RTU2
02/13/2023

Notes: -NO OA FILTER - CONSTRUCTION FILTERS IN FILTER BANKS BUT THEY ARE CLEAN -ALL LINER DIFFUSER WHERE REPLACED WITH 24X24 DIFFUSERS LIKE THE OTHER ONES ON THE PLANS

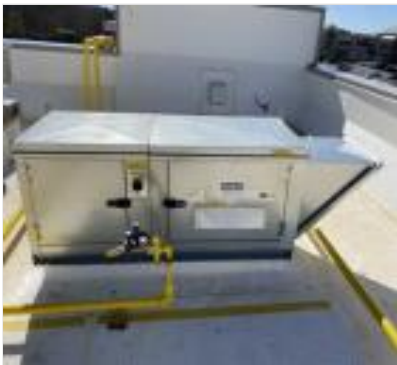
MUA1
02/13/2023

Issue Name : MUA Reduced From Design Airflow
Description : GRIDDLE UNABLE TO BE PLACED AGAINST THE WALL DUE TO GAS REGULATOR PLACEMENT. GRIDDLE STICKS OUT APROX 6" FROM THE WALL ON THE RIGHT SIDE PREVENT HOOD FROM 100% SMOKE CAPTURE UNDER DESIGN SPECIFICATIONS. TECHNICIAN ON SITE REDUCED OA FROM HOOD 1 IN ORDER TO GET 100% SMOKE CAPTURE.
Created By : National TAB **Assigned To :** National TAB - JOASH ALBIN
Status : Open
Originated Date : 05/17/2023 - Stephen Tassinaro - National TAB

Test Data		
	Design	Actual
CFM	1650	1257
SF RPM	1855	DD
Motor RPM	-	DD
SF System SetPt	-	40.4HZ
RL Voltage	-	139.4/135.6/138.4
RL Amperage	-	3.13/3.14/3.11

- **05/17/2023 National TAB - Stephen Tassinaro**
 - RECOMMEND RESOLVING GRIDDLE PLACEMENT AND INCREASING MUA TO POSITIVELY PRESSURIZE BUILDING WHILE MAINTAINING 100% SMOKE CONTAINMENT.

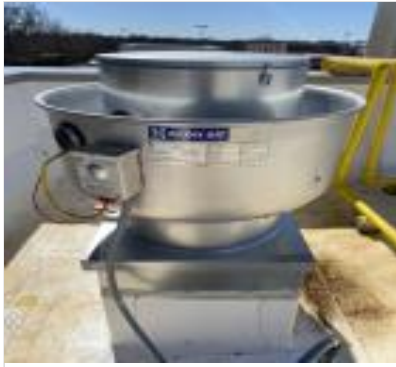
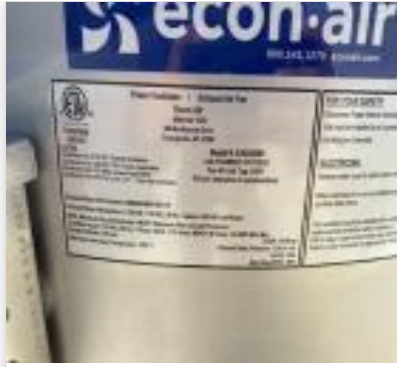
KEF1-1
02/13/2023

Test Data		
	Design	Actual
CFM	1120	1179
Fan RPM	1215	DD
Fan Rotation	-	DD CCW
Motor RPM	-	DD
System SetPt	-	50%
RL Voltage	-	125.1
RL Amperage	-	3.36
Total ESP	1.15"	0.63"
Fan Inlet SP	-	-0.63"
Fan Discharge SP	-	ATM

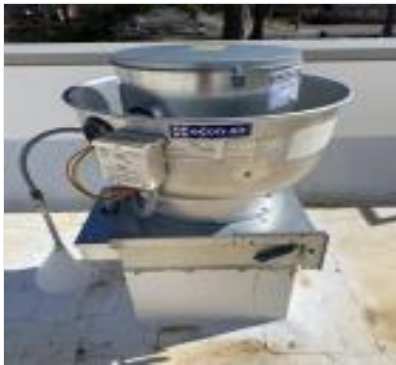
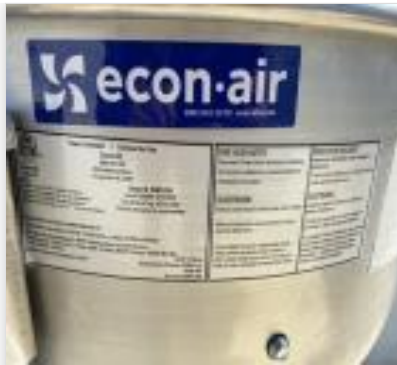
KEF2-1
02/13/2023

Test Data		
	Design	Actual
CFM	700	678
Fan RPM	1360	DD
Fan Rotation	-	DD CCW
Motor RPM	-	DD
System SetPt	-	85%
RL Voltage	-	125.6
RL Amperage	-	2.2
Total ESP	0.6"	0.97"
Fan Inlet SP	-	-0.97"
Fan Discharge SP	-	ATM

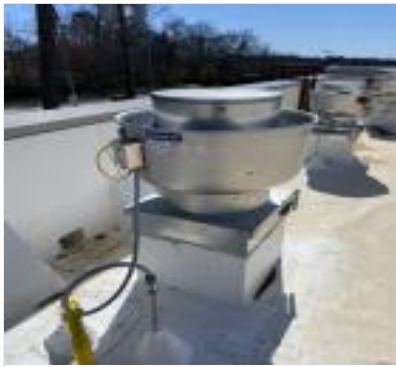
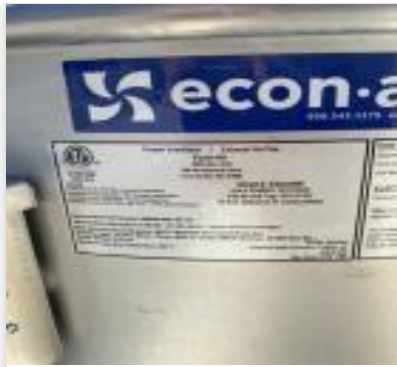
KEF3-1
02/13/2023

Test Data		
	Design	Actual
CFM	833	822
Fan RPM	1144	DD
Fan Rotation	-	DD CCW
Motor RPM	-	DD
System SetPt	-	50%
RL Voltage	-	125.2
RL Amperage	-	2.42
Total ESP	1.15"	0.65"
Fan Inlet SP	-	-0.65"
Fan Discharge SP	-	ATM

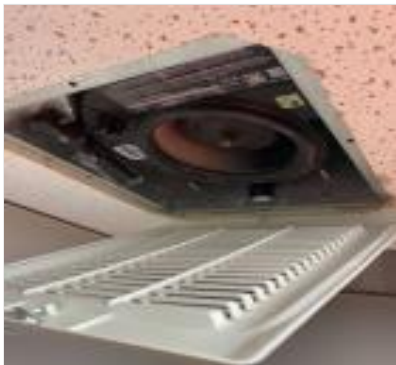
EF1
02/13/2023

Test Data		
	Design	Actual
CFM	75	78
Fan RPM	-	HIGH
Fan Rotation	-	CCW
RL Voltage	-	115
Total ESP	0.1"	NA

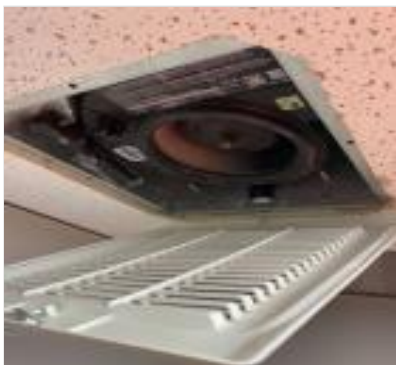
EF2
02/13/2023

Test Data		
	Design	Actual
CFM	75	79
Fan RPM	-	DD
Fan Rotation	-	CCW
RL Voltage	-	115
Total ESP	0.1"	NA

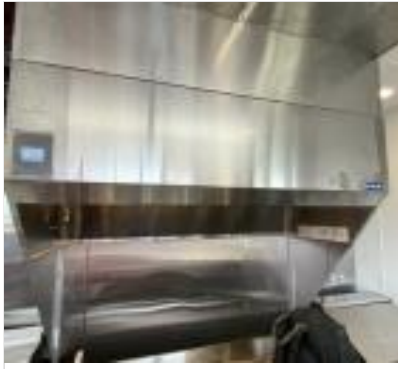
HOOD1
02/13/2023

SMOKE TEST WAS DONE WITH FOOD EQUIPMENT OFF BECAUSE STARTUPS ON FOOD SERVICE EQUIPMENT HAVE NOT BEEN CONDUCTED AT THAT TIME. GAS PIPING PREVENTED GRIDDLE FROM SITTING AGAINST THE BACK OF THE HOOD. INITIAL SMOKE TEST SHOWED THAT CAPTURE WAS AT 50%. TECHNICIAN ON SITE REDUCED MAU DESIGN FOR HOOD 1 SO THAT SMOKE CAPTURE WOULD BE 100%.

Test Data Supply		
	Design	Actual
Total AK Area	7	6.61
Kv factor (Vel)	0.89	0.89
Num of Readings	-	4
Reading1 FPM	-	115
Reading2 FPM	-	106
Reading3 FPM	-	115
Reading4 FPM	-	129
Ave FPM(corr)	-	103
CFM	1000	680

Test Data Exhaust		
	Design	Actual
Filter Type	CAPTRATE SOLO	CAPTRATE SOLO
Filter Size 1	16X16	16X16
Filter Qty 1	4	4
Filter AK factor size 1	1.62	1.62
Filter Total AK Area	6.48	6.48
Filter1 FPM	-	181
Filter2 FPM	-	177
Filter3 FPM	-	189
Filter4 FPM	-	181
Filter Ave FPM(corr)	-	182
CFM	1120	1179

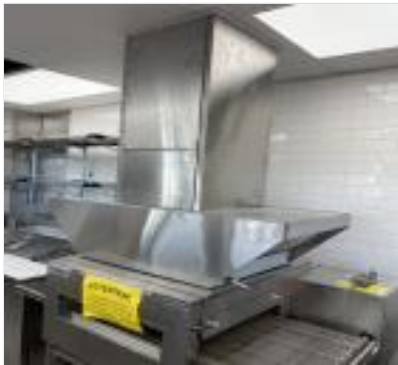
HOOD2
02/13/2023

Design	Actual
Filter Type	SS BAFFLE	BAFFLE
Filter Size 1	20X10	20X10
Filter Qty 1	2	2
Filter AK factor size 1	-	2.7
Filter1 FPM	-	245
Filter2 FPM	-	256
Filter Ave FPM(corr)	-	250
CFM	700	676

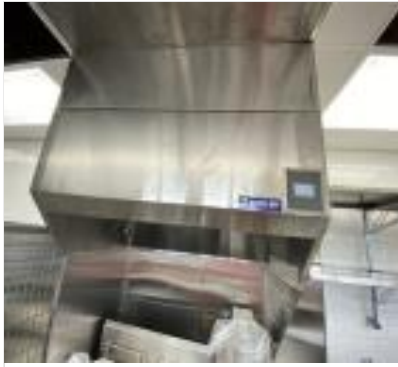
HOOD3
02/13/2023

Test Data Supply		
	Design	Actual
Total AK Area	4.8	3.9
Kv factor (Vel)	0.89	0.89
Num of Readings	-	4
Reading1 FPM	-	176
Reading2 FPM	-	167
Reading3 FPM	-	159
Reading4 FPM	-	164
Ave FPM(corr)	-	148
CFM	650	577

Test Data Exhaust		
	Design	Actual
Filter Type	CAPTRATE SOLE	CAPTRATE SOLO
Filter Size 1	16X16	16X16
Filter Qty 1	3	3
Filter AK factor size 1	1.62	1.62
Filter Total AK Area	4.86	4.86
Filter1 FPM	-	165
Filter2 FPM	-	169
Filter3 FPM	-	175
Filter Ave FPM(corr)	-	170
CFM	833	826

Notes: INITAIL SMOKE CAPTURE WAS 80%. REDUCED MAU IN ORDER TO GET A 100% CAPTURE

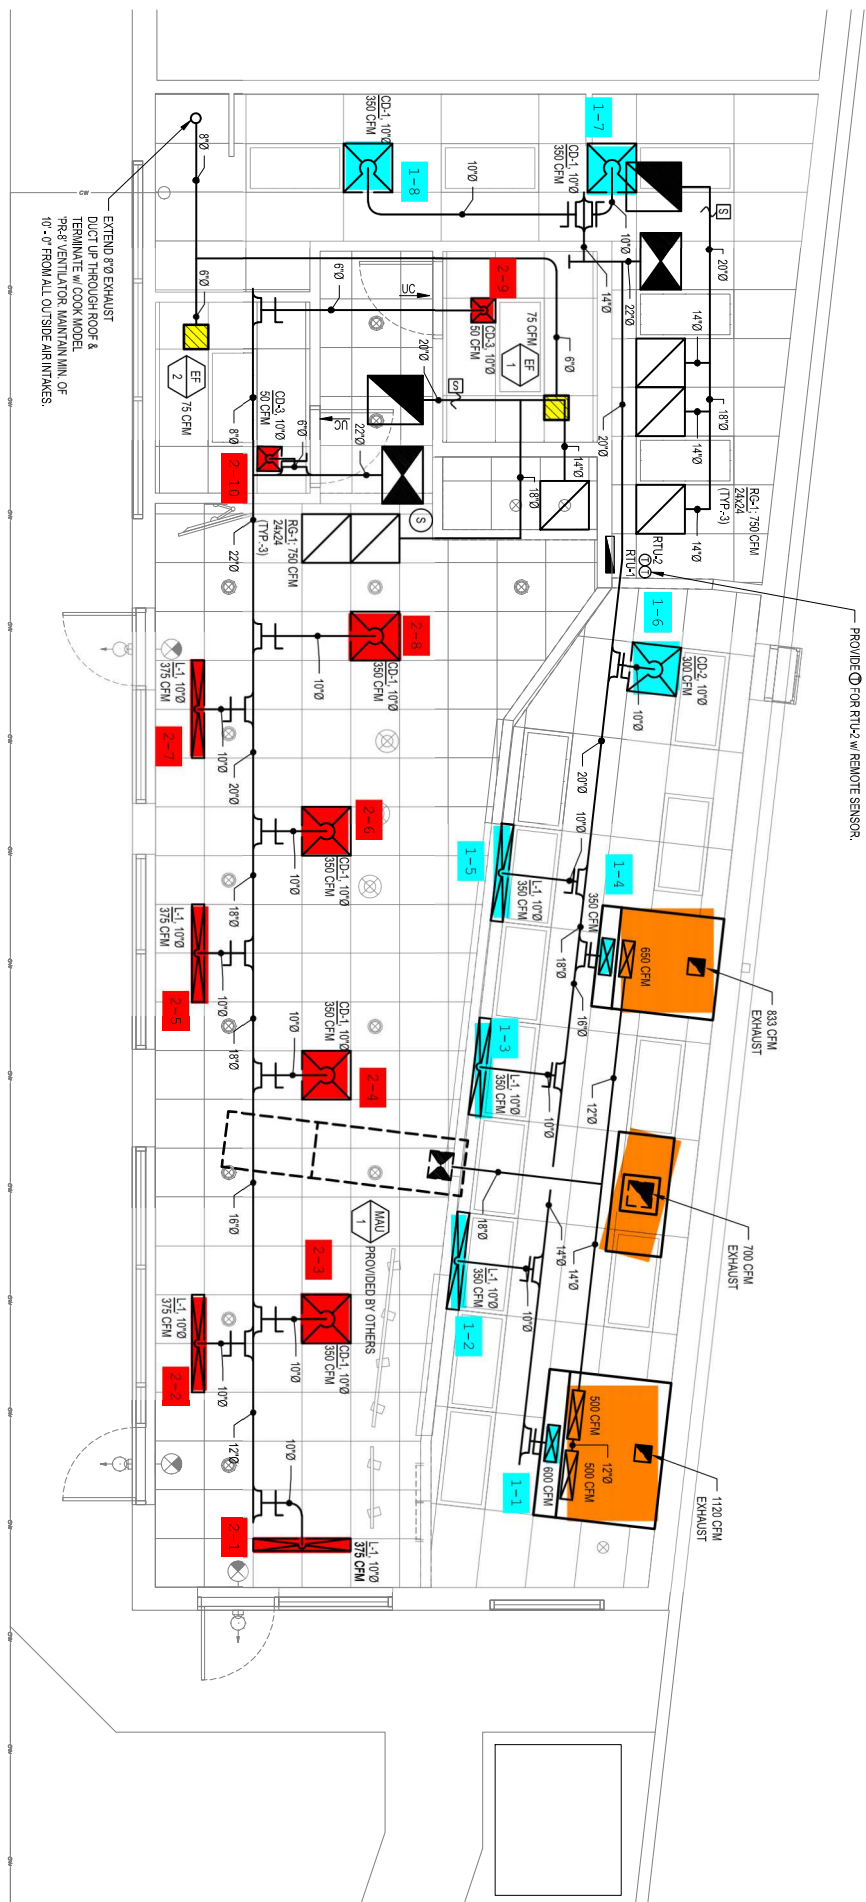
EXTEND 8" EXHAUST
 DUCT UP THROUGH ROOF &
 TERMINATE W/ COOK MODEL
 PR-8 VENTILATOR MAINTAIN MIN. OF
 10'-0" FROM ALL OUTSIDE AIR INTAKES.

PROVIDE FOR RTU-2 W/ REMOTE SENSOR.

833 CFM
 EXHAUST

700 CFM
 EXHAUST

1120 CFM
 EXHAUST
