**Report: TAB REPORT  
Function: Test, Adjust, & Balance  
Date: 02/20/2023**

**PROJECT  
02-13-23 PENN STATION - DALLAS, NC**

Project: 02-13-23 PENN STATION - DALLAS, NC

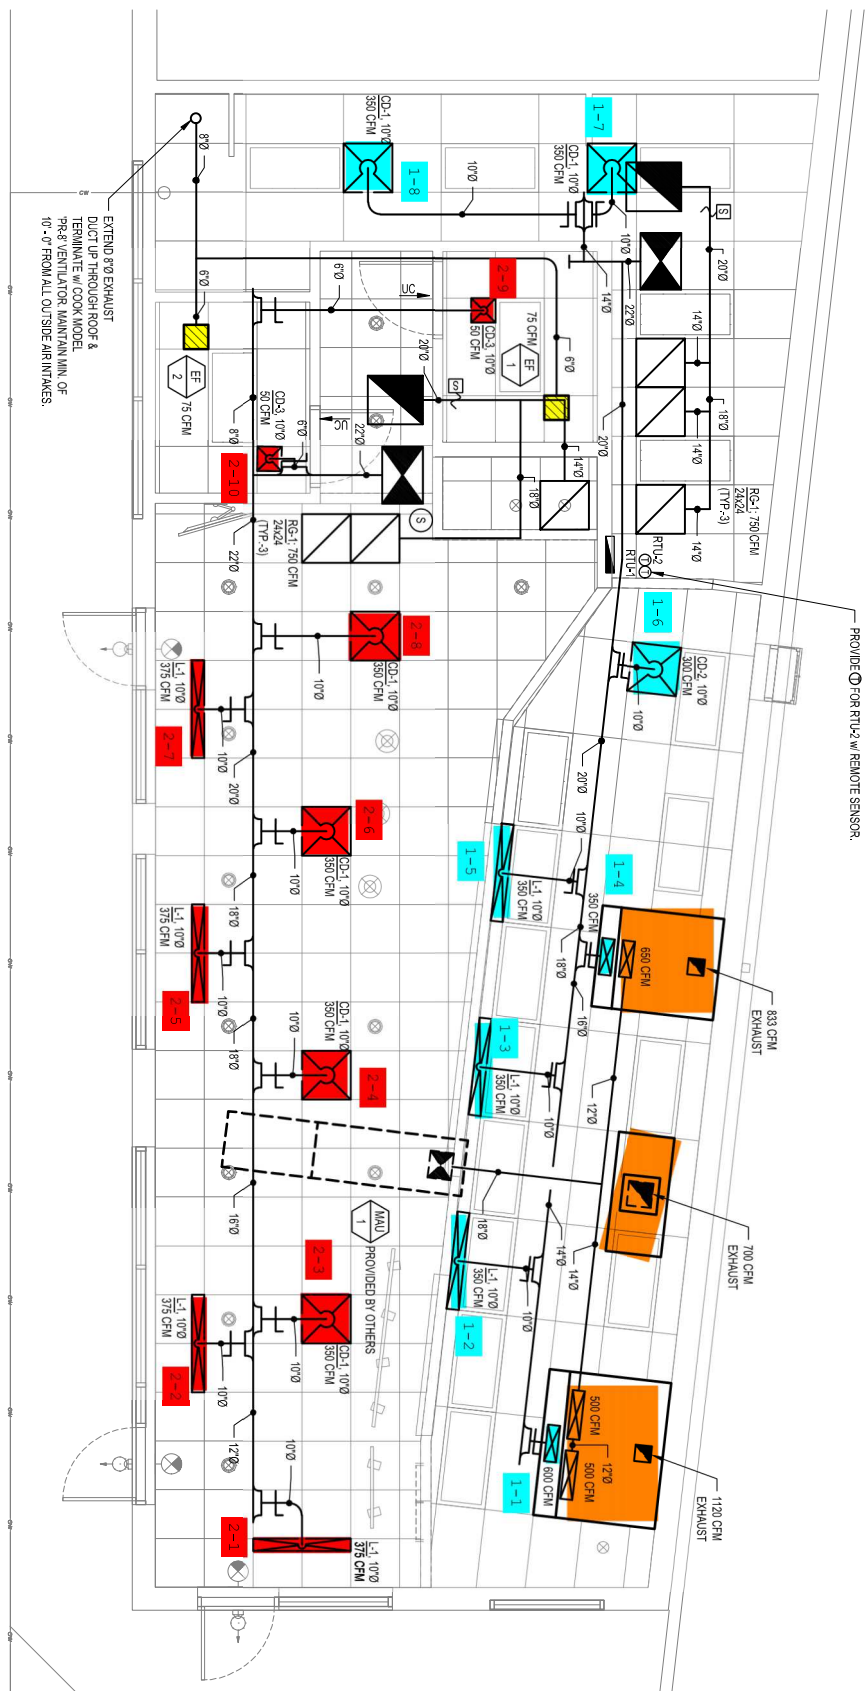
EXTEND 8" EXHAUST  
DUCT UP THROUGH ROOF &  
TERMINATE W/ COOK MODEL  
P-88 VENTILATOR MAINTAIN MIN. OF  
10'-0" FROM ALL OUTSIDE AIR INTAKES.

PROVIDE FOR RTU-2 W/ REMOTE SENSOR.

833 CFM  
EXHAUST

700 CFM  
EXHAUST

1120 CFM  
EXHAUST
