**Report: TAB REPORT
Function: Test, Adjust, & Balance
Date: 02/20/2023**

**PROJECT
02-13-23 PENN STATION - DALLAS, NC**

Project: 02-13-23 PENN STATION - DALLAS, NC

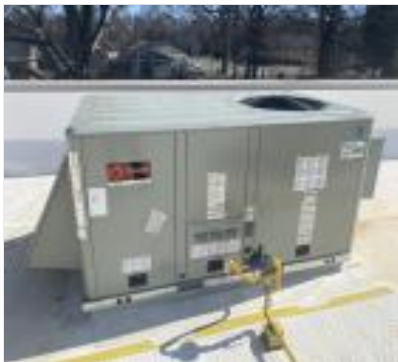
RTU-1

Test Data		
	Design	Actual
SF CFM	3000	2932
SF RPM	-	1045
RA CFM	2400	2310
OA CFM	600	622
RL Voltage	-	215.4/215.7/216.1
RL Amperage	-	2.9/3.1/2.7
SF Rotation	-	CW
RA Damper Position	-	79%
Min OA Damper Position	-	21%
Min OA Damper Type	-	ODB
OA Enthalpy Setpt	-	E

Notes: CONSTRUCTION FILTER//CLEAN

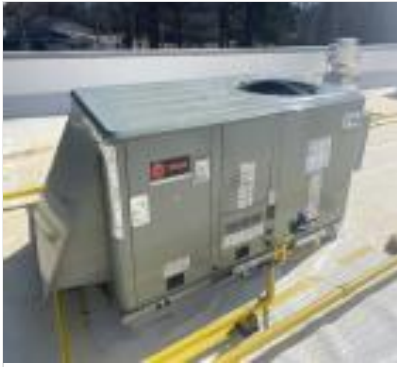
RTU-2

Test Data		
	Design	Actual
SF CFM	3000	2813
SF RPM	-	1057
RA CFM	2400	2186
OA CFM	600	627
RL Voltage	-	216.4/216.5/216.7
RL Amperage	-	3.24/3.12/3.28
SF Rotation	-	CW
RA Damper Position	-	80%
Min OA Damper Position	-	20%
Min OA Damper Type	-	SODB
OA Enthalpy Setpt	-	E

Notes: -NO OA FILTER - CONSTRUCTION FILTERS IN FILTER BANKS BUT THEY ARE CLEAN -ALL LINER DIFFUSER WHERE REPLACED WITH 24X24 DIFFUSERS LIKE THE OTHER ONES ON THE PLANS

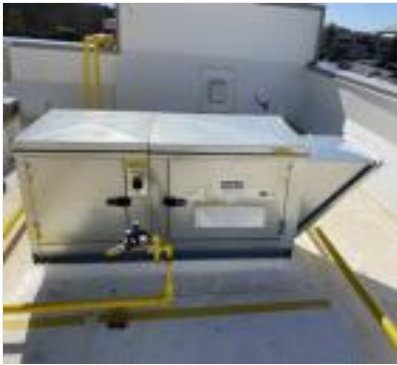
MUA-1

Test Data		
	Design	Actual
CFM	1650	1257
SF RPM	1855	DD
Motor RPM	-	DD
SF System SetPt	-	40.4HZ
RL Voltage	-	139.4/135.6/138.4
RL Amperage	-	3.13/3.14/3.11

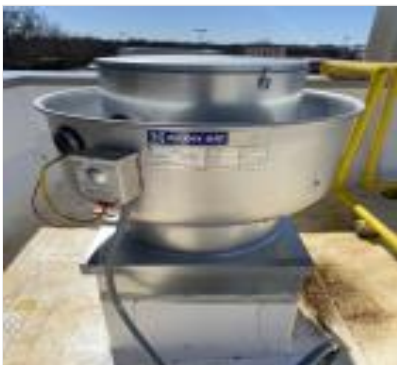
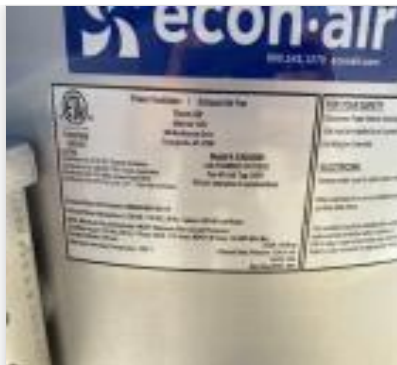
KEF-1

Test Data		
	Design	Actual
CFM	1120	1179
Fan RPM	1215	DD
Fan Rotation	-	DD CCW
Motor RPM	-	DD
System SetPt	-	50%
RL Voltage	-	125.1
RL Amperage	-	3.36
Total ESP	1.15"	0.63"
Fan Inlet SP	-	-0.63"
Fan Discharge SP	-	ATM

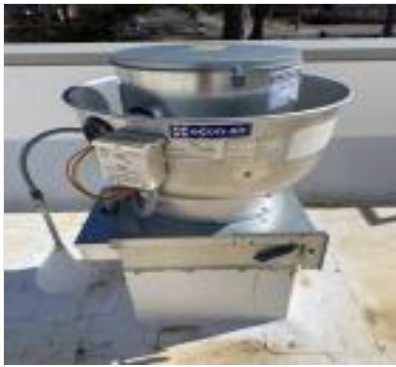
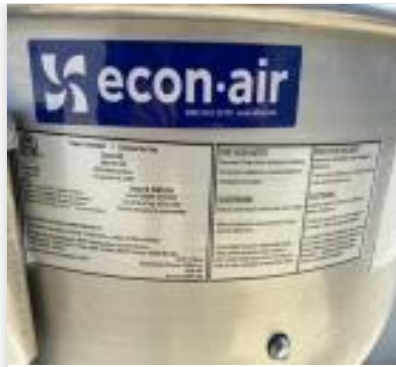
KEF-2

Test Data		
	Design	Actual
CFM	700	678
Fan RPM	1360	DD
Fan Rotation	-	DD CCW
Motor RPM	-	DD
System SetPt	-	85%
RL Voltage	-	125.6
RL Amperage	-	2.2
Total ESP	0.6"	0.97"
Fan Inlet SP	-	-0.97"
Fan Discharge SP	-	ATM

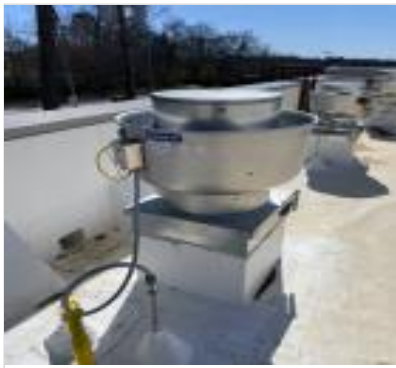
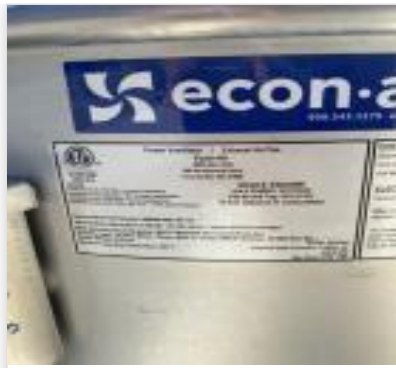
KEF-3

Test Data		
	Design	Actual
CFM	833	822
Fan RPM	1144	DD
Fan Rotation	-	DD CCW
Motor RPM	-	DD
System SetPt	-	50%
RL Voltage	-	125.2
RL Amperage	-	2.42
Total ESP	1.15"	0.65"
Fan Inlet SP	-	-0.65"
Fan Discharge SP	-	ATM

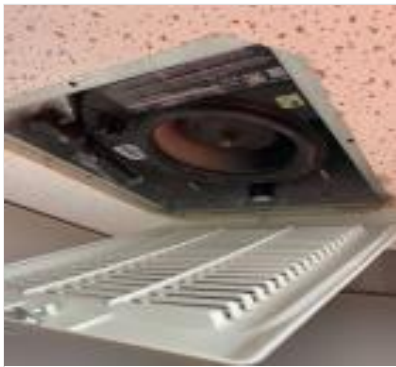
EF-1

Test Data		
	Design	Actual
CFM	75	78
Fan RPM	-	HIGH
Fan Rotation	-	CCW
RL Voltage	-	115
Total ESP	0.1"	NA

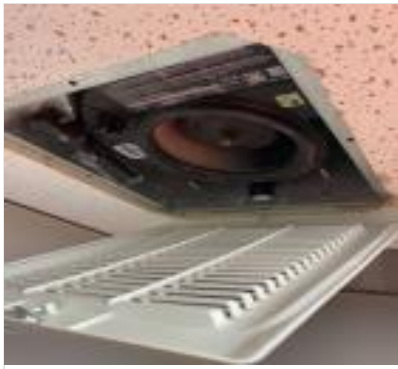
EF-2

Design	Actual
CFM	75	79
Fan RPM	-	DD
Fan Rotation	-	CCW
RL Voltage	-	115
Total ESP	0.1"	NA

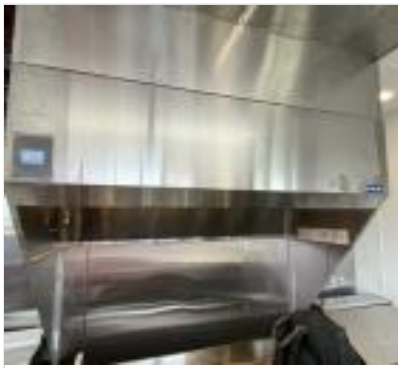
HOOD-1

SMOKE TEST WAS DONE WITH FOOD EQUIPMENT OFF BECAUSE STARTUPS ON FOOD SERVICE EQUIPMENT HAVE NOT BEEN CONDUCTED AT THAT TIME. GAS PIPING PREVENTED GRIDDLE FROM SITTING AGAINST THE BACK OF THE HOOD. INITIAL SMOKE TEST SHOWED THAT CAPTURE WAS AT 50%. TECHNICIAN ON SITE REDUCED MAU DESIGN FOR HOOD 1 SO THAT SMOKE CAPTURE WOULD BE 100%.

Kitchen equipment installed in proper places?	GRIDDLE UNABLE TO BE PLACED AGAINST THE WALL DUE TO GAS REGULATOR PLACEMENT. GRIDDLE STICKS OUT APROX 6" FROM THE WALL ON THE RIGHT SIDE PREVENT HOOD FROM 100% SMOKE CAPTURE UNDER DESIGN SPECIFICATIONS. TECHNICIAN ON SITE REDUCED OA FROM HOOD 1 IN ORDER TO GET 100% SMOKE CAPTURE
Can kitchen equipment be turned on for final smoke test?	NO

Test Data Supply		
	Design	Actual
Total AK Area	7	6.61
Kv factor (Vel)	0.89	0.89
Num of Readings	-	4
Reading1 FPM	-	115
Reading2 FPM	-	106
Reading3 FPM	-	115
Reading4 FPM	-	129
Ave FPM(corr)	-	103
CFM	1000	680

Test Data Exhaust		
	Design	Actual
Filter Type	CAPTRATE SOLO	CAPTRATE SOLO
Filter Size 1	16X16	16X16
Filter Qty 1	4	4
Filter AK factor size 1	1.62	1.62
Filter Total AK Area	6.48	6.48
Filter1 FPM	-	181
Filter2 FPM	-	177
Filter3 FPM	-	189
Filter4 FPM	-	181
Filter Ave FPM(corr)	-	182
CFM	1120	1179

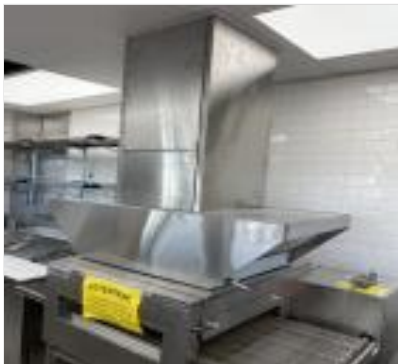
HOOD-2

Test Data Exhaust		
	Design	Actual
Filter Type	SS BAFFLE	BAFFLE
Filter Size 1	20X10	20X10
Filter Qty 1	2	2
Filter AK factor size 1	-	2.7
Filter1 FPM	-	245
Filter2 FPM	-	256
Filter Ave FPM(corr)	-	250
CFM	700	676

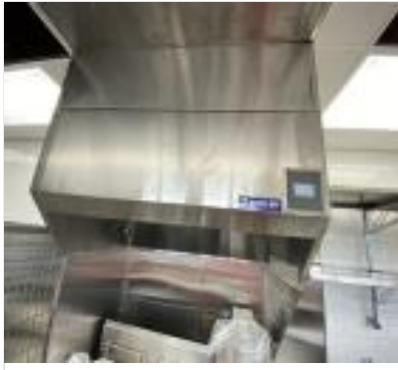
HOOD-3

Test Data Supply		
	Design	Actual
Total AK Area	4.8	3.9
Kv factor (Vel)	0.89	0.89
Num of Readings	-	4
Reading1 FPM	-	176
Reading2 FPM	-	167
Reading3 FPM	-	159
Reading4 FPM	-	164
Ave FPM(corr)	-	148
CFM	650	577

Test Data Exhaust		
	Design	Actual
Filter Type	CAPTRATE SOLE	CAPTRATE SOLO
Filter Size 1	16X16	16X16
Filter Qty 1	3	3
Filter AK factor size 1	1.62	1.62
Filter Total AK Area	4.86	4.86
Filter1 FPM	-	165
Filter2 FPM	-	169
Filter3 FPM	-	175
Filter Ave FPM(corr)	-	170
CFM	833	826

Notes: INITAIL SMOKE CAPTURE WAS 80%. REDUCED MAU IN ORDER TO GET A 100% CAPTURE
