Report: TAB Report
Function: Test, Adjust, & Balance
Date: 11/27/2024
Completed By: National TAB

11-25-24 WAWA #8117 WARRINGTON, PA

Project: 11-25-24 WAWA #8117 WARRINGTON, PA

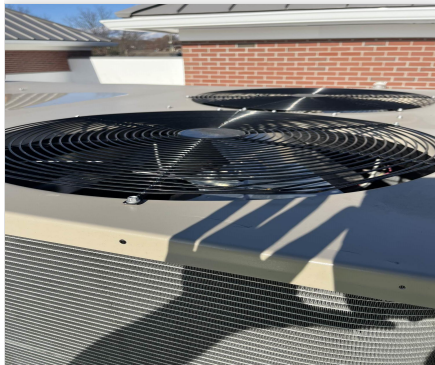
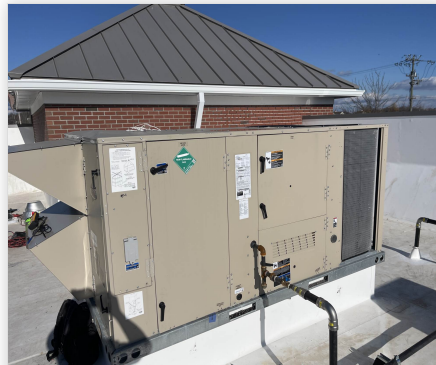
Issue Name : RTU-1 Condenser fan
Description : RTU-1 has a condenser fan motor that is not operational. This will impact cooling efficiency. Recommend MC repair/warranty replace as applicable.
Created By : National TAB **Assigned To :** National TAB - Tyler Youells
Status : Open
Priority : Medium **Asset Tag :**
Originated Date : 11/26/2024 - Tyler Youells - National TAB

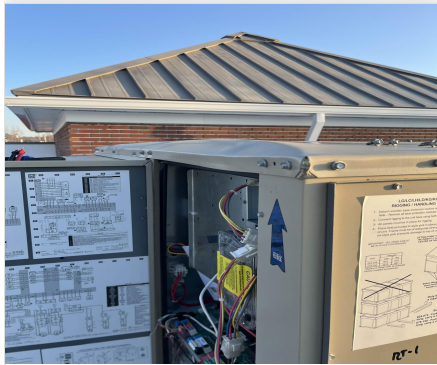
Issue Name : RTU-1 Damage
Description : RTU-1 has damage to the cabinet near the top of the control panel access door. The control access door scraps when trying to open. MC to fix at the discretion of the GC, CM.
Created By : National TAB **Assigned To :** National TAB - Tyler Youells
Status : Open
Priority : InfoOnly **Asset Tag :**
Originated Date : 11/25/2024 - Tyler Youells - National TAB

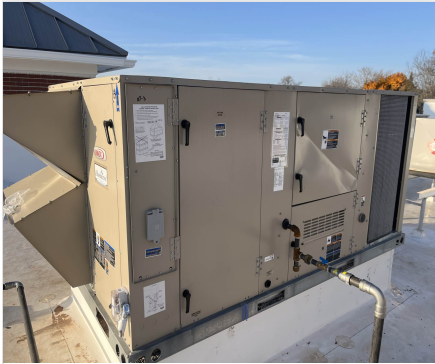
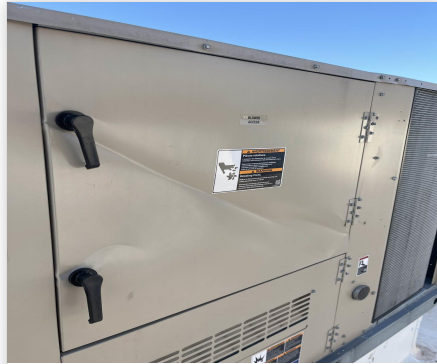
Issue Name : RTU-3 Damage to fan access door
Description : Rtu-3 fan access door has damage to it. MC to correct at the discretion of the GC, CM
Created By : National TAB **Assigned To :** National TAB - Tyler Youells
Status : Open
Priority : InfoOnly **Asset Tag :**
Originated Date : 11/25/2024 - Tyler Youells - National TAB

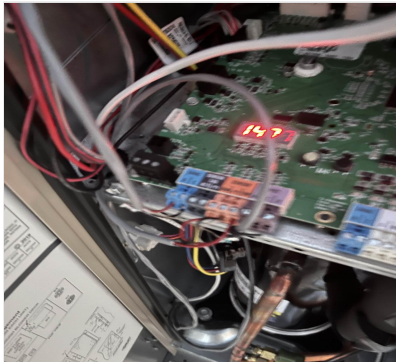
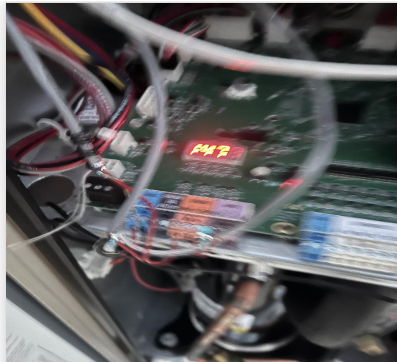
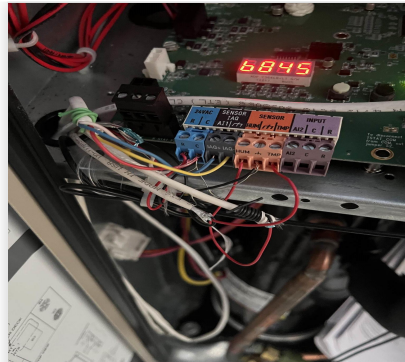
2 conductor shielded cable has one wire landed to Vin, one to GND, and the shield wire is not connected. Pass

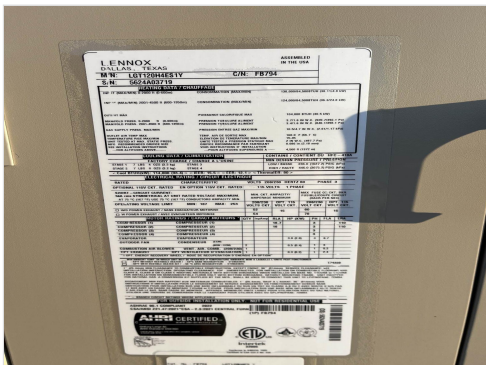
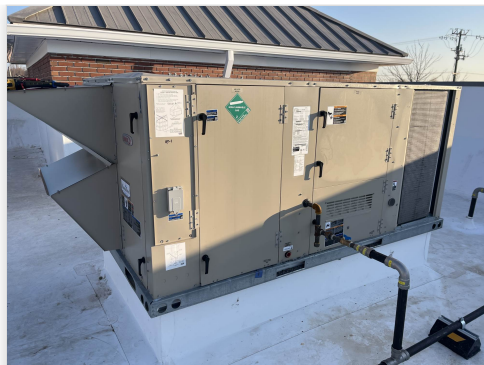
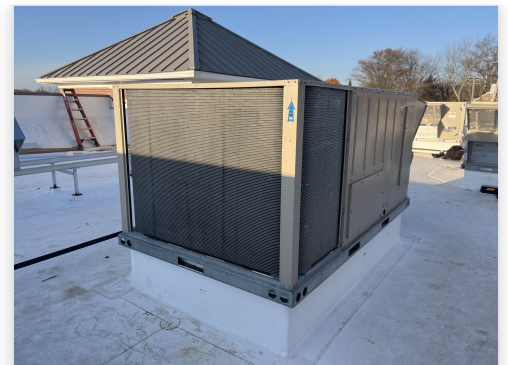
Unit Data - PHOTO LOG

Unit Data		
	Design	Actual
MFG	LENNOX ENLIGHT	LENNOX ENLIGHT
Serial Num	-	5624A03719
Model Num	LGT120H4E	LGT120H4ES1Y
Type	RTU	RTU
Configuration	VERTICAL	VERTICAL
Num OA Filters 1	-	2
OA Filter Size 1	-	16X25
Num Final Filter 1	-	4
Final Filter Size 1	-	20X25X2

Test Data		
	Design	Actual
SF CFM	4000	3942
SF RPM	-	1848
MOTOR RPM	-	1848
RA CFM	3450	3382
OA CFM	550	560
RL Voltage	-	212.9/212.5/211.9
RL Amperage	-	5.73/5.77/5.77
SF System SetPt	-	84%
RA Damper Position	-	MECHANICAL LINKAGE
OA Damper Position	-	26%
OA Damper Type	-	ECONOMIZER

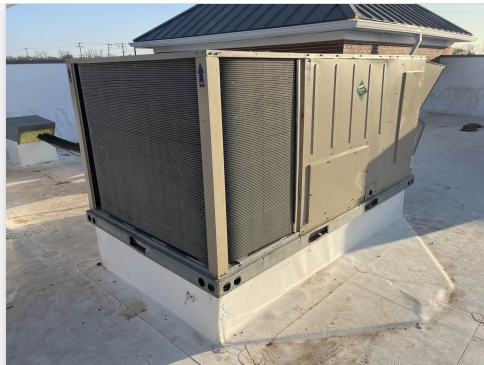
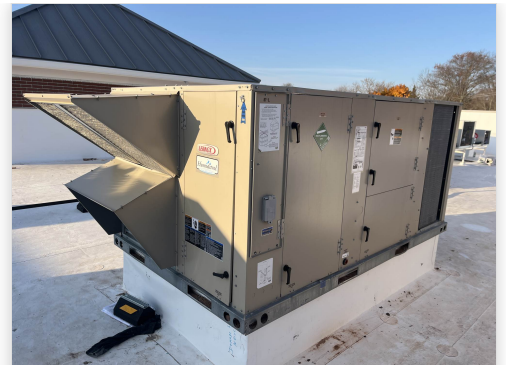
Unit Data - PHOTO LOG

Unit Data		
	Design	Actual
MFG	LENNOX ENLIGHT	LENNOX ENLIGHT
Serial Num	-	5623J00945
Model Num	LGT120H4E	LCT120H4EN1Y
Type	RTU	RTU
Configuration	VERTICAL	VERTICAL
Num OA Filters 1	-	2
OA Filter Size 1	-	16X25
Num Final Filter 1	-	4
Final Filter Size 1	-	20X25X2

Test Data		
	Design	Actual
SF CFM	4000	3889
SF RPM	-	1804
MOTOR RPM	-	1804
RA CFM	3450	3320
OA CFM	550	569
RL Voltage	-	212.5/212.6/213.0
RL Amperage	-	5.36/5.34/5.36
SF System SetPt	-	82%
RA Damper Position	-	MECHANICAL LINKAGE
OA Damper Position	-	22%
OA Damper Type	-	ECONOMIZER

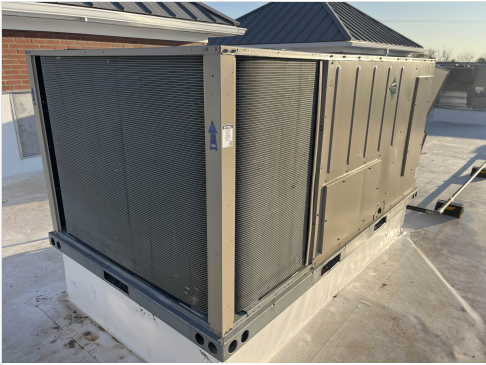
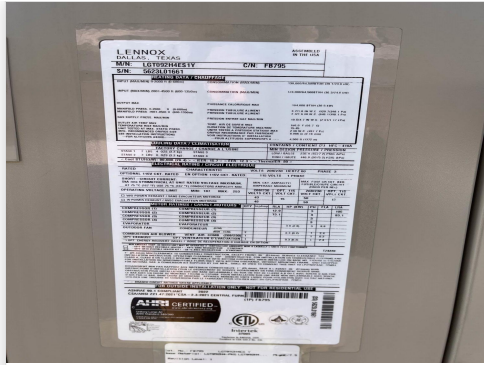
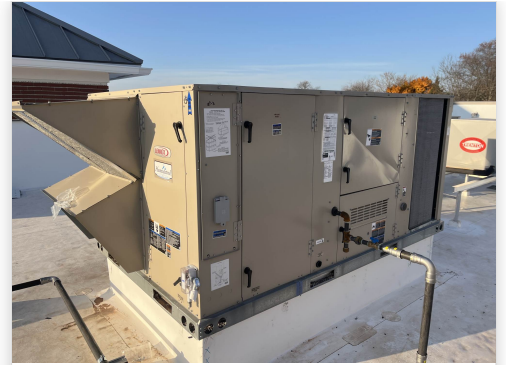
Unit Data - PHOTO LOG

Unit Data		
	Design	Actual
MFG	LENNOX ENLIGHT	LENNOX ENLIGHT
Serial Num	-	5623L01661
Model Num	LGT092H4E	LGT092H4ES1Y
Type	RTU	RTU
Configuration	VERTICAL	VERTICAL
Num OA Filters 1	-	2
OA Filter Size 1	-	16X25
Num Final Filter 1	-	4
Final Filter Size 1	-	20X25X2

Test Data		
	Design	Actual
SF CFM	3000	3049
SF RPM	-	1320
MOTOR RPM	-	1320
RA CFM	2600	2631
OA CFM	400	418
RL Voltage	-	212.4/211.9/211.9
RL Amperage	-	2.46/2.53/2.51
SF System SetPt	-	60%
RA Damper Position	-	MECHANICAL LINKAGE
OA Damper Position	-	24%
OA Damper Type	-	ECONOMIZER

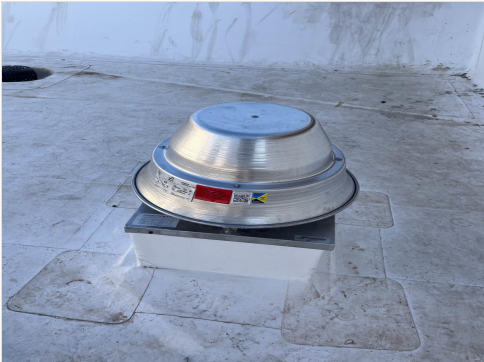
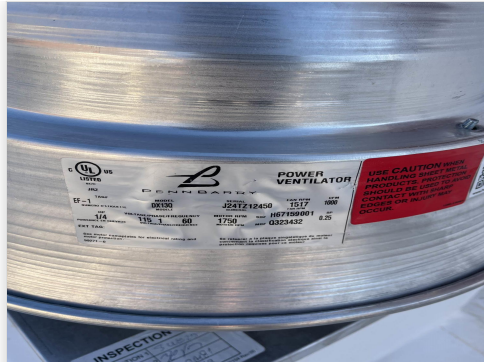
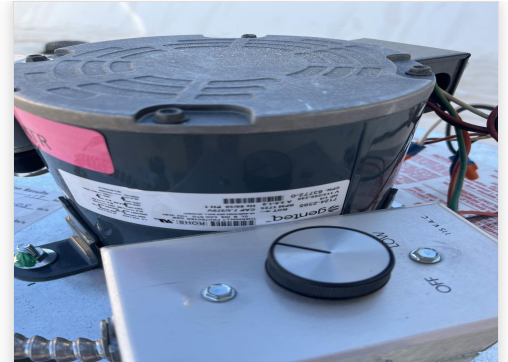
Test Data - PHOTO LOG

Unit Data		
	Design	Actual
MFG	PENNBARRY	PENNBARRY
Model Num	DX13Q	DX13Q
Serial Num	-	J24TZ12450
Type	CENTRIFUGAL	CENTRIFUGAL
Configuration	VERTICAL	DOWNBLAST

Test Data		
	Design	Actual
CFM	1000	964
Fan RPM	1725	1725
Fan Rotation	-	CCW
Motor RPM	-	1725
System SetPt	-	FULL SPEED
RL Voltage	-	118.1
RL Amperage	-	3.78
Total ESP	0.250"	0.47"
Fan Inlet SP	-	-0.47"
Fan Discharge SP	-	ATM

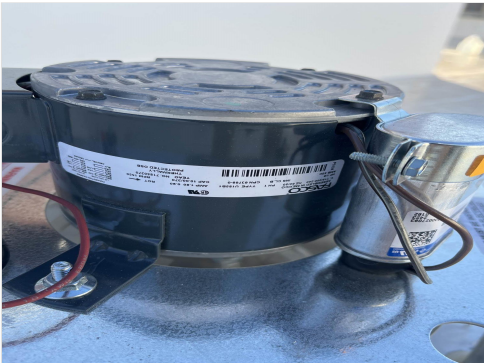
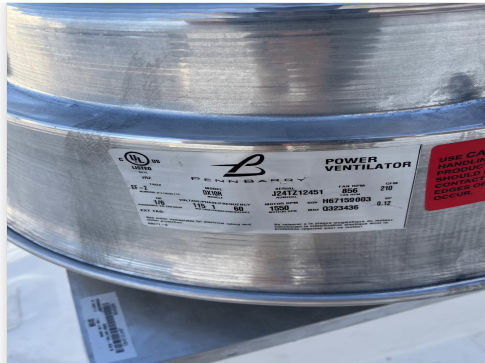
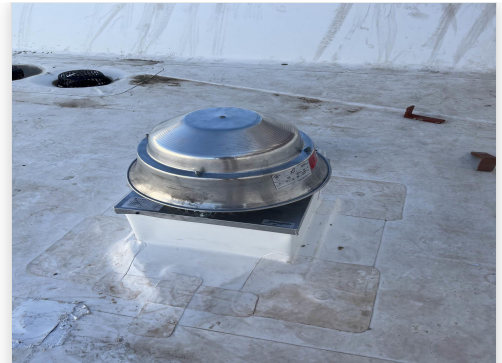
Unit Data - PHOTO LOG

Unit Data		
	Design	Actual
MFG	PENNBARRY	PENNBARRY
Model Num	DX10R	DX10R
Serial Num	-	J24TZ12451
Type	CENTRIFUGAL	CENTRIFUGAL
Configuration	VERTICAL	DOWNBLAST

Test Data		
	Design	Actual
CFM	200	201
Fan RPM	1550	NA
Fan Rotation	-	CCW
Motor RPM	-	NA
System SetPt	-	MARKED ON DIAL
RL Voltage	-	92.6
RL Amperage	-	1.56
Total ESP	0.125"	0.36"
Fan Inlet SP	-	-0.36"
Fan Discharge SP	-	ATM
