**Report: TAB Report**  
**Function: Test, Adjust, & Balance**  
**Date: 10/22/2025**  
**Completed By: National TAB**

**PROJECT**  
**10-27-25 QT #1416 PHOENIX, AZ**

QUIKTRIP  
4705 SOUTH 129TH EAST AVENUE  
TULSA, OK 74134

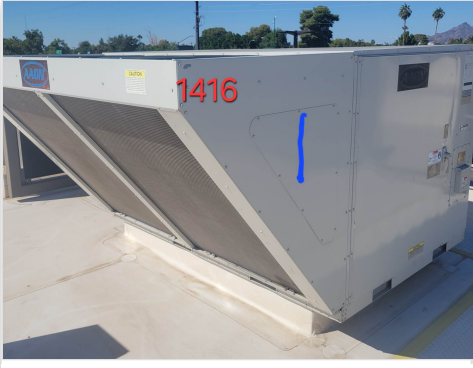
**Unit Data - PHOTO LOG**

Unit Data		
	Design	Actual
MFG	NA	AAON
Serial Num	-	202009-ANEK20979
Model Num	NA	RN-013-8-0-EA0A-152
Num OA Filters 1	-	1
OA Filter Size 1	-	45X22
Num Final Filter 1	-	2
Final Filter Size 1	-	46X19.5X2

Test Data		
	Design	Actual
SF CFM	4200	4566
SF RPM	-	46 HZ
OA CFM (Hoods On)	800	846
OA CFM (Hoods Off)	350	358
RL Voltage	-	158.0
RL Amperage	-	7.95
VFD Max SetPt	-	77
VFD Min SetPt	-	24
OA Damper Position (Hoods On)	-	46.0
OA Damper Position (Hoods Off)	-	0.0

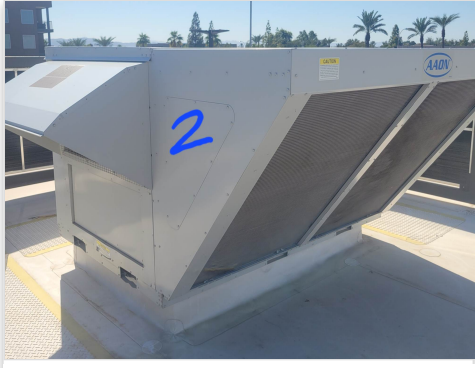
## Unit Data - PHOTO LOG

Unit Data		
	Design	Actual
MFG	NA	AAON
Serial Num	-	202009-ANEK20977
Model Num	NA	RN-013-8-0-EA0A-152
Num OA Filters 1	-	1
OA Filter Size 1	-	45X22
Num Final Filter 1	-	2
Final Filter Size 1	-	46X19.5X2

Test Data		
	Design	Actual
SF CFM	4200	4408
SF RPM	-	46.2 HZ
OA CFM (Hoods On)	800	825
OA CFM (Hoods Off)	350	330
RL Voltage	-	159.0
RL Amperage	-	7.9
VFD Max SetPt	-	77
VFD Min SetPt	-	24
OA Damper Position (Hoods On)	-	46.0
OA Damper Position (Hoods Off)	-	0.0

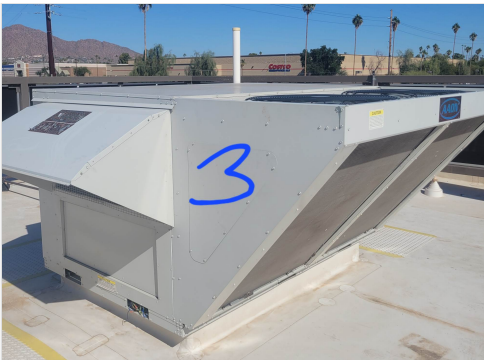
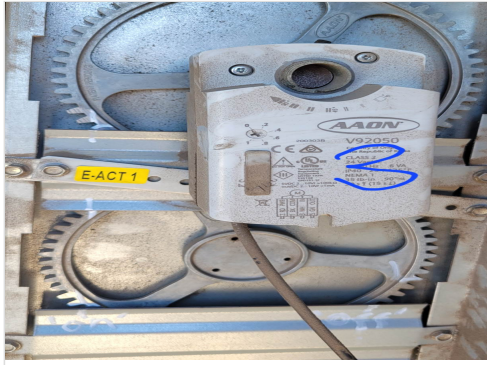
### Unit Data - PHOTO LOG

Unit Data		
	Design	Actual
MFG	NA	AAON
Serial Num	-	202009-ANEK20978
Model Num	NA	RN-013-8-0-EA0A-152
Num OA Filters 1	-	1
OA Filter Size 1	-	45X22
Num Final Filter 1	-	2
Final Filter Size 1	-	46X19.5X2

Test Data		
	Design	Actual
SF CFM	4200	4146
SF RPM	-	47 HZ
OA CFM (Hoods On)	800	880
OA CFM (Hoods Off)	350	316
RL Voltage	-	163.9
RL Amperage	-	7.9
VFD Max SetPt	-	78.3
VFD Min SetPt	-	24
OA Damper Position (Hoods On)	-	46.0
OA Damper Position (Hoods Off)	-	0.0

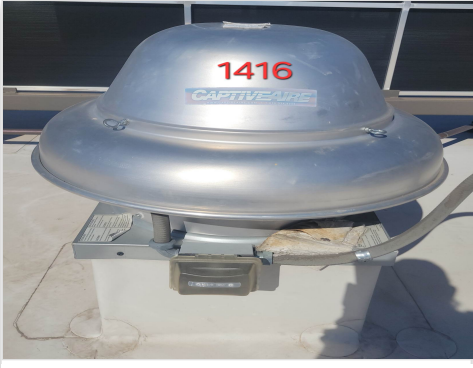
**Unit Data - PHOTO LOG**

Unit Data		
	Design	Actual
MFG	NA	CAPTIVE AIRE
Model Num	NA	DR50HFA
Serial Num	-	4546739
Type	-	DOWNBLAST
Configuration	-	VERTICAL

Test Data		
	Design	Actual
CFM	750	959
Fan RPM	-	N/A
Fan Rotation	-	CCW
Motor RPM	-	N/A
System SetPt	-	LOW
RL Voltage	-	N/A
RL Amperage	-	7.62
Total ESP	-	0.33"
Fan Inlet SP	-	-0.33"
Fan Discharge SP	-	ATMS

[1] FAN SPEED IS FULLY MINIMIZED.

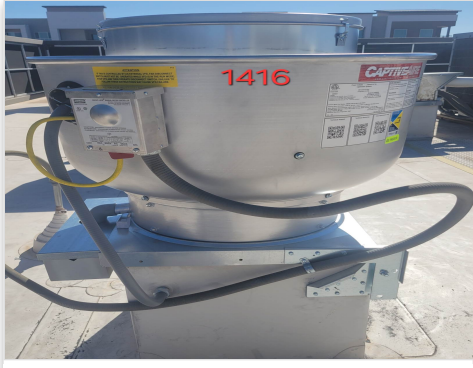
## Unit Data - PHOTO LOG

Unit Data		
	Design	Actual
MFG	NA	CAPTIVEAIRE
Model Num	NA	DU50HFA
Serial Num	-	7660154
Type	UPBLAST	UPBLAST
Configuration	VERTICAL	VERTICAL

Test Data		
	Design	Actual
CFM	1350	1398
Fan RPM	-	1307
Fan Rotation	-	CCW
Motor RPM	-	1307
System SetPt	-	54.8 HZ
RL Voltage	-	219.4
RL Amperage	-	2.07
Total ESP	-	0.40"
Fan Inlet SP	-	-0.40"
Fan Discharge SP	-	ATMS

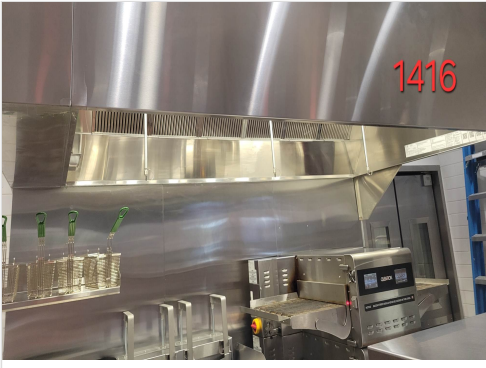
**Unit Data - PHOTO LOG**

Unit Data		
	Design	Actual
MFG	CAPTIVEAIRE	CAPTIVEAIRE
Model Num	6030ND-2-F	6030ND-2-F
Job / Serial Num	-	7660154
Type	-	TYPE I CANOPY
Hood length	-	108"
Hood Width	-	60"

Test Data Exhaust		
	Design	Actual
Filter Type	-	CAPTRATE SOLO
Filter Size 1	-	16X20
Filter Qty 1	-	6
Filter AK factor size 1	-	2.08
Filter Total AK Area	-	12.48
Filter1 FPM	-	116
Filter2 FPM	-	116
Filter3 FPM	-	112
Filter4 FPM	-	116
Filter5 FPM	-	103
Filter6 FPM	-	108
Filter Ave FPM(corr)	-	112
CFM	1350	1398
