Report: FINAL TAB REPORT
Function: Test, Adjust, & Balance
Date: 9/2/2022

PROJECT
08-08 CULVERS - LADSON, SC

Project: 08-08 CULVERS - LADSON, SC

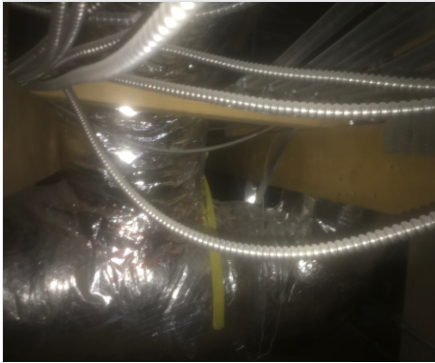
Project Issue File Details

Issue Name : RTU1 / SGRD2 AND SGRD15

Description : [1] SGRD2 AND SGRD15 ARE LOW OF DESIGN AIR FLOW DUE TO DUCTWORK HAVING TO BE ROUTED DIFFERENTLY THEN SHOWN IN PRINTS DUE TO LATE INSTILATION. UNABLE TO PUSH AIR TO THESE TWO GRILLS TO BRING THEM WITNIN DESIGN. UNIT TOTAL IS WITHIN DESIGN. THIS SHOULD NOT BE AN ISSUE WITH COMFORT AND HOOD CAPTURES 100%
