**Report: FINAL TAB REPORT
Function: Test, Adjust, & Balance
Date: 8/24/2022**

**PROJECT
08-08 CULVERS - LADSON, SC**

Project: 08-08 CULVERS - LADSON, SC

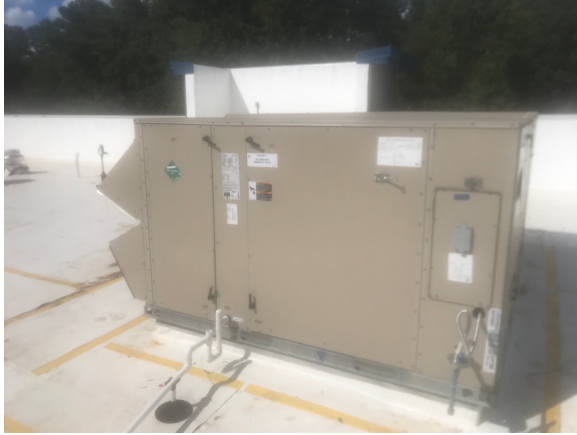
RTU2

Test Data		
	Design	Actual
SF CFM	6150	5907
SF RPM	-	884
RA CFM	4450	4121
OA CFM	1700	1786
RL Voltage	-	206/206/206
RL Amperage	-	10.5/10.5/10.1
SF Rotation	-	CCW
RA Damper Position	-	2.0"
Min OA Damper Position	-	45% / 1.75' OPEN
Min OA Damper Type	-	ECON

Performance Data		
	Design	Actual
MA Plenum SP	-	-0.43"
Fan Suction SP	-	-0.789"
Fan Discharge SP	-	0.521"
Total ESP	-	0.951"
Fan Total SP	-	1.31"

Drive Data		
	Design	Actual
Motor Sheave Size	-	VP50
Motor Bore Size	-	1 1/8
Motor Sheave SetPt	-	MINIMIZED
Fan Sheave Size	-	9 3/8
Fan Sheave Bore	-	1 1/8
Belt CL Distance	-	20 5/8
Num of Belts	-	1
Belt Size	-	BX61
Belt Alignment	-	GOOD

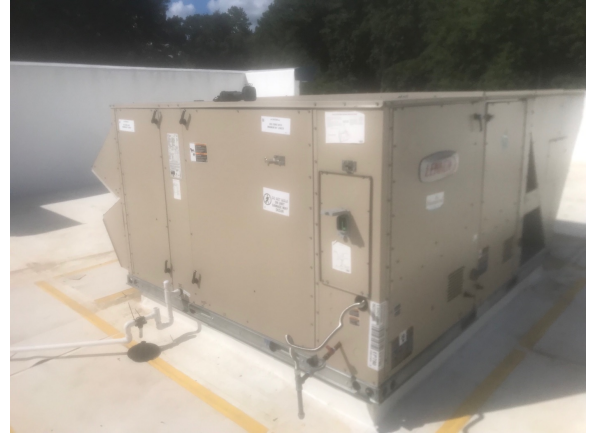
Issue Name : RTU1 / SGRD2 AND SGRD15

Description : [1] SGRD2 AND SGRD15 ARE LOW OF DESIGN AIR FLOW DUE TO DUCTWORK HAVING TO BE ROUTED DIFFERENTLY THEN SHOWN IN PRINTS DUE TO LATE INSTILATION. UNABLE TO PUSH AIR TO THESE TWO GRILLS TO BRING THEM WITNIN DESIGN. UNIT TOTAL IS WITHIN DESIGN. THIS SHOULD NOT BE AN ISSUE WITH COMFORT AND HOOD CAPTURES 100%

Drive Data		
	Design	Actual
Motor Sheave Size	-	VP50
Motor Bore Size	-	1 1/8
Motor Sheave SetPt	-	MINIMIZED
Fan Sheave Size	-	9 5/8
Fan Sheave Bore	-	1 3/8
Belt CL Distance	-	20 5/8
Num of Belts	-	1
Belt Size	-	BX61
Belt Alignment	-	NO

Test Data		
	Design	Actual
SF CFM	5850	5974
SF RPM	-	867
RA CFM	4100	4287
OA CFM	1800	1687
RL Voltage	-	208/207/209
RL Amperage	-	10.6/9.6/10.2
SF Rotation	-	CCW
RA Damper Position	-	2.0"
Min OA Damper Position	-	45 / 1.50" OPEN
Min OA Damper Type	-	ECON

Performance Data		
	Design	Actual
MA Plenum SP	-	-0.450"
Fan Suction SP	-	-0.726"
Fan Discharge SP	-	0.651"
Total ESP	-	1.101"
Fan Total SP	-	1.377"

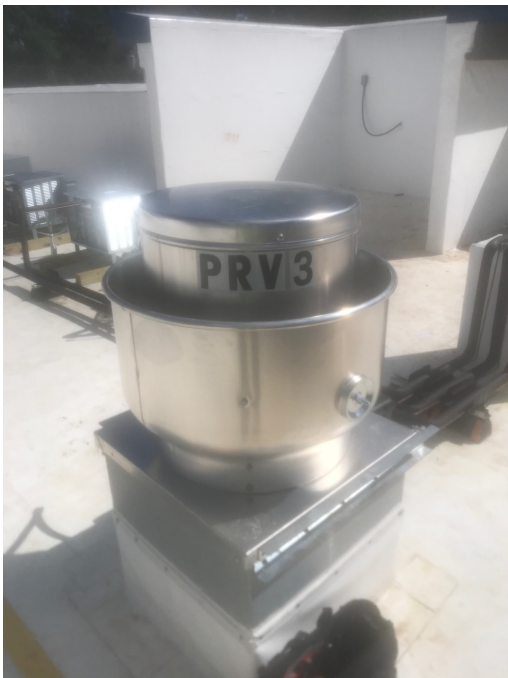
PRV3

Test Data		
	Design	Actual
CFM	1500	1408
Fan RPM	1377	1586
Fan Rotation	-	CCW
Motor RPM	-	1783
RL Voltage	-	209/209/208
RL Amperage	-	1.9/1.9/2.0
Suction ESP	-	-0.515"
Discharge ESP	-	ATM
Total ESP	1.0"	-0.515"

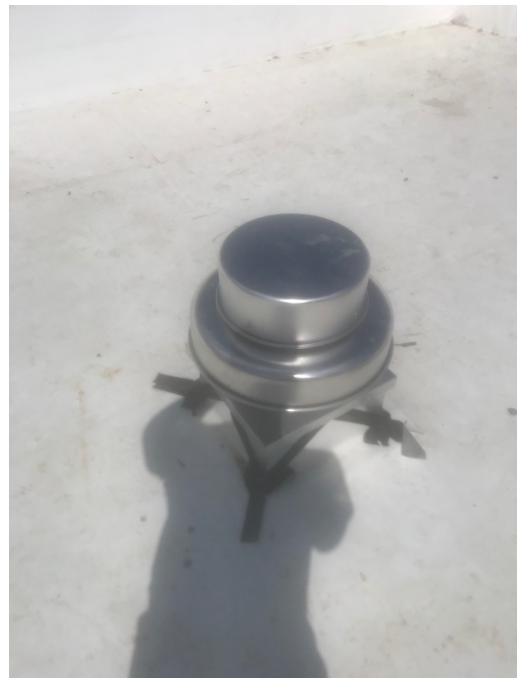
PRV1

Test Data		
	Design	Actual
CFM	375	384
Fan RPM	1479	DD
Fan Rotation	-	CCW
Motor RPM	-	DD
System SetPt	-	SETPOINT 6
RL Voltage	-	121
RL Amperage	-	0.77
Total ESP	0.5"	0.153"
Fan Inlet SP	-	-0.153"
Fan Discharge SP	-	ATM

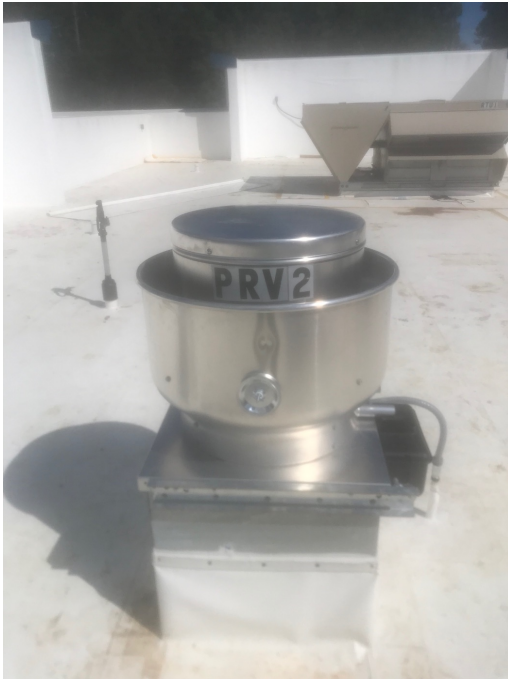
PRV2

Test Data		
	Design	Actual
CFM	1500	1598
Fan RPM	2411	2586
Fan Rotation	-	CCW
Motor RPM	-	1781
RL Voltage	-	206/206/206
RL Amperage	-	4.1/4.1/3.9
Suction ESP	-	-1.13"
Discharge ESP	-	ATM
Total ESP	2.337"	1.13"

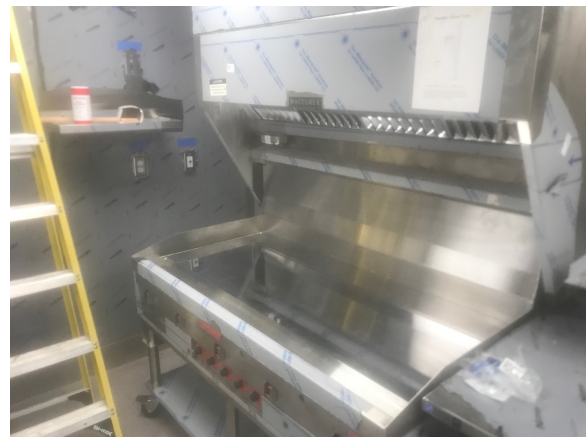
GRIDDLE HOOD

Performance Data		
	Design	Actual
Smoke Generation Type	-	SMOKE EMITTER
Hood Capture %	-	100%
End Panels Installed (Y/N)	-	YES

Test Data Exhaust		
	Design	Actual
Filter Type	GREASE GRABBER	GREASE GRABBER
Filter Size 1	16X16	16X16
Filter Qty 1	4	4
Filter AK factor size 1	1.53	1.53
Filter Total AK Area	6.12	6.12
Filter1 FPM	-	283
Filter2 FPM	-	229
Filter3 FPM	-	238
Filter4 FPM	-	291
Filter Ave FPM(corr)	-	260
CFM	-	1598

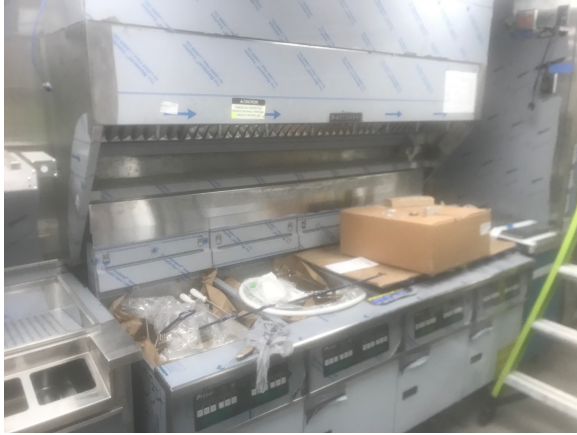
FRYER HOOD

Test Data Exhaust		
	Design	Actual
Filter Type	X-TRACTOR	X-TRACTOR
Filter Size 1	16X16	16X16
Filter Qty 1	5	5
Filter AK factor size 1	1.53	1.53
Filter Total AK Area	7.65	7.65
Filter1 FPM	-	198
Filter2 FPM	-	177
Filter3 FPM	-	176
Filter4 FPM	-	183
Filter5 FPM	-	188
Filter Ave FPM(corr)	-	184
CFM	-	1408

Performance Data		
	Design	Actual
Smoke Generation Type	-	SMOKE EMITTER
Hood Capture %	-	100%
End Panels Installed (Y/N)	-	YES
