**Report: FINAL TAB REPORT
Function: Test, Adjust, & Balance
Date: 9/2/2022**

**PROJECT
08-08 CULVERS - LADSON, SC**

Project: 08-08 CULVERS - LADSON, SC

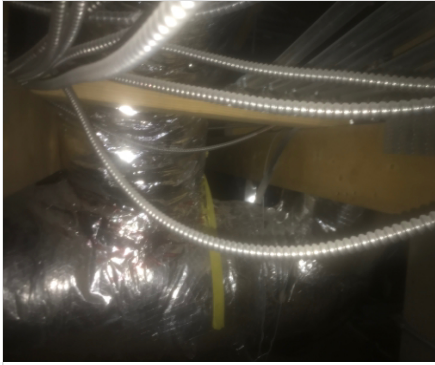
FuselTe970e387b40043cf9b79c3
1a03fcf16c.jpeg

Issue Name : RTU2 / SGRD2 AND SGRD15

Description : TOTAL FLOW FOR RTU-2 IS WITHIN DESIGN HOWEVER GRILLES 2 AND 15 ARE SLIGHTLY BELOW DESIGN. DEVIATIONS IN THE DUCTWORK WERE REQUIRED ABOVE CEILING WHICH APPEARS TO BE THE CAUSE. SMOKE CAPTURE IS 100% AND NO COMFORT ISSUES NOTED SO NO FURTHER ACTION IS RECOMMENDED.

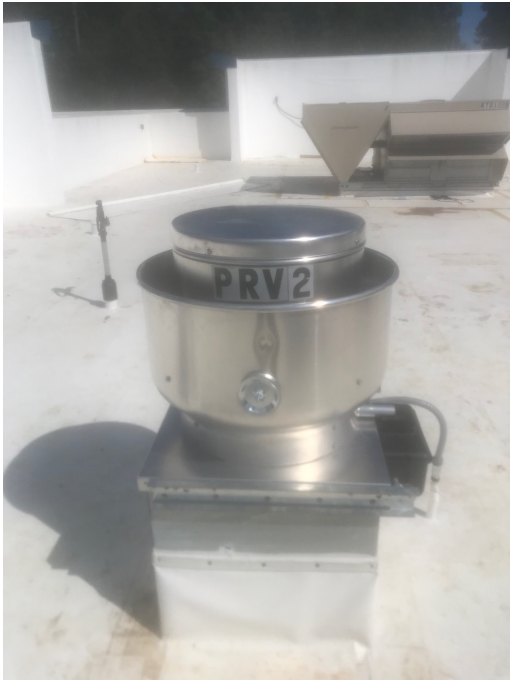
PRV2

Test Data		
	Design	Actual
CFM	1500	1598
Fan RPM	2411	2586
Fan Rotation	-	CCW
Motor RPM	-	1781
RL Voltage	-	206/206/206
RL Amperage	-	4.1/4.1/3.9
Suction ESP	-	-1.13"
Discharge ESP	-	ATM
Total ESP	2.337"	1.13"
