Report: TAB Report
Function: Test, Adjust, & Balance
Date: 01/31/2025
Completed By: National TAB

01-20-25 WAWA #6108 GOLDSBORO, NC

Project: 01-20-25 WAWA #6108 GOLDSBORO, NC

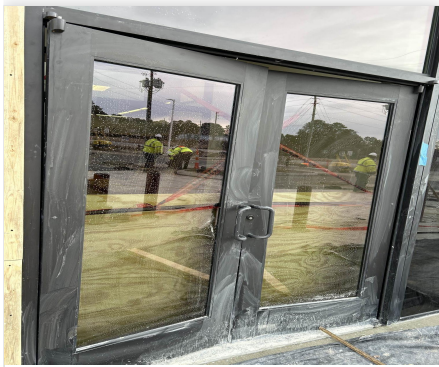
Issue Name : Building Pressure
Description : The building pressure cannot be accurately measured due to the rear door being off its hinges and damaged.
Created By : National TAB **Assigned To :** National TAB - Will Turnbough
Status : Open
Priority : Medium **Asset Tag :** HVAC EQUIPMENT1
Originated Date : 01/21/2025 - Jearod Ferrette - National TAB

Unable to get accurate read. See issue

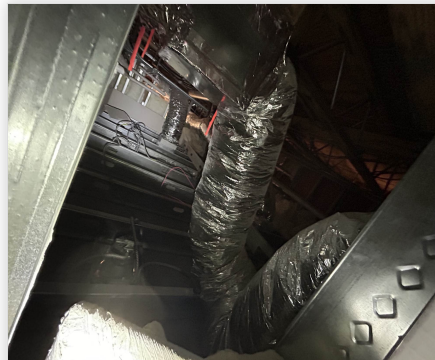
Issue Name : EF-2 Low Flow / Limited Access
Description : The fan is exhausting 308CFM out of 400CFM design (77%). One of the damper handles is situated above the hard ceiling. The ductwork lacks proper support, resulting in sagging and pinching into two hard 90-degree bends. Accessible dampers will need to be added as well as straightening the flex duct in order to balance the fan to design airflow.
Created By : National TAB **Assigned To :** National TAB - Will Turnbough
Status : Open
Priority : Urgent **Asset Tag :** EF2
Originated Date : 01/21/2025 - Jearod Ferrette - National TAB

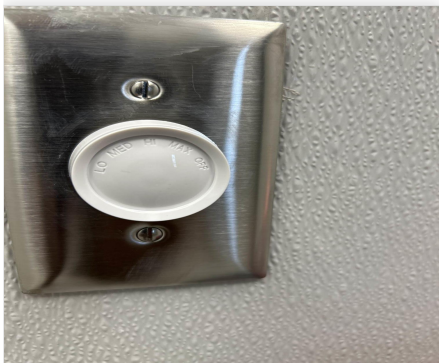
Issue Name : EF-3 High Flow / Speed Controller Issue
Description : EF-3 is currently exhausting 246CFM out of 200CFM design (123%). The installed speed controller has 4 speed setpoints, none of which set the fan within design. Recommend installing a speed controller that does not lock into individual setpoints and then rebalancing.
Created By : National TAB **Assigned To :** National TAB - Will Turnbough
Status : Open
Priority : Urgent **Asset Tag :**
Originated Date : 02/05/2025 - Stephen Tassinaro - National TAB

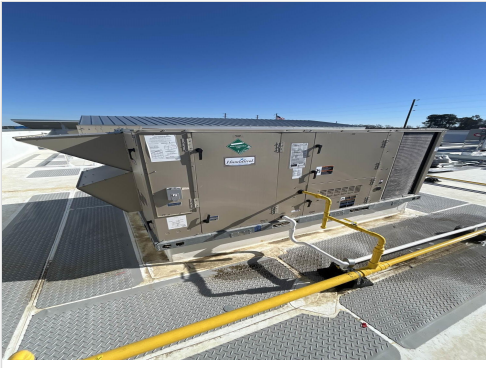
Unit Data - PHOTO LOG

Unit Data		
	Design	Actual
MFG	LENNOX	LENNOX
Serial Num	-	5424K0121
Model Num	LGT120H4E	LGT120H4E
Type	RTU	RTU
Configuration	VERTICAL	VERTICAL
Num OA Filters 1	-	2
OA Filter Size 1	-	14X24
Num Final Filter 1	-	4
Final Filter Size 1	-	20X25X2

Test Data		
	Design	Actual
SF CFM	3600	3701
SF RPM	-	DD/50%
RA CFM	2900	2965
OA CFM	700	736
RL Voltage	-	215/216/215
RL Amperage	-	5.9/5.9/5.8
SF Rotation	-	CCW
SF System SetPt	-	50%
Min OA Damper Position	-	33%
Min OA Damper Type	-	OBD

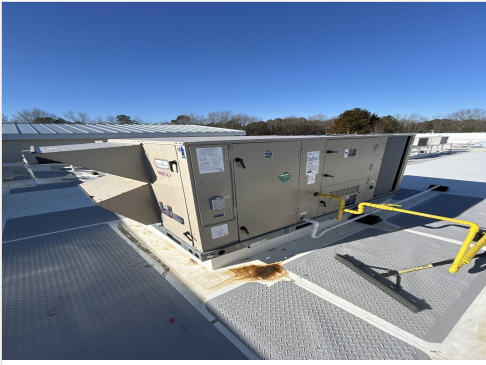
Unit Data - PHOTO LOG

Unit Data		
	Design	Actual
MFG	LENNOX ENLIGHT	LENNOX
Serial Num	-	5624J03610
Model Num	LGT120H4E	LGT120H4E
Type	RTU	RTU
Configuration	VERTICAL	VERTICAL
Num OA Filters 1	-	2
OA Filter Size 1	-	14X24
Num Final Filter 1	-	4
Final Filter Size 1	-	20X25X2

Test Data		
	Design	Actual
SF CFM	3250	3236
SF RPM	-	DD/43%
RA CFM	2870	2864
OA CFM	380	372
RL Voltage	-	215/216/215
RL Amperage	-	2.3/2.4/2.3
SF System SetPt	-	43%
OA Damper Position	-	27%
OA Damper Type	-	OBD

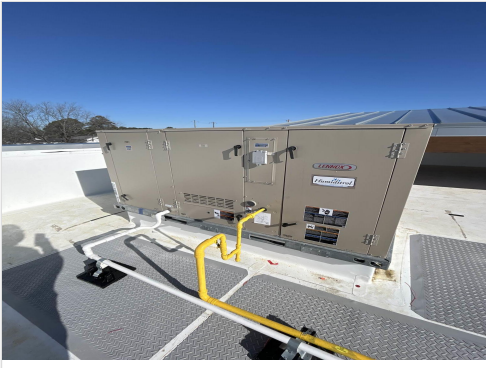
Unit Data - PHOTO LOG

Unit Data		
	Design	Actual
MFG	LENNOX ENLIGHT	LENNOX
Serial Num	-	5624K01022
Model Num	LGT060H4E	LGT060H4E
Type	RTU	RTU
Configuration	VERTICAL	VERTICAL
Num OA Filters 1	-	1
OA Filter Size 1	-	14.5X28.25
Num Final Filter 1	-	4
Final Filter Size 1	-	20X20X2

Test Data		
	Design	Actual
SF CFM	2000	2135
SF RPM	-	DD/67%
MOTOR RPM	-	DD/67%
RA CFM	1800	1903
OA CFM	200	232
RL Voltage	-	214/215/214
RL Amperage	-	3.3/3.3/3.2
SF System SetPt	-	67%
RA Damper Type	-	OBD
OA Damper Position	-	19%
OA Damper Type	-	ECON

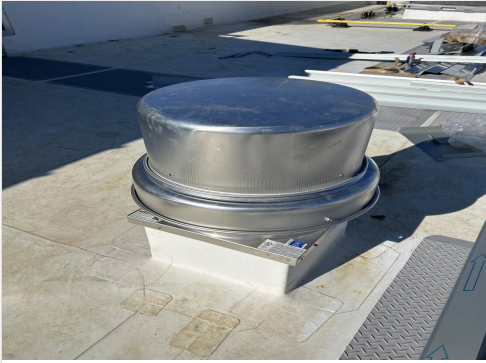
Unit Data - PHOTO LOG

Test Data		
	Design	Actual
CFM	400	308
Fan RPM	-	1161
Fan Rotation	-	CCW
Motor RPM	-	1763
System SetPt	-	2 TURNS OUT
RL Voltage	115	115
RL Amperage	3.8	NA
Total ESP	0.38"	0.32"
Fan Inlet SP	-	-0.32"
Fan Discharge SP	-	ATMO

Notes:
EF-2 AT 77% OF DESIGN, SEE ISSUE

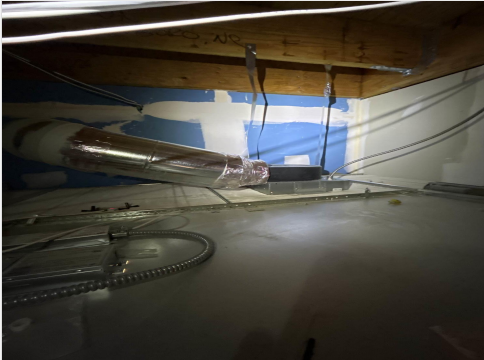
Unit Data - PHOTO LOG

Test Data		
	Design	Actual
CFM	200	246
Fan RPM	-	NA
Fan Rotation	-	CW
Motor RPM	-	NA
System SetPt	-	MAX
RL Voltage	115	115
RL Amperage	-	NA
Total ESP	0.50"	NA
Fan Inlet SP	-	NA
Fan Discharge SP	-	ATMO

Notes:
FAN CONTROLS HAS 4 SPEEDS. MAX SPEED IS 246 CFMS AND HIGH SPEED IS 100 CFMS
