**Report: TAB Report**  
**Function: Test, Adjust, & Balance**  
**Date: 02/11/2026**  
**Completed By: National TAB**

## 01-26-26 WAWA #5448 PENSACOLA, FL

9262 W HWY 98

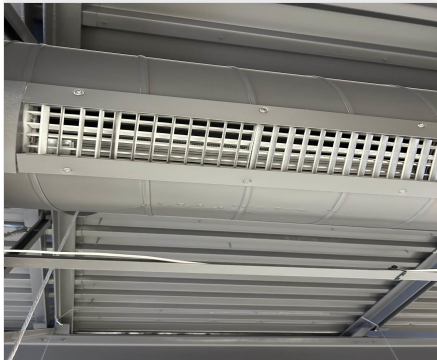
**Issue Name :** JAMMED DAMPER  
**Description :** ON DIFFUSER 2-12 THE DAMPER IS JAMMED NOT ALLOWING ME TO ADJUST IT CAUSING LOW AIRFLOW AND OUT OF BALANCE.  
**Created By :** National TAB                      **Assigned To :** National TAB - Brianna Biggs  
**Status :** Open  
**Priority :** High                                      **Asset Tag :**  
**Originated Date :** 01/30/2026 - Anthony Taylor - National TAB

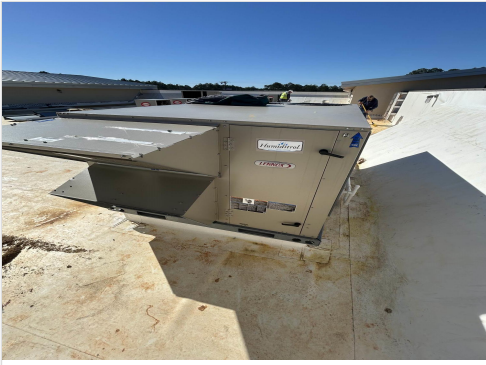
## Unit Data - PHOTO LOG

Unit Data		
	Design	Actual
MFG	LENNOX	LENNOX
Serial Num	-	5624L01935
Model Num	LCT150H4E	LCT150H4E
Type	RTU	RTU
Configuration	VERTICAL	VERTICAL
Num OA Filters 1	-	2
OA Filter Size 1	-	24X16
Num Final Filter 1	-	2
Final Filter Size 1	-	20X25X2

Test Data		
	Design	Actual
SF CFM	4500	4629
MOTOR RPM	-	1369
RA CFM	3800	3449
OA CFM	700	714
RL Voltage	-	209
RL Amperage	-	3.9
SF System SetPt	-	77%
RA Damper Position	-	82%
RA Damper Type	-	OBD
OA Damper Position	-	18%
OA Damper Type	-	OBD

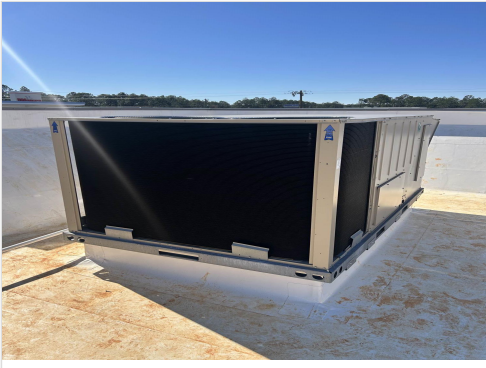
## Unit Data - PHOTO LOG

Unit Data		
	Design	Actual
MFG	LENNOX	LENNOX
Serial Num	-	5624L05182
Model Num	LCT102H4E	LCT102H4E
Type	RTU	RTU
Configuration	VERTICAL	VERTICAL
Num OA Filters 1	-	2
OA Filter Size 1	-	24X16
Num Final Filter 1	-	2
Final Filter Size 1	-	20X25X2

Test Data		
	Design	Actual
SF CFM	3400	3358
MOTOR RPM	-	1317
RA CFM	3020	2891
OA CFM	380	394
RL Voltage	-	211
RL Amperage	-	3.65
SF System SetPt	-	74%
RA Damper Position	-	88%
RA Damper Type	-	OBD
OA Damper Position	-	12%
OA Damper Type	-	OBD

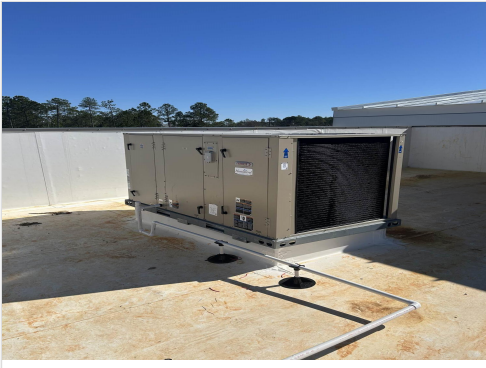
## Unit Data - PHOTO LOG

Unit Data		
	Design	Actual
MFG	LENNOX	LENNOX
Serial Num	-	5624L01931
Model Num	LCT072H4E	LCT072H4E
Type	RTU	RTU
Configuration	VERTICAL	VERTICAL
Num OA Filters 1	-	2
OA Filter Size 1	-	16X14
Num Final Filter 1	-	4
Final Filter Size 1	-	20X25X2

Test Data		
	Design	Actual
SF CFM	2400	2400
MOTOR RPM	-	2244
RA CFM	2200	2400
OA CFM	200	0
RL Voltage	-	210
RL Amperage	-	3.95
SF System SetPt	-	92%
RA Damper Position	-	100%
RA Damper Type	-	OBD
OA Damper Position	-	0%
OA Damper Type	-	OBD

UNABLE TO BALANCE INDIVIDUAL DIFFUSERS DUE TO LIMITED HEIGHT ACCESS, USED FAN LAW TO BRING THE UNIT TO TOTAL DESIGN.

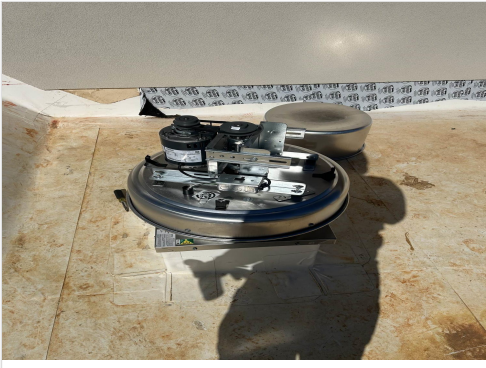
## Unit Data - PHOTO LOG

Unit Data		
	Design	Actual
MFG	GREENHECK	GREENHECK
Model Num	GB-098-6	Q48S17D1279G
Serial Num	-	G25J54928
Type	DOWNBLAST	DOWNBLAST
Configuration	VERTICAL	VERTICAL

Test Data		
	Design	Actual
CFM	375	368
Fan Rotation	-	CCW
Motor RPM	-	1725
System SetPt	-	BELT
RL Voltage	-	115
RL Amperage	-	3.7
Total ESP	0.38"	0.20"
Fan Inlet SP	-	-0.20"
Fan Discharge SP	-	ATM
