Report: TAB Report
Function: Test, Adjust, & Balance
Date: 02/04/2026
Completed By: National TAB

PROJECT
02-09-26 QT #1145 GREENVILLE, SC

1509 GROVE RD

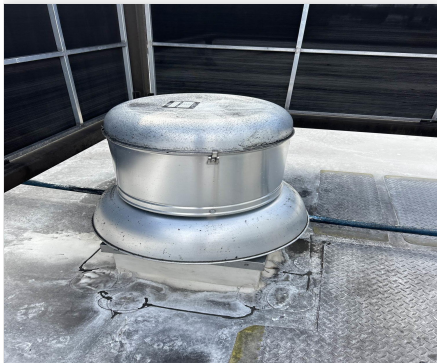
Issue Name : EF-3 at 81% of design
Description : EF-2 is currently at 81% of design. The motor is at max on dail.
Created By : National TAB **Assigned To :** National TAB - Dan Hertenstein
Status : Open
Priority : InfoOnly **Asset Tag :** EF2
Originated Date : 02/18/2026 - Jearod Ferrette - National TAB

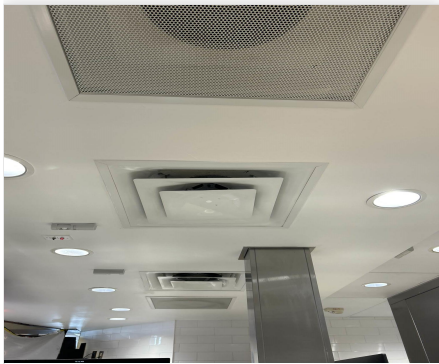
Issue Name : Improper diffusers in kitchen
Description : Improper kitchen diffusers not installed
Created By : National TAB **Assigned To :** National TAB - Dan Hertenstein
Status : Open
Priority : Medium **Asset Tag :** RT-3
Originated Date : 02/18/2026 - Jearod Ferrette - National TAB

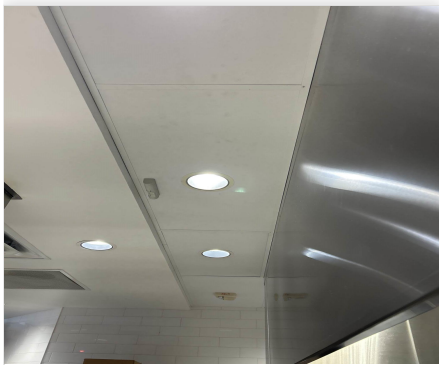
Issue Name : Kitchen dampers inaccessible
Description : First 4 dampers in the kitchen are inaccessible. The electric wire for the light was cut short, which prevents the ceiling tiles to be moved enough so that you're able to reach to dampers.
Created By : National TAB **Assigned To :** National TAB - Dan Hertenstein
Status : Open
Priority : Medium **Asset Tag :** RT-3
Originated Date : 02/18/2026 - Jearod Ferrette - National TAB
