Report: TAB Report
Function: Test, Adjust, & Balance
Date: 02/25/2026
Completed By: National TAB

PROJECT
02-09-26 QT #1145 GREENVILLE, SC

1509 GROVE RD

Project: 02-09-26 QT #1145 GREENVILLE, SC

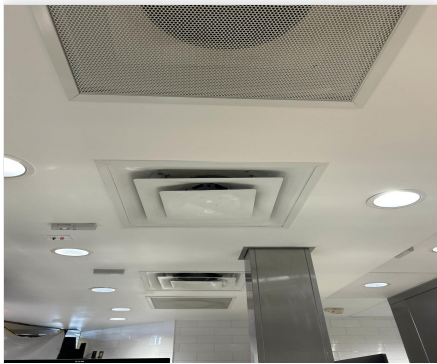
Issue Name : Improper diffusers in kitchen
Description : Specified kitchen diffusers not installed
Created By : National TAB **Assigned To :** National TAB - Dan Hertenstein
Status : Open
Priority : Medium **Asset Tag :** RT-3
Originated Date : 02/18/2026 - Jearod Ferrette - National TAB

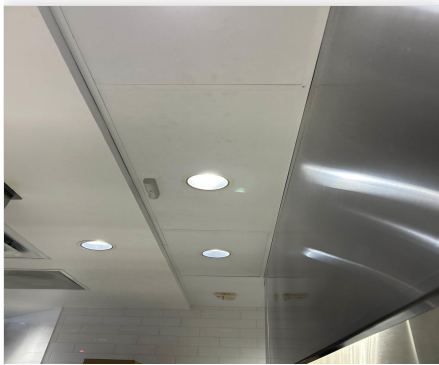
Issue Name : Kitchen dampers inaccessible
Description : First 4 dampers in the kitchen are inaccessible. The electric wire for the light was cut short, which prevents the ceiling tiles to be moved enough to reach the dampers. Face accessible OBD's need to be installed on these diffusers unless the wiring can be resolved.
Created By : National TAB **Assigned To :** National TAB - Dan Hertenstein
Status : Open
Priority : Medium **Asset Tag :** RT-3
Originated Date : 02/18/2026 - Jearod Ferrette - National TAB

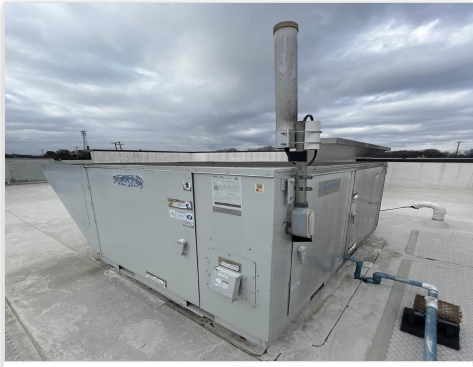
Asset: RT-1

Test Data		
	Design	Actual
SF CFM	4200	4167
SF RPM	-	DD/33 HZ
OA CFM (Hoods On)	800	883
OA CFM (Hoods Off)	350	361
RL Voltage	-	77 VFD
RL Amperage	-	7.5 VFD
VFD Max SetPt	-	33HZ
OA Damper Position (Hoods On)	-	46%
OA Damper Position (Hoods Off)	-	26%

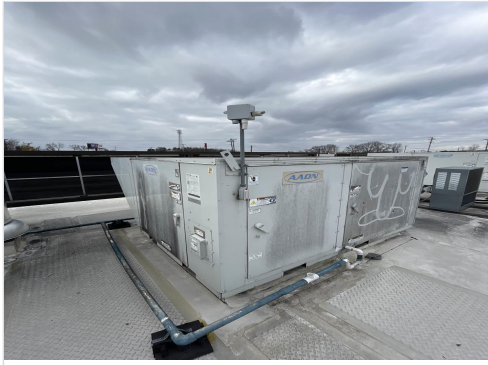
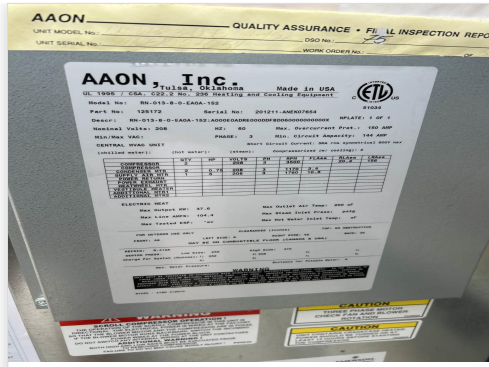
Asset: RT-3

Test Data		
	Design	Actual
SF CFM	4200	4213
SF RPM	-	DD/43 HZ
OA CFM (Hoods On)	800	876
OA CFM (Hoods Off)	350	382
RL Voltage	-	143 VFD
RL Amperage	-	9.5 VFD
VFD Max SetPt	-	43 HZ
OA Damper Position (Hoods On)	-	46%
OA Damper Position (Hoods Off)	-	26%

Notes:
First 4 dampers in the kitchen are inaccessible.

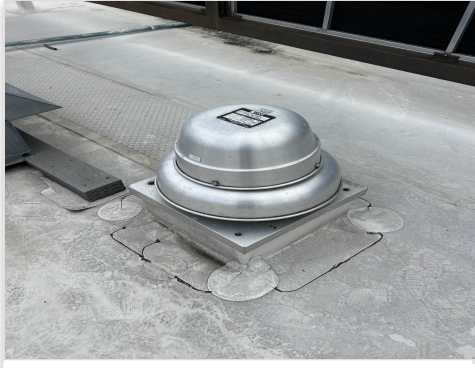
Asset: EF1

Test Data		
	Design	Actual
CFM	225	223
Fan RPM	-	DD
Fan Rotation	-	CCW
Motor RPM	-	DD
System SetPt	-	80%
Total ESP	-	0.15"
Fan Inlet SP	-	-0.15"
Fan Discharge SP	-	ATMO

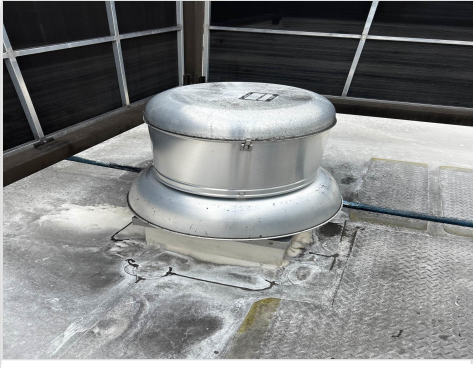
Asset: EF2

Test Data		
	Design	Actual
CFM	525	430
Fan RPM	-	DD
Fan Rotation	-	CCW
Motor RPM	-	DD
System SetPt	-	MAX ON DAIL
Total ESP	-	0.17"
Fan Inlet SP	-	-0.17"
Fan Discharge SP	-	ATMO

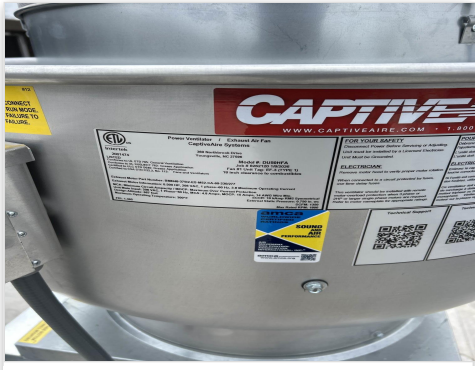
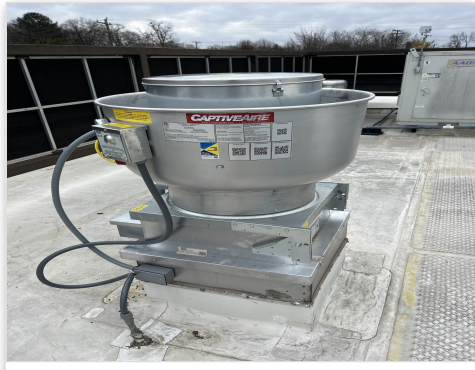
Asset: EF3

Test Data		
	Design	Actual
CFM	1350	1360
Fan RPM	-	1230
Fan Rotation	-	CCW
Motor RPM	-	1230
System SetPt	-	54.8HZ
Total ESP	-	0.27"
Fan Inlet SP	-	-0.27"
Fan Discharge SP	-	ATMO

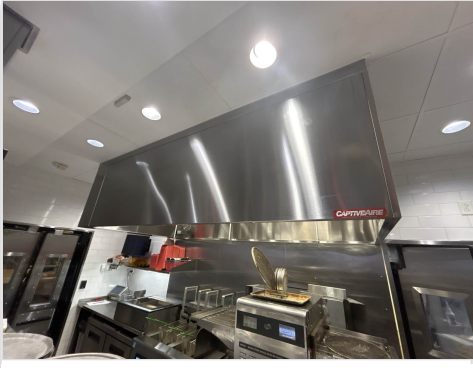
Asset: HD1

Test Data Exhaust		
	Design	Actual
Filter Type	CAPTRATE SOLO FILTER	CAPTRATE SOLO FILTER
Filter Size 1	16X20	16X20
Filter Qty 1	6	6
Filter AK factor size 1	2.08	2.08
Filter Total AK Area	12.48	12.48
Filter1 FPM	-	107
Filter2 FPM	-	115
Filter3 FPM	-	127
Filter4 FPM	-	111
Filter5 FPM	-	96
Filter6 FPM	-	103
Filter Ave FPM(corr)	-	109
CFM	1350	1360
