**Report: TAB Report**  
**Function: Test, Adjust, & Balance**  
**Date: 03/10/2026**  
**Completed By: National TAB**

**PROJECT**  
**03-09-26 QT #0743 MARIETTA, GA**

QUIKTRIP  
4705 SOUTH 129TH EAST AVENUE  
TULSA, OK 74134

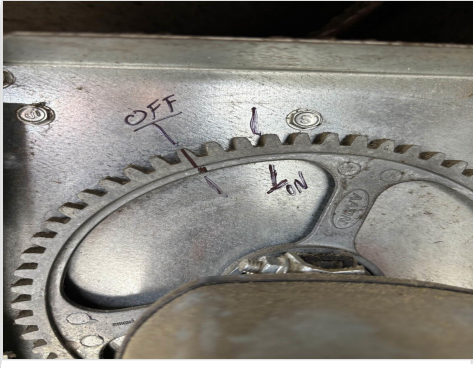
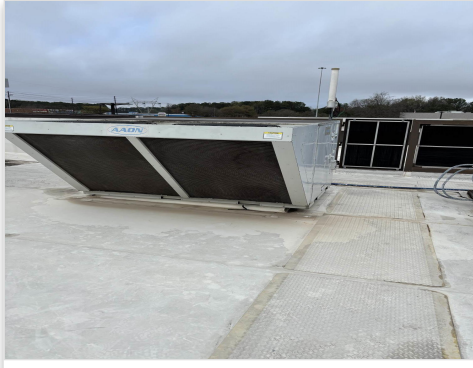
**Unit Data - PHOTO LOG**

Asset: RT-1

AREA:SALES FLOOR

Unit Data	
	Actual
MFG	AAON
Serial Num	201511-ANEK13272
Model Num	RN-013-8-0-EA0A-152
Num OA Filters 1	1
OA Filter Size 1	22X45
Num Final Filter 1	4
Final Filter Size 1	20X25X2

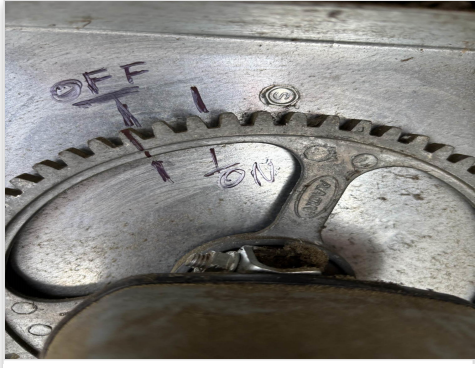
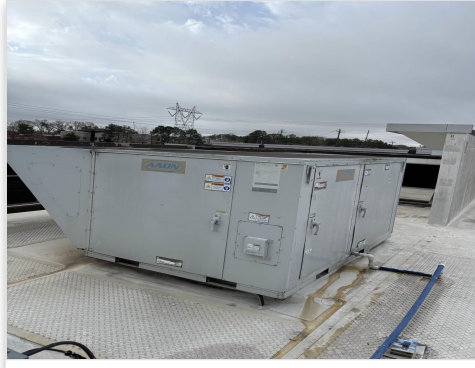
**Unit Data - PHOTO LOG**

Asset: RT-2

AREA:SALES FLOOR

Unit Data	
	Actual
MFG	AAON
Serial Num	201511-ANEK13271
Model Num	RN-013-8-0-EA0A-152
Num OA Filters 1	1
OA Filter Size 1	22X45
Num Final Filter 1	4
Final Filter Size 1	20X25X2

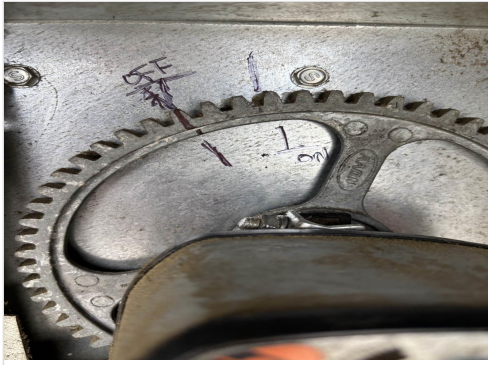
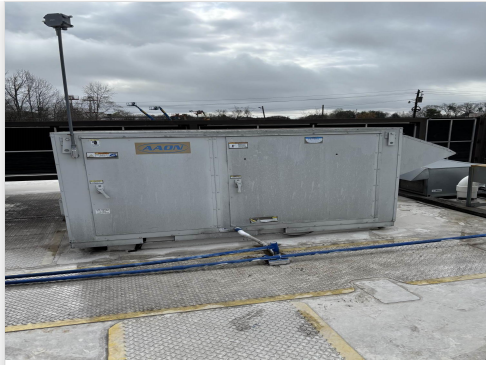
**Unit Data - PHOTO LOG**

Asset: RT-3

AREA:BOH/KITCHEN

Unit Data	
	Actual
MFG	AAON
Serial Num	201511-ANEK13270
Model Num	RN-013-8-0-EA0A-152
Num OA Filters 1	1
OA Filter Size 1	22X45
Num Final Filter 1	4
Final Filter Size 1	20X25X2

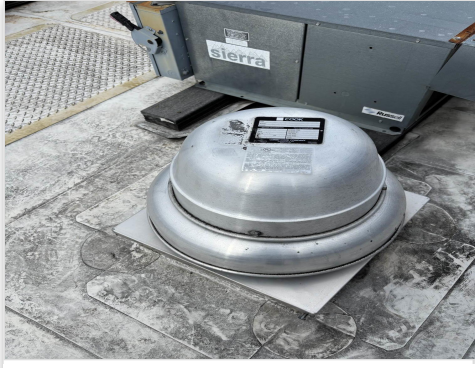
**Unit Data - PHOTO LOG**

Asset: EF1

AREA:WOMEN'S RR

Unit Data	
	Actual
MFG	COOK COMPANY
Model Num	90 ACEH 90C15DH
Serial Num	050SC16048-00
Type	DOWNBLAST
Configuration	VERTICAL

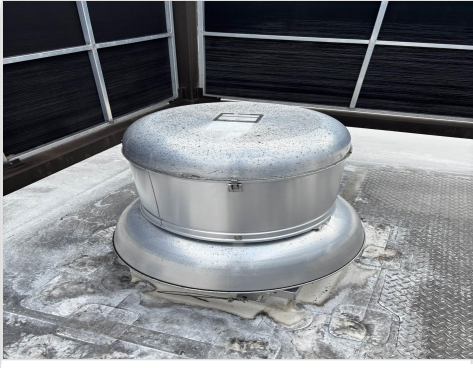
**Unit Data - PHOTO LOG**

Asset: EF2

AREA: MEN'S RR/COMBI

Unit Data	
	Actual
MFG	COOK COMPANY
Model Num	120 ACE 120C13D 33
Serial Num	050SG16048-00
Type	DOWNBLAST
Configuration	VERTICAL

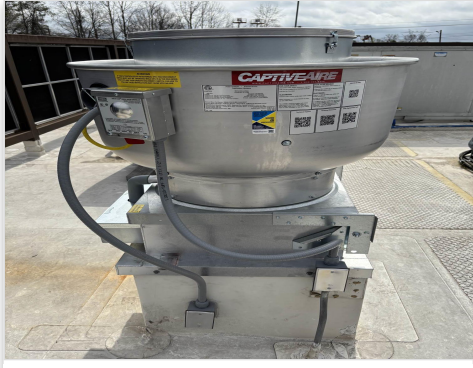
## Unit Data - PHOTO LOG

Asset: EF3

AREA:KITCHEN HD

Unit Data	
	Actual
MFG	CAPTIVEAIRE
Model Num	DU50HFA
Serial Num	8317100
Type	UPBLAST
Configuration	VERTICAL

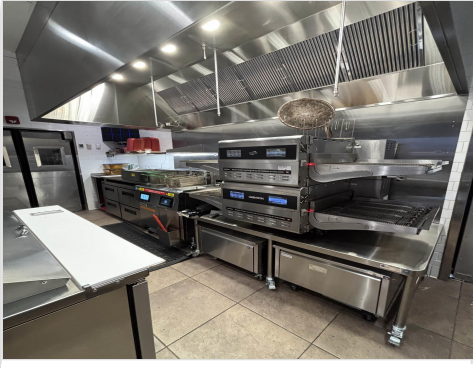
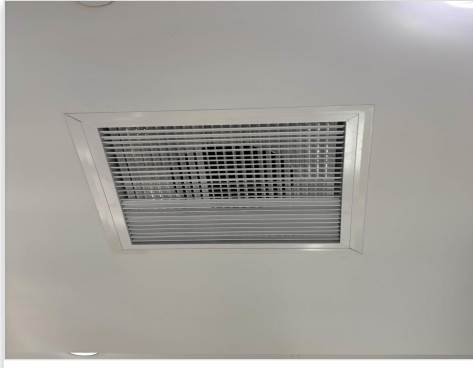
**Unit Data - PHOTO LOG**

Asset: HD1

AREA:GRIDDLE

Design	Actual
MFG	CAPTIVEAIRE	CAPTIVEAIRE
Model Num	6030ND-2-F	6030ND-2-F
Job / Serial Num	-	8317100
Type	TYPE I CANOPY	TYPE I CANOPY
Hood length	108"	108"
Hood Width	60"	60"
