Report: TAB Report
Function: Test, Adjust, & Balance
Date: 11/14/2024
Completed By: National TAB

PROJECT
11-11-24 WAWA #5452 ORLANDO, FL

Project: 11-11-24 WAWA #5452 ORLANDO, FL

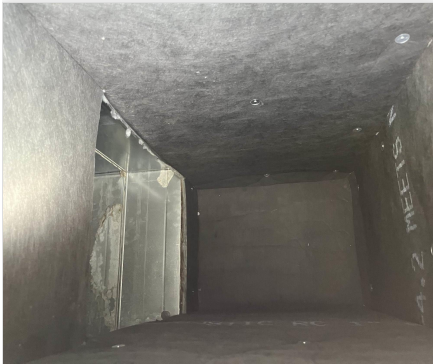
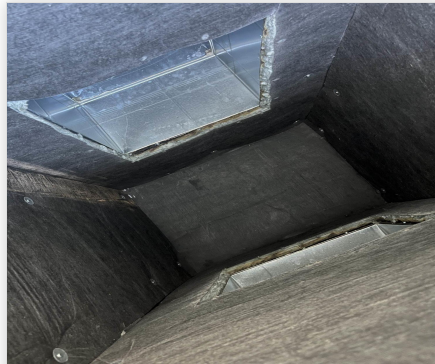
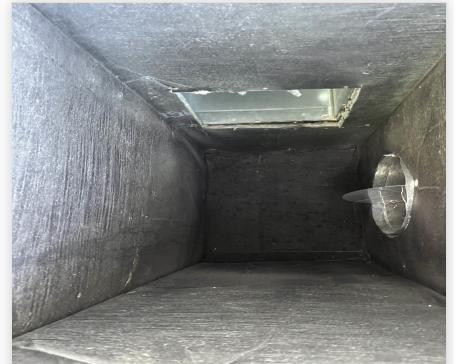
Issue Name : All RTUs - No Turning Vanes
Description : There are no turning vanes installed in any of the RTU supply drops.
Created By : National TAB **Assigned To :** National TAB - Stephen Tassinaro
Status : Open
Priority : Urgent **Asset Tag :**
Originated Date : 11/13/2024 - Stephen Tassinaro - National TAB

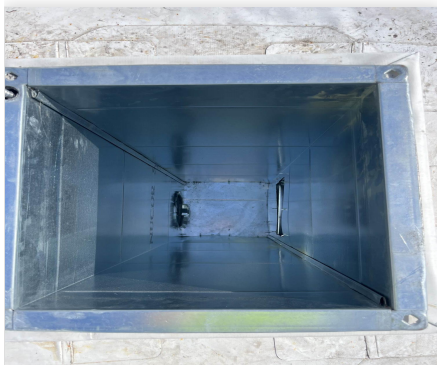
Issue Name : EF-1 Missing Backdraft Damper
Description : There is no backdraft damper installed in the EF-1 drop.
Created By : National TAB **Assigned To :** National TAB - Stephen Tassinaro
Status : Open
Priority : Medium **Asset Tag :**
Originated Date : 11/13/2024 - Stephen Tassinaro - National TAB

- **11/15/2024 National TAB - Stephen Tassinaro**
 - Unable to confirm if backdraft damper was added when curb adapter was installed. Fan was jammed onto the curb adapter and NTi tech was unable to separate without risking damage to fan.

EF-1 no backdraft damper installed

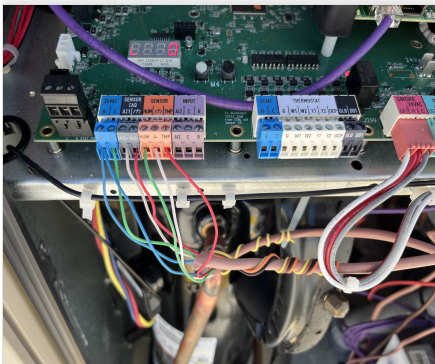
Issue Name : Remote Sensor Wire Incorrect Type
Description : All remote sensors were ran with generic thermostat cable. Qty (2) 2-wire shielded cables are to be used for each temp/humidity sensor.
Created By : National TAB **Assigned To :** National TAB - Stephen Tassinaro
Status : Open
Priority : High **Asset Tag :**
Originated Date : 11/13/2024 - Stephen Tassinaro - National TAB

Single thermostat cable used for all sensors

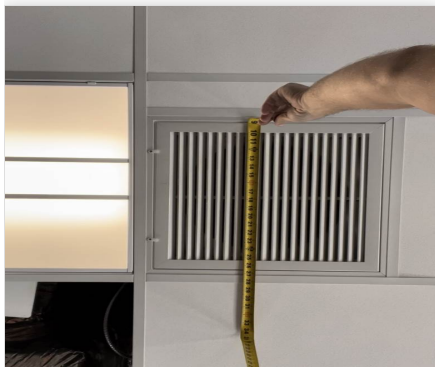
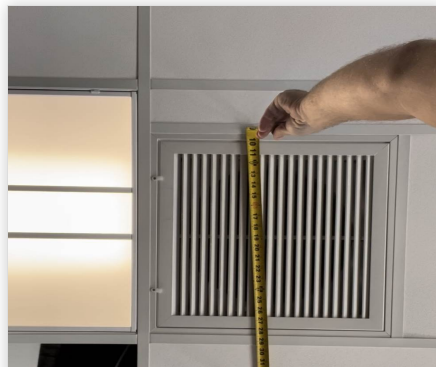
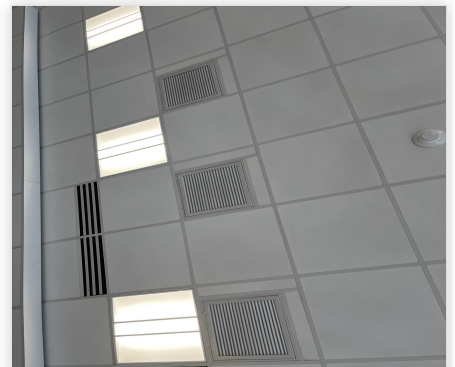
Issue Name : RTU Return Grille Sizing
Description : All RTUs call for G-1 return grilles. A G-1 air device is specified to have a 20"x20" neck and a face size of "NECK+3-3/4". The installed grilles are undersized and measure ~17"x17", with an open area of ~15.5"x15.5".
Created By : National TAB **Assigned To :** National TAB - Stephen Tassinaro
Status : Open
Priority : High **Asset Tag :**
Originated Date : 11/14/2024 - Stephen Tassinaro - National TAB

Note: Return grilles appear to be smaller than shown on air device schedule. Recommend confirming with Wawa/Engineer.

There is a hum from the return grilles on RTU-2. Potentially due to their smaller size. Not expected to be heard over store music.

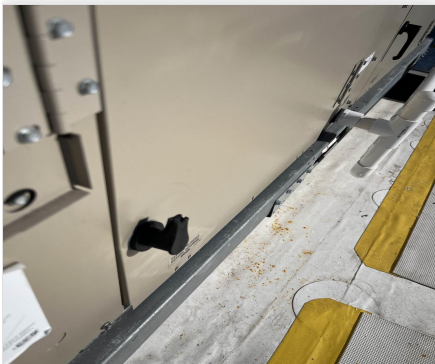
Issue Name : RTU-1 Broken Handle
Description : RTU-1 has a broken handle on the filter access door. Recommend replacement.
Created By : National TAB **Assigned To :** National TAB - Stephen Tassinaro
Status : Open
Priority : Low **Asset Tag :**
Originated Date : 11/13/2024 - Stephen Tassinaro - National TAB

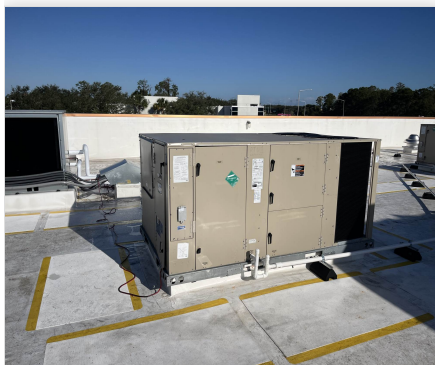
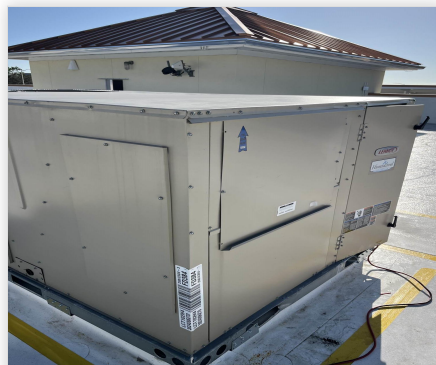
Issue Name : RTU-1 OA Hood Not Assembled
Description : The outside air hood is not assembled on RTU-1. NTi tech temporarily removed the panel in front of the outside air damper to reduce restriction on the unit. The hood assembly will need to be installed to accurately set the outside air on this RTU.
Created By : National TAB **Assigned To :** National TAB - Stephen Tassinaro
Status : Open
Priority : Urgent **Asset Tag :**
Originated Date : 11/13/2024 - Stephen Tassinaro - National TAB

Actual RTU-1 outdoor air value is unknown at this time due to a lack of outside air hood assembly. The damper is functional and has been set to an average value based on other Wawa locations.

RTU 1: FAIL - Outside air not able to be balanced due to lack of hood assembly.

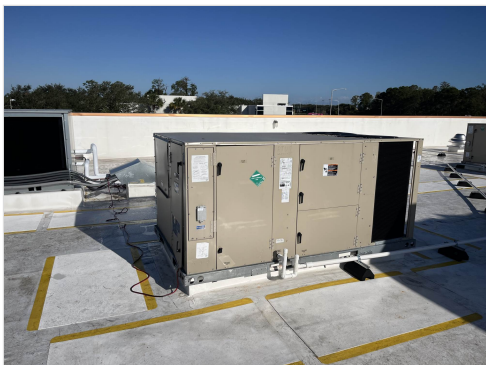
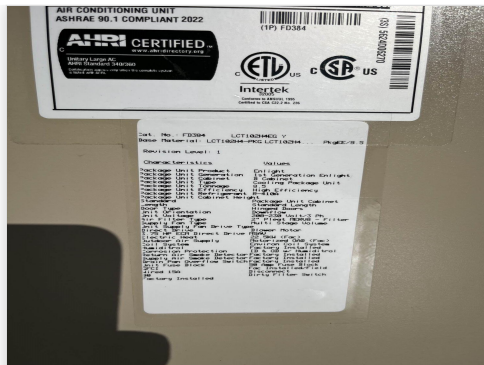
Unit Data - PHOTO LOG

Unit Data		
	Design	Actual
MFG	LENNOX ENLIGHT	LENNOX ENLIGHT
Serial Num	-	5624D06270
Model Num	LCT102H4E	LCT102H4EG1Y
Type	RTU	RTU
Configuration	VERTICAL	VERTICAL
Num OA Filters 1	-	*
OA Filter Size 1	-	*
Num Final Filter 1	-	4
Final Filter Size 1	-	20X25X2

* Outside air hood not installed. Outside air damper set to a reasonable starting point but will need to be adjusted once hood assembly is installed. Static pressures to be taken once outside air is finalized.

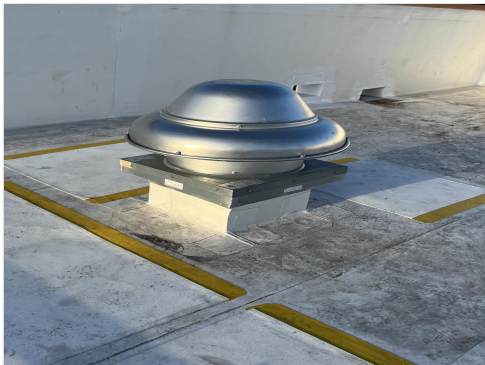
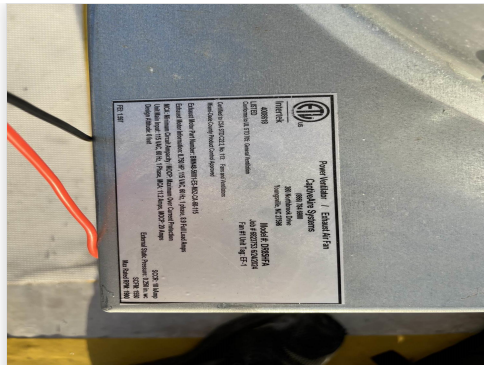
Unit Data - PHOTO LOG

Unit Data		
	Design	Actual
MFG	GREENHECK	CAPTIVE AIRE
Model Num	G-160	DR85HFA
Serial Num	-	6823753
Type	DOWNBLAST	CENTRIFUGAL
Configuration	VERTICAL	DOWNBLAST

Notes:
*Fan jammed onto curb adapter and could not be lifted to take static pressure measurement.
