Report: TAB REPORT
Function: Test, Adjust, & Balance
Date: 08/28/2023

08-21-23 FREDDY'S - NACOGDOCHES, TX

Project: 08-21-23 FREDDY'S - NACOGDOCHES, TX

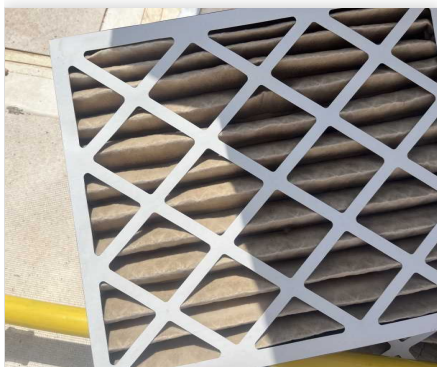
FILTERS
08/28/2023

Issue Name : DOAS Filters
Description : DOAS filters are dirty. Half of filters for each DOAS unit were removed during testing. Recommend replacing. Replacement filter sizes: DOAS-1 (4) 20x25x2 (MERV 8) (4) 20x25x2 (MERV 13) DOAS-2 (4) 16x20x2 (MERV 8) (4) 16x20x2 (MERV 13)
Created By : National TAB **Assigned To :** National TAB - Will Turnbough
Status : Open
Originated Date : 08/28/2023 - Wesley John - National TAB

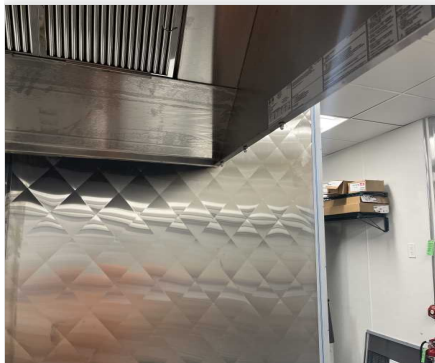
END_PANELS
08/28/2023

Issue Name : Hood End Panels
Description : Hood end panels are not installed on Hood-1 and Hood-2. Recommend installing to aid hood performance.
Created By : National TAB **Assigned To :** National TAB - Will Turnbough
Status : Open
Originated Date : 08/28/2023 - Wesley John - National TAB
