**Report: TAB REPORT**  
**Function: Test, Adjust, & Balance**  
**Date: 08/28/2023**

**08-21-23 FREDDY'S - NACOGDOCHES, TX**

# National TAB

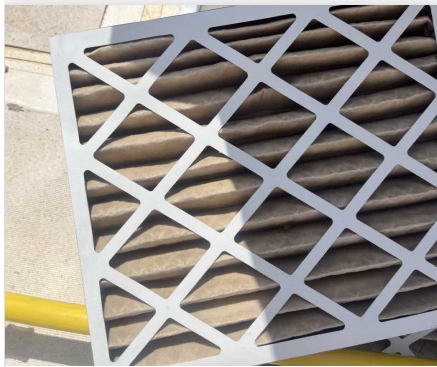
**FILTERS**  
**08/28/2023**

**Issue Name :** DOAS Filters  
**Description :** DOAS filters are dirty. Half of filters for each DOAS unit were removed during testing. Recommend replacing. Replacement filter sizes: DOAS-1 (4) 20x25x2 (MERV 8) (4) 20x25x2 (MERV 13) DOAS-2 (4) 16x20x2 (MERV 8) (4) 16x20x2 (MERV 13)  
**Created By :** National TAB                      **Assigned To :** National TAB - Will Turnbough  
**Status :** Open  
**Originated Date :** 08/28/2023 - Wesley John - National TAB

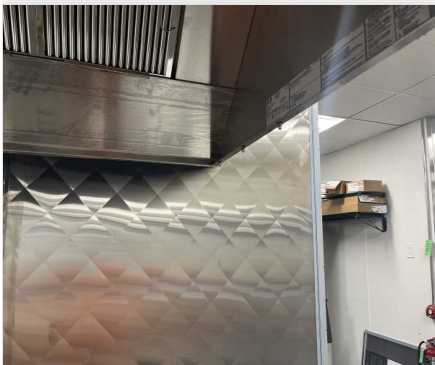
**END\_PANELS**  
**08/28/2023**

**Issue Name :** Hood End Panels  
**Description :** Hood end panels are not installed on Hood-1 and Hood-2. Recommend installing to aid hood performance.  
**Created By :** National TAB                      **Assigned To :** National TAB - Will Turnbough  
**Status :** Open  
**Originated Date :** 08/28/2023 - Wesley John - National TAB

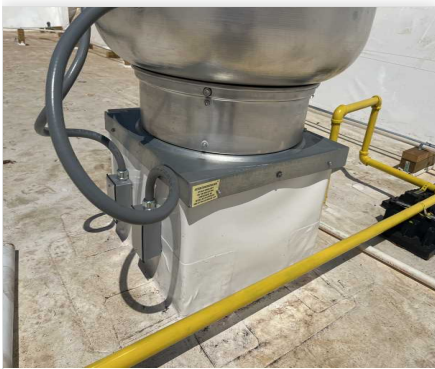
**HINGE\_KIT**  
**08/28/2023**

**Issue Name :** KEF-2  
**Description :** KEF-2 (fryer hood) is missing hinge kit. Recommend installing to allow for grease duct cleaning. Fan should be able to hinge completely given length of electrical conduit.  
**Created By :** National TAB                      **Assigned To :** National TAB - Will Turnbough  
**Status :** Open  
**Originated Date :** 08/28/2023 - Wesley John - National TAB

HINGE KIT MISSING ON KEF-2

UNABLE TO CHECK UNDER KEF-2 (MISSING HINGE KIT)

Notes:  
[1] HINGE KIT NOT INSTALLED. UNABLE TO MEASURE FAN SUCTION STATIC PRESSURE.

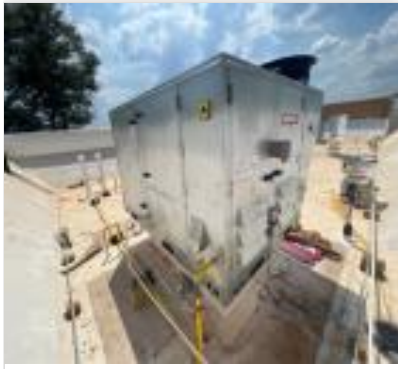
**DOAS-1**  
**08/24/2023**

Unit Data		
	Design	Actual
MFG	CAPTIVE-AIRE	CAPTIVE-AIRE
Serial Num	-	5565563
Model Num	CASRTU2-I.200-15-20T-DOAS	CASRTU3-I.200-15-20T
Type	DOAS	DOAS
Configuration	VERTICAL DISCHARGE	VERTICAL DISCHARGE
Num OA Filters 1	-	4
OA Filter Size 1	-	16x25x2
Num Final Filter 1	-	4 (MERV 8)
Final Filter Size 1	-	20x25x2
Num Final Filter 2	-	4 (MERV13)
Final Filter Size 2	-	20x25x2

Test Data		
	Design	Actual
SF CFM	2650	2556
SF RPM	-	1769
RA CFM	0	0
OA CFM	2650	2556
RL Voltage	-	206
RL Amperage	-	5.4
SF Rotation	-	CCW
RA Damper Position	-	0%
Min OA Damper Position	-	100%
Min OA Damper Type	-	OPPOSED BLADE

General		
	Design	Actual
Fan Rotation Correct	-	YES
Unit Filters Clean	-	NO

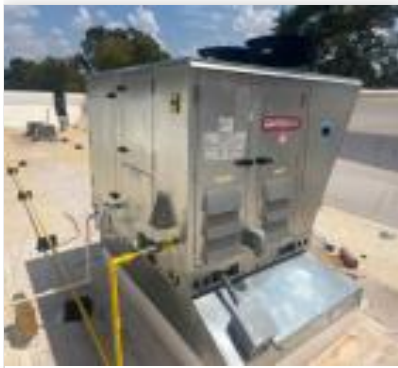
**DOAS-2**  
**08/24/2023**

Unit Data		
	Design	Actual
MFG	CAPTIVE-AIRE	CAPTIVE-AIRE
Serial Num	-	5565563
Model Num	CASRTU2-I.200-15-20T-DOAS	CASRTU2-I.250-18-10T
Type	DOAS	DOAS
Configuration	VERTICAL DISCHARGE	VERTICAL DISCHARGE
Num OA Filters 1	-	2
OA Filter Size 1	-	20x25x2
Num Final Filter 1	-	4 (MERV 8)
Final Filter Size 1	-	16x20x2
Num Final Filter 2	-	4 (MERV 13)
Final Filter Size 2	-	16x20x2

Test Data		
	Design	Actual
SF CFM	4000	3907
SF RPM	-	2188
RA CFM	3200	3095
OA CFM	800	812
RL Voltage	-	189
RL Amperage	-	12.2
SF Rotation	-	CCW
RA Damper Position	-	52%
Min OA Damper Position	-	48%
Min OA Damper Type	-	OPPOSED BLADE

General		
	Design	Actual
Fan Rotation Correct	-	YES
Unit Filters Clean	-	NO
