Report: TAB Report

Function: Test, Adjust, & Balance

02-10-25 WAWA #5459 STARKE, FL

Project: 02-10-25 WAWA #5459 STARKE, FL

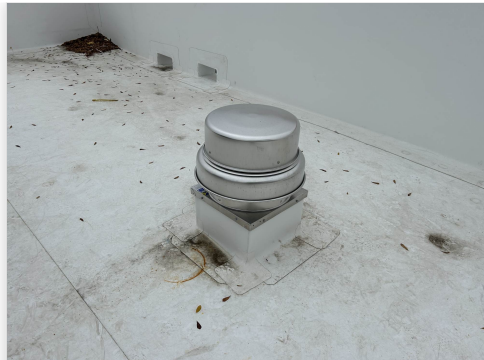
Unit Data - PHOTO LOG

Asset: EF1

Unit Data		
	Design	Actual
MFG	GREENHECK	GREENHECK
Model Num	G-120	G-120-B-4-1-19-X
Serial Num	-	26145230
Type	DOWNBLAST	DOWNBLAST
Configuration	VERTICAL	VERTICAL

Test Data		
	Design	Actual
CFM	800	805
Fan Rotation	-	CORRECT
System SetPt	-	HIGH SPEED CONTROLLER
RL Voltage	-	122
RL Amperage	-	2.4
Total ESP	0.250"	0.305"
Fan Inlet SP	-	-0.305"
Fan Discharge SP	-	ATM
