Report: TAB Report
Function: Test, Adjust, & Balance
Date: 03/04/2025
Completed By: National TAB

PROJECT
02-10-25 WAWA #5459 STARKE, FL

Project: 02-10-25 WAWA #5459 STARKE, FL

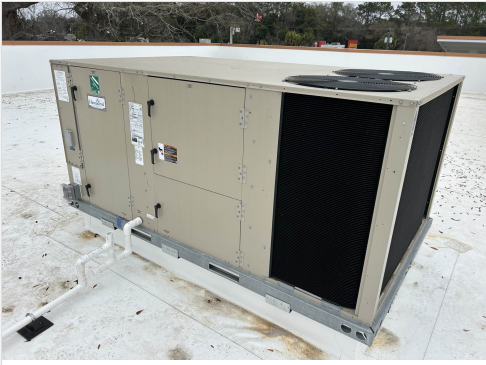
Unit Data - PHOTO LOG

Asset: RTU1

Unit Data		
	Design	Actual
MFG	LENNOX	LENNOX
Serial Num	-	5624H04153
Model Num	LCT102H4E	LCT102H4EG1Y
Type	RTU	RTU
Configuration	VERTICLE	VERTICAL
Num OA Filters 1	-	1
OA Filter Size 1	-	23x14
Num Final Filter 1	-	4
Final Filter Size 1	-	20x25x2

Test Data		
	Design	Actual
SF CFM	3400	3456
SF RPM	-	1298
MOTOR RPM	-	1298
RA CFM	2900	2937
OA CFM	500	519
RL Voltage	-	205/206/206
RL Amperage	-	2.5/2.4/2.4
SF System SetPt	-	59%
OA Damper Position	-	45%
OA Damper Type	-	SINGLE BLADE

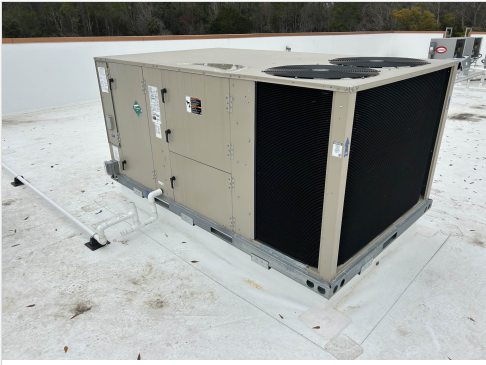
Unit Data - PHOTO LOG

Asset: RTU2

Unit Data		
	Design	Actual
MFG	LENNOX	LENNOX
Serial Num	-	5624H04159
Model Num	LCT150H4E	LCT150H4EN1Y
Type	RTU	RTU
Configuration	VERTICAL	VERTICAL
Num OA Filters 1	-	1
OA Filter Size 1	-	23x14
Num Final Filter 1	-	4
Final Filter Size 1	-	20x25x2

Test Data		
	Design	Actual
SF CFM	5000	4992
SF RPM	-	1914
MOTOR RPM	-	1914
RA CFM	4500	4475
OA CFM	500	517
RL Voltage	-	205/206/207
RL Amperage	-	6.1/6.2/6.1
SF System SetPt	-	87%
OA Damper Position	-	36%
OA Damper Type	-	SINGLE BLADE

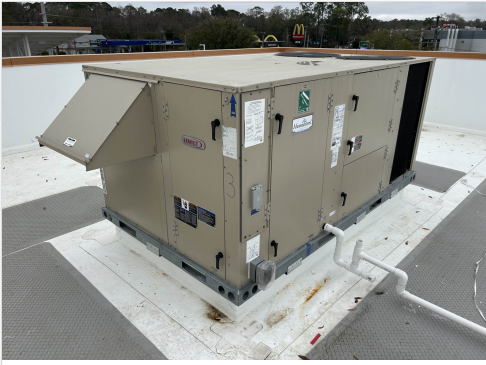
Unit Data - PHOTO LOG

Asset: RTU3

Unit Data		
	Design	Actual
MFG	LENNOX	LENNOX
Serial Num	-	5624H04556
Model Num	LCT092H4E	LCT092H4EG1Y
Type	RTU	RTU
Configuration	VERTICAL	VERTICAL
Num OA Filters 1	-	1
OA Filter Size 1	-	23x14
Num Final Filter 1	-	4
Final Filter Size 1	-	20x25x2

Test Data		
	Design	Actual
SF CFM	3000	3059
SF RPM	-	1210
MOTOR RPM	-	1210
RA CFM	2700	2753
OA CFM	300	306
RL Voltage	-	206/205/205
RL Amperage	-	2.2/2.1/2.1
SF System SetPt	-	55%
OA Damper Position	-	35%
OA Damper Type	-	SINGLE BLADE

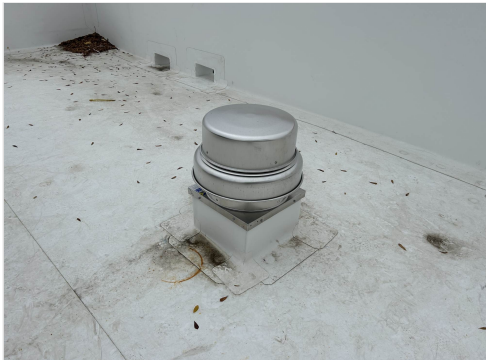
Unit Data - PHOTO LOG

Asset: EF1

Unit Data		
	Design	Actual
MFG	GREENHECK	GREENHECK
Model Num	G-120	G-120-B-4-1-19-X
Serial Num	-	26145230
Type	DOWNBLAST	DOWNBLAST
Configuration	VERTICAL	VERTICAL

Test Data		
	Design	Actual
CFM	800	805
Fan Rotation	-	CORRECT
System SetPt	-	HIGH SPEED CONTROLLER
RL Voltage	-	122
RL Amperage	-	2.4
Total ESP	0.250"	0.305"
Fan Inlet SP	-	-0.305"
Fan Discharge SP	-	ATM

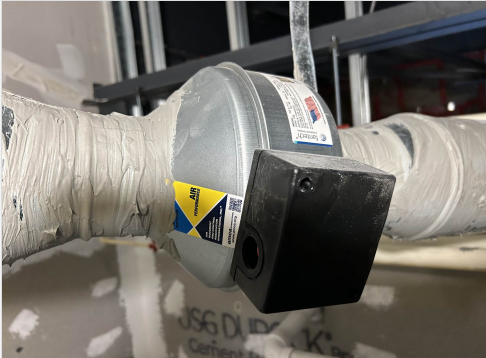
Unit Data - PHOTO LOG

Asset: EF2

Unit Data		
	Design	Actual
MFG	GREENHECK	FANTECH
Model Num	CSP-B110	FG4/K4
Serial Num	-	1009059251
Type	INLINE	INLINE
Configuration	VERTICAL	VERTICAL

Test Data		
	Design	Actual
CFM	60	62
Fan RPM	584	DD
Fan Rotation	-	CORRECT
Motor RPM	-	DD
System SetPt	-	SPEED CONTROLLER (MARKED)
RL Voltage	-	120
RL Amperage	-	0.1
