Report: TAB REPORT
Function: Test, Adjust, & Balance
Date: 08/14/2023

PROJECT
07-31-23 SWEETGREEN - BLOOMINGTON, IN
(TAB, IAQ)

210 E KIRKWOOD AVE

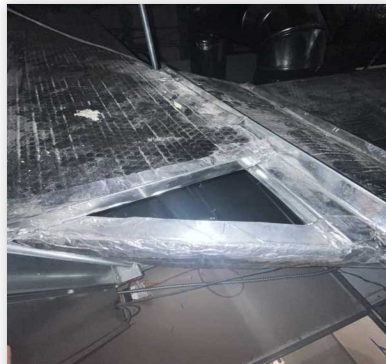
Issue Name : AHU-2 ductwork has a large gap.
Description : AHU-2 ductwork has a gap that needs to be sealed above Hood 1. Recommend mechanical contractor complete.
Created By : National TAB **Assigned To :** National TAB - Dylan Crisman
Status : Open
Originated Date : 08/01/2023 - Dylan Crisman - National TAB

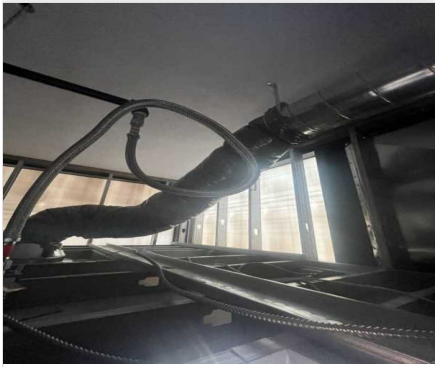
2981513D_3C24_4C53_82..
08/03/2023

Issue Name : Diffuser 2-1 (Vestibule) is missing a damper.
Description : Airflow is 165 CFM out of 125 CFM design. Unable to reduce airflow any further due to damper not being installed. Recommend installing damper.
Created By : National TAB **Assigned To :** National TAB - Dylan Crisman
Status : Open
Originated Date : 08/03/2023 - Dylan Crisman - National TAB
