**Report: TAB REPORT**  
**Function: Test, Adjust, & Balance**  
**Date: 12/13/2022**

## 12-01 MOD PIZZA - LENEXA, KS

Project: 12-01 MOD PIZZA - LENEXA, KS

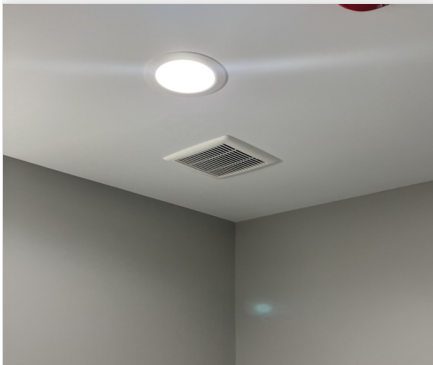
EF2.jpeg

**Issue Name :** EF2/EF3 low flow, no speed control

**Description :** EF2 and EF3 are experiencing low flow issues. There is no speed control to increase it any further. The backdraft damper in the fans could be stuck, however tech cannot confirm since the fans are below hard ceiling.

Test Data		
	Design	Actual
CFM	75	38
Fan RPM	900	DD
Fan Rotation	-	CCW
Motor RPM	-	DD
System SetPt	-	NO SPEED CONTROL
RL Voltage	-	121
RL Amperage	-	NOT SAFE
Total ESP	0.375"	UTO
Fan Inlet SP	-	UTO
Fan Discharge SP	-	UTO

Notes: Single Speed fan below hard ceiling. Unable to increase speed.

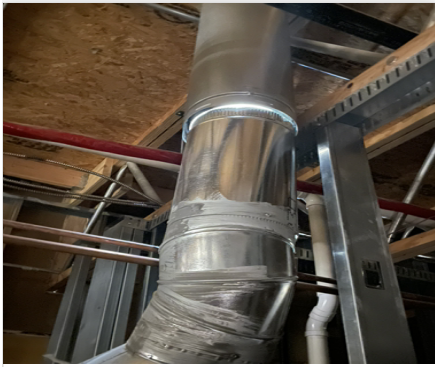
Ductleak.jpeg

**Issue Name :** EF2/EF3/EF4 roof duct leakage

**Description :** There appears to be duct leakage for the exhaust duct for the 3 fans.
