National TAB
1329 E. KEMPER ROAD
SUITE 4210
CINCINNATI, OH 45246

Report: TAB REPORT
Function: Test, Adjust, & Balance
Date: 12/13/2022

12-01 MOD PIZZA - LENEXA, KS

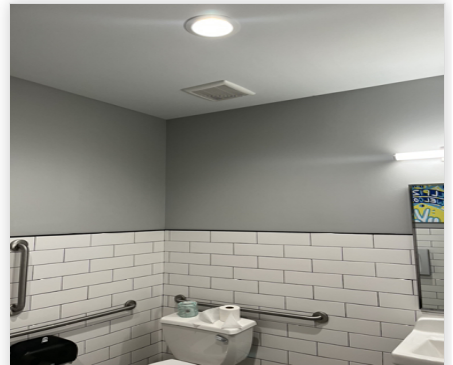
Ef3.jpeg

Issue Name : EF2/EF3 low flow, no speed control

Description : EF2 and EF3 are low on flow. There is no speed control to increase it any further. Recommend ensuring that the internal backdraft dampers are fully open.

Notes: Single Speed fan below hard ceiling. Unable to increase speed.

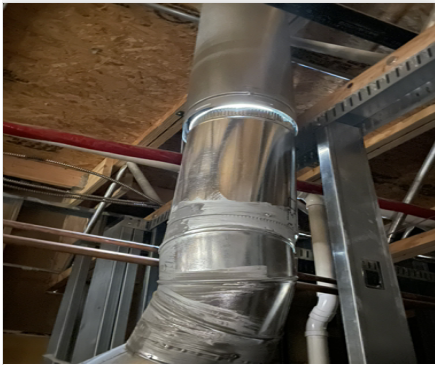
Ductleak.jpeg

Issue Name : EF2/EF3/EF4 discharge duct leakage

Description : Discharge duct for the restroom exhaust fans is disconnected above the ceiling. Recommend connecting.
