Report: TAB Report
Function: Test, Adjust, & Balance
Date: 03/07/2024

PROJECT
03-04-24 PENN STATION - SEYMOUR, IN

Project: 03-04-24 PENN STATION - SEYMOUR, IN

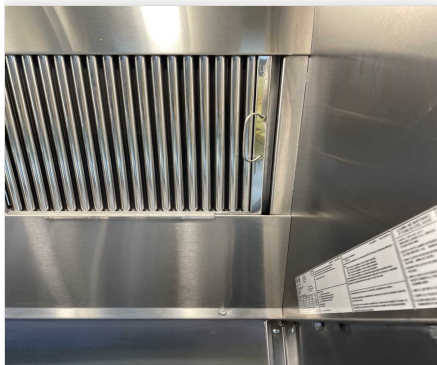
IMG_3146
03/06/2024

Issue Name : Hood 3 Gap in Filter Bank
Description : Hood 3 hood bank has a slight gap when all filters are installed. Taped over during testing. Recommend installing attachment to close gap.
Created By : National TAB **Assigned To :** National TAB - Jordan Best
Status : Open
Priority : Medium **Asset Tag :**
Originated Date : 03/06/2024 - Jordan Best - National TAB

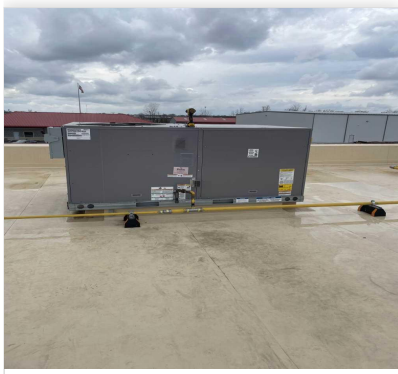
IMG_3135
03/06/2024

RTU-2
