Report: TAB REPORT
Function: Test, Adjust, & Balance
Date: 07/11/2025
Completed By: National TAB

06-30-25 CHIPOTLE #5399 MT PLEASANT, PA

200 BESSEMER RD

MT PLEASANT , PA 15666

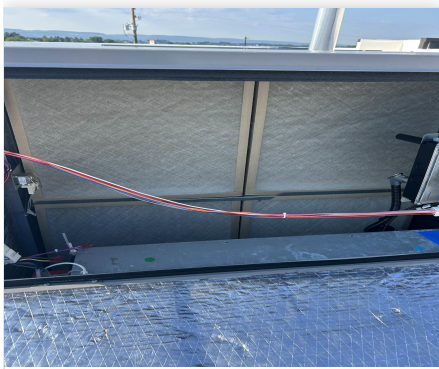
Issue Name : RTUs - Construction Filters
Description : Both RTUs have temporary construction filters installed. Recommend installing required final filters.
Created By : National TAB **Assigned To :** National TAB - Mark Johnson
Status : Open
Priority : Low **Asset Tag :**
Originated Date : 07/11/2025 - Mark Johnson - National TAB

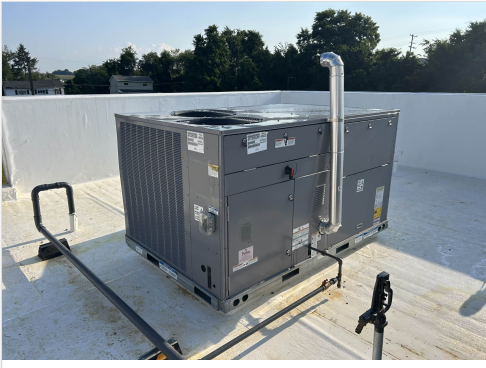
Unit Data - PHOTO LOG

General	
	Actual
Fan Rotation Correct	YES
Unit Filters Clean	CONSTRUCTION FILTERS
Condensate Drain Installed	YES

Notes:
Lines 1 and 3 not safely accessible for amperage reading

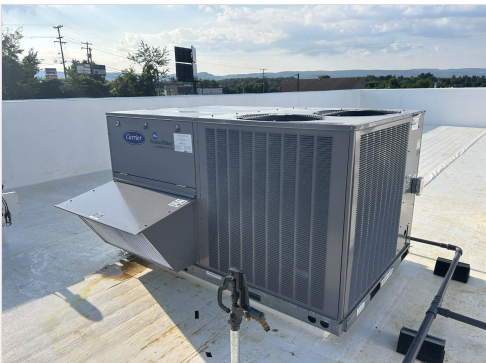
Unit Data - PHOTO LOG

General	
	Actual
Fan Rotation Correct	YES
Unit Filters Clean	CONSTRUCTION FILTERS
Condensate Drain Installed	YES
