**Report: Cody Mauro**  
**Function: Test, Adjust, & Balance**  
**Date: 10/03/2025**  
**Completed By: National TAB**

**PROJECT**  
**09-29-25 CAVA SAVANNAH, GA**  
**(OGLETHORPE MALL)**

Project: 09-29-25 CAVA SAVANNAH, GA (OGLETHORPE MALL)

## Project Summary

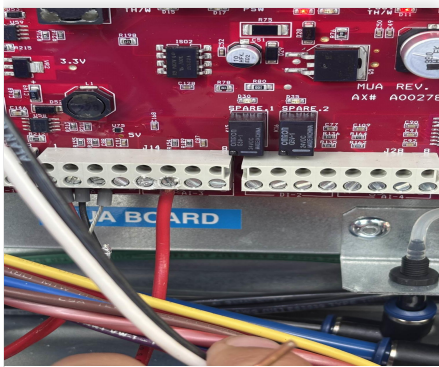
**Issue Name :** MAU FAN CONTROL  
**Description :** Fan speed not programmed into hood HMI. Control system not wired into MAU board on the roof. Manually changed speed on VFD from 48Hz to 52Hz.  
**Created By :** National TAB                      **Assigned To :** National TAB - Cody Mauro  
**Status :** Open  
**Priority :** Urgent                                      **Asset Tag :**  
**Originated Date :** 10/01/2025 - Cody Mauro - National TAB

NET BUILDING TOTAL OA is high due to RTU2 economizer dampers not communicating with board. Dampers are cracked open a bit too far, unable to close more. Remote dampers for RTU2 inaccessible, totals in design. Hood interface cannot control MA fan supply speed, control system not wired on MAU unit board.

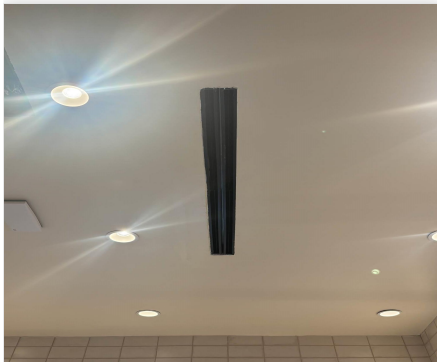
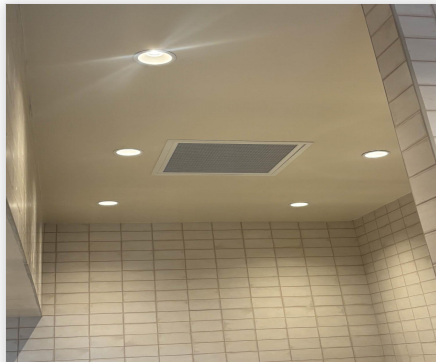
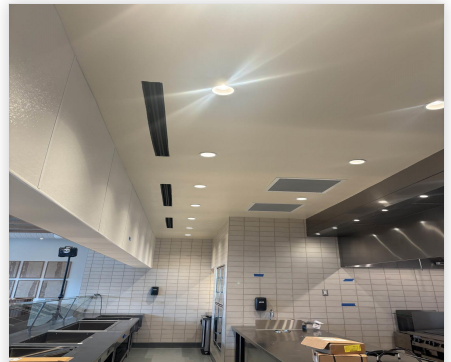
**Issue Name :** RTU2 REMOTE DAMPERS  
**Description :** Dampers for diffusers 2-1 through 2-8 are inaccessible. They all sit above dry wall ceiling. SGRD2-8 not pictured, but duct line runs close to hood, which sits above drywall ceiling.  
**Created By :** National TAB                      **Assigned To :** National TAB - Cody Mauro  
**Status :** Open  
**Priority :** High                                      **Asset Tag :**  
**Originated Date :** 09/30/2025 - Cody Mauro - National TAB

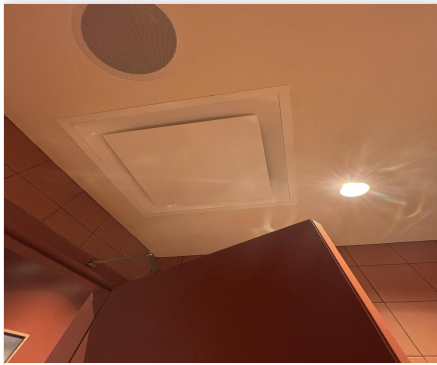
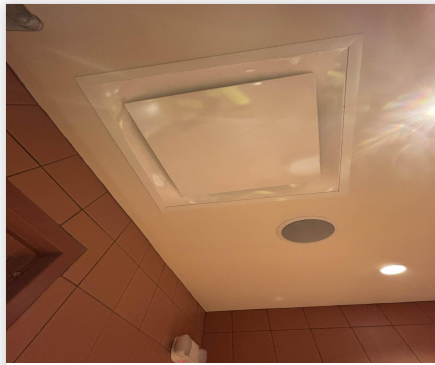
**Issue Name :** SGRD1-13 & 1-14 (RESTROOMS)  
**Description :** Dampers for these diffusers are inaccessible. They sit above dry wall ceiling.  
**Created By :** National TAB                      **Assigned To :** National TAB - Cody Mauro  
**Status :** Open  
**Priority :** High                                      **Asset Tag :**  
**Originated Date :** 09/30/2025 - Cody Mauro - National TAB

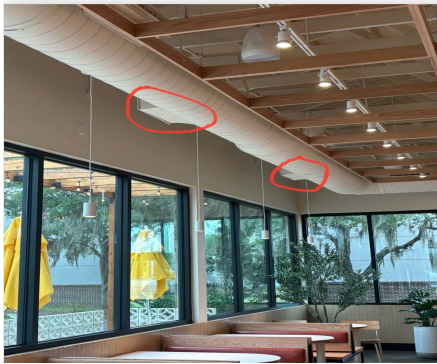
**Issue Name :** SGRD1-4 & SGRD1-6  
**Description :** Cannot access dampers or read airflow on these diffusers. Every other diffuser on this line is balanced. Can assume these diffusers are close to, if not already within design  
**Created By :** National TAB                      **Assigned To :** National TAB - Cody Mauro  
**Status :** Open  
**Priority :** Low                                      **Asset Tag :**  
**Originated Date :** 09/30/2025 - Cody Mauro - National TAB

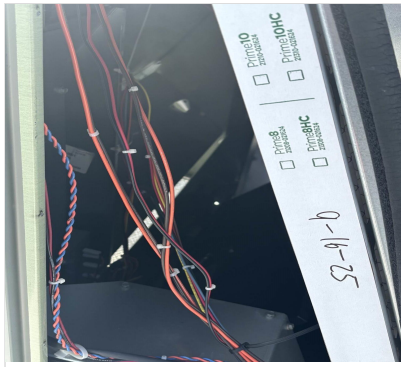
10/01/2025

**Economizer wired to control board**

Fail

RTU2 Economizer dampers able to be changed, no change happens. There is a disconnect somewhere between the board and Economizer

Fix Economizer for RTU2, set OA damper positions to around 11-12%.
