**Report: TAB REPORT**  
**Function: Test, Adjust, & Balance**  
**Date: 06/18/2025**  
**Completed By: National TAB**

**06-16-25 WAWA #6121 GREENVILLE, NC**

Project: 06-16-25 WAWA #6121 GREENVILLE, NC

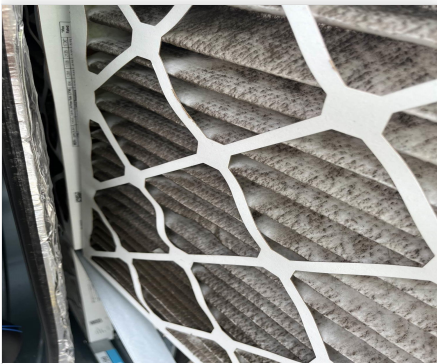
**Issue Name :** RTU1, RTU2, RTU3 / Dirty Filters  
**Description :** RTU1, RTU2, RTU3 filters are dirty, recommend they be replaced.  
**Created By :** National TAB                      **Assigned To :** National TAB - Dale Wheeler  
**Status :** Open  
**Priority :** **Medium**                                      **Asset Tag :**  
**Originated Date :** 06/18/2025 - Dale Wheeler - National TAB

RTU1, RTU2, RTU3 FILTERS ARE DIRTY

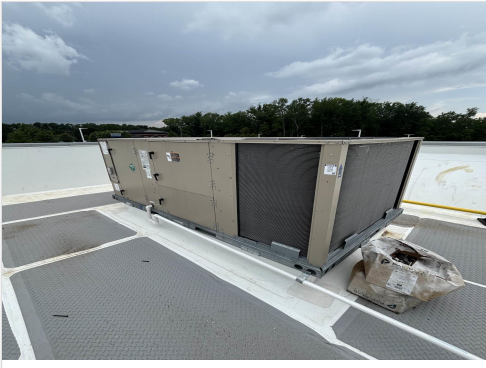
Asset: RTU1

Unit Data		
	Design	Actual
MFG	LENNOX	LENNOX
Serial Num	-	5624J05370
Model Num	LCT150H4E	LCT150H4EN1Y
Type	RTU	RTU
Configuration	VERTICAL	VERTICLE
Num OA Filters 1	-	2
OA Filter Size 1	-	14.25X22.5
Num OA Filters 2	-	4
OA Filter Size 2	-	20X25X2

Notes:  
[1] EGRD3 DAMPER IS 100% RETURN GRILL UNABLE TO REACH DESIGN CFM.

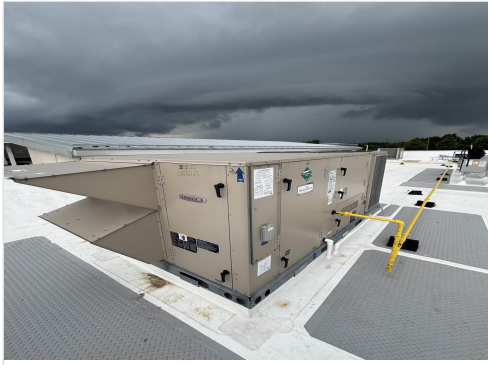
Asset: RTU2

Unit Data		
	Design	Actual
MFG	LENNOX	LENNOX
Serial Num	-	5624L03361
Model Num	LGT102H4E	LGT072H4EQ1Y
Type	RTU	RTU
Configuration	VERTICAL	VERTICLE
Num OA Filters 1	-	1
OA Filter Size 1	-	29X14
Num OA Filters 2	-	4
OA Filter Size 2	-	20X20X2

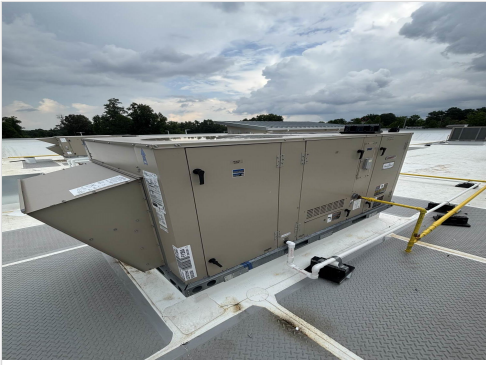
Asset: RTU3

Unit Data		
	Design	Actual
MFG	LENNOX	LENNOX
Serial Num	-	5624J05372
Model Num	LGT072H4E	LGT102H4ES1Y
Type	RTU	RTU
Configuration	VERTICAL	VERTICLE
Num OA Filters 1	-	2
OA Filter Size 1	-	14.25X23
Num OA Filters 2	-	4
OA Filter Size 2	-	20X25X2

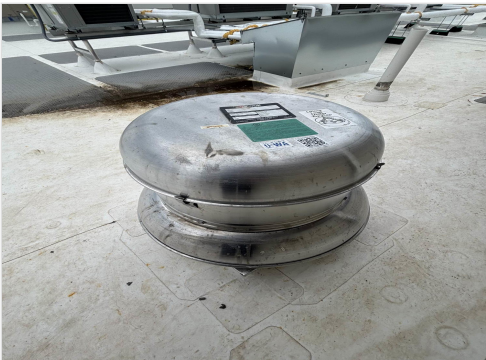
Asset: EF1

Unit Data		
	Design	Actual
MFG	GREENHECK	COOK
Model Num	GB-09-6	10 0C2B 100 ACE
Serial Num	-	203SL39950- 00/0000701
Type	DOWNBLAST	UPBLAST
Configuration	VERTICAL	VERTICLE

Notes:  
[1] UNABLE TO TAKE VOLTS AND AMPS DUE TO LIGHT SWITCH STYLE DISCONNECT

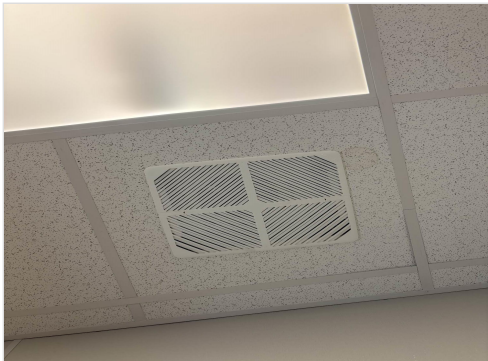
Asset: EF3

Unit Data		
	Design	Actual
MFG	GREENHECK	GREENHECK
Model Num	SP-B200	SP-B200-QD
Serial Num	-	184454826-0066
Type	CEILING	CEILING
Configuration	VERTICAL	VERTICAL
