**Report: TAB REPORT**  
**Function: Test, Adjust, & Balance**  
**Date: 03/08/2023**

## 03-06-23 TACO BELL - JACKSONVILLE, NC

185 FREEDOM WAY

Project: 03-06-23 TACO BELL - JACKSONVILLE, NC

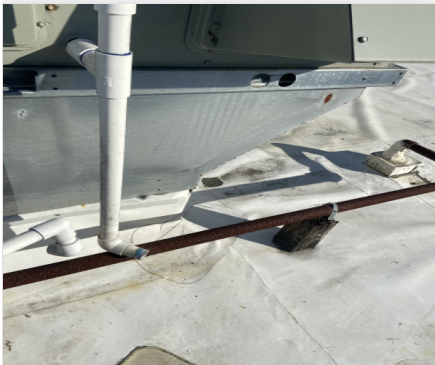
Not-connected.jpeg

**Issue Name :** RTU-1 condensate drain not secure

**Description :** DRAIN IS NOT ATTACHED PROPERLY AND WAS DETACHED WHEN I ARRIVED ON SITE. I REATTACHED THEM, BUT THE ADHESIVE USED HAS DEGRADED AND NEEDS TO BE REAPPLIED.

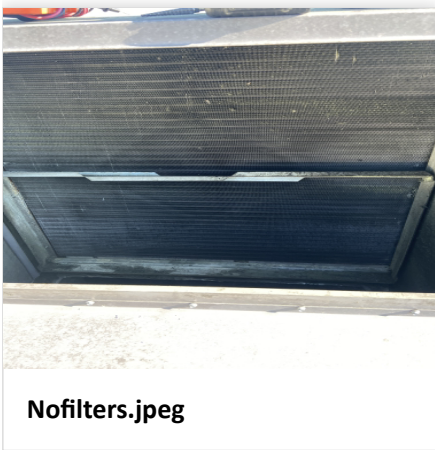
**Issue Name :** RTU-2

**Description :** No EVAP FILTERs/ recommend getting new filters

General		
	Design	Actual
Fan Rotation Correct	-	YES
Unit Filters Clean	-	NO FILTERS
Condensate Drain Installed	-	YES

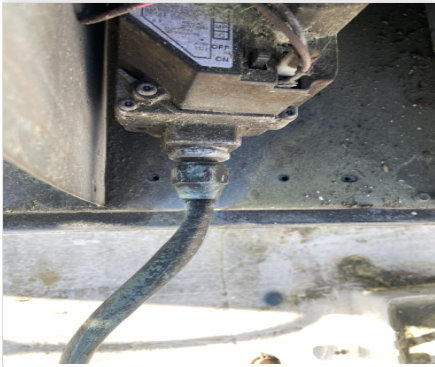
PINCHEDtwistedgasline...

**Issue Name :** RTU-2 gas line?

**Description :** Gas line looks slightly pinched

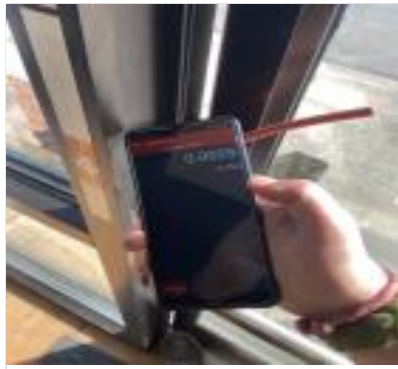
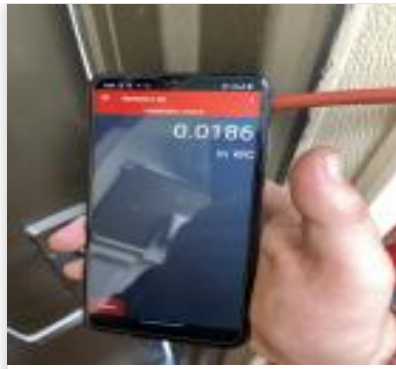
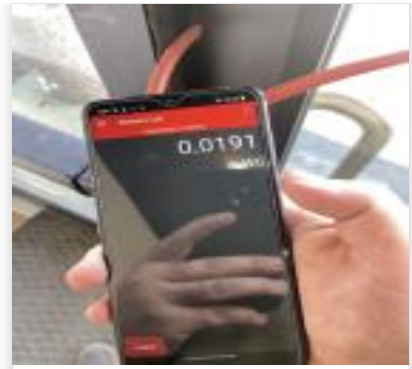
DOOR TESTED	BUILDING PRESSURE MEASUREMENTS (IN. H2O)
FRONT	0.0075
SIDE	0.019
REAR	0.018
<b>AVERAGE</b>	<b>0.0148</b>

Date test was completed	03/08/2023
TAB tech name / Firm	JOASH N ALBIN/ NTAB
Site super name / Firm	Video capture
Owner representative name / Firm (if Applicable)	Video capture
Building pressure at front & back doors (All Systems On)	Yes
