Report: PRELIM

Function: Test, Adjust, & Balance

01-12-26 CULVERS GOLF, FL (DOAS TAB)

Project: 01-12-26 CULVERS GOLF, FL (DOAS TAB)

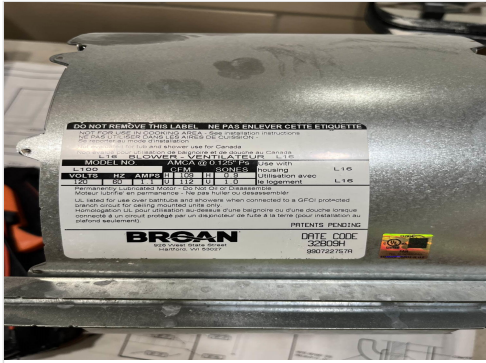
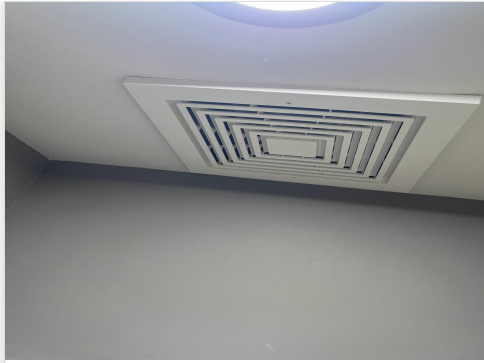
Unit Data - PHOTO LOG

Unit Data		
	Design	Actual
MFG	CAPTIVEAIRE	BROAN
Model Num	CFA 100CA	L100
Serial Num	-	-
Type	INLINE	CEILING
Configuration	VERTICAL	VERTICAL

Test Data		
	Design	Actual
CFM	70	71
Fan RPM	470	DD
Fan Rotation	-	CORRECT
Motor RPM	-	DD
System SetPt	-	SPEED CONTROLLER
RL Voltage	-	118
RL Amperage	-	0.3

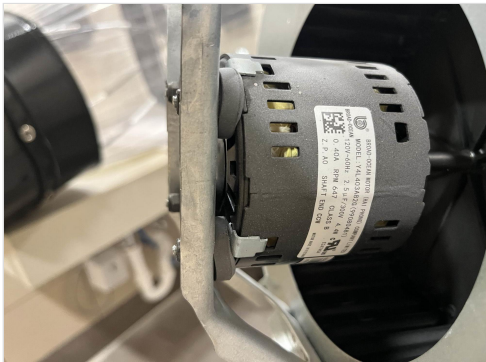
Motor Data - PHOTO LOG

Motor Data		
	Design	Actual
Motor MFG	-	BROAD OCEAN
Motor Rpm	-	647
Phase	1	1
Voltage (rated)	115	120
Amperage (rated)	-	0.4

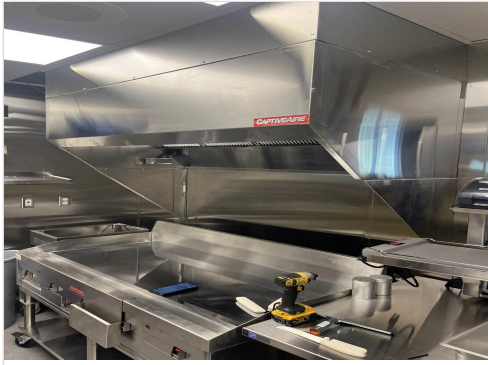
Unit Data - PHOTO LOG

Unit Data		
	Design	Actual
MFG	CAPTIVE AIRE	CAPTIVE AIRE
Model Num	3347 BD-2	3347 BD-2
Job / Serial Num	-	7432301
Type	TYPE I CANOPY	TYPE I CANOPY
Hood length	66"	66"
Hood Width	33"	33"

Test Data Exhaust		
	Design	Actual
Filter Type	CAPTRATE SOLO	CAPTRATE SOLO
Filter Size 1	16x16	16x16
Filter Qty 1	4	4
Filter AK factor size 1	1.62	1.62
Filter Total AK Area	6.48	6.48
Filter1 FPM	-	226
Filter2 FPM	-	230
Filter3 FPM	-	234
Filter4 FPM	-	229
Filter Ave FPM(corr)	-	230
CFM	1500	1490

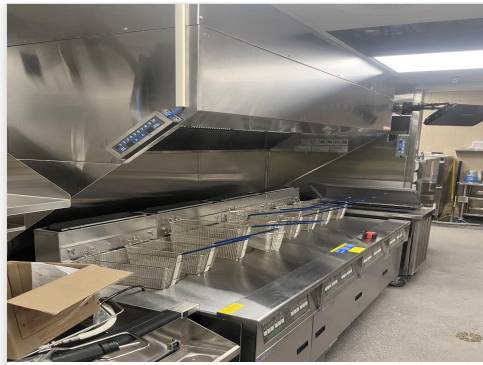
Unit Data - PHOTO LOG

Unit Data		
	Design	Actual
MFG	CAPTIVE AIRE	CAPTIVE AIRE
Model Num	3347 BD-2	3347 BD-2
Job / Serial Num	-	7432301
Type	TYPE I CANOPY	TYPE I CANOPY
Hood length	84"	84"
Hood Width	33"	33"

Test Data Exhaust		
	Design	Actual
Filter Type	CAPTRATE SOLO	CAPTRATE SOLO
Filter Size 1	16X16	16x16
Filter Qty 1	5	5
Filter AK factor size 1	1.62	1.62
Filter Total AK Area	8.1	8.1
Filter1 FPM	-	196
Filter2 FPM	-	213
Filter3 FPM	-	203
Filter4 FPM	-	192
Filter5 FPM	-	193
Filter Ave FPM(corr)	-	199
CFM	1500	1612
