Report: TAB REPORT
Function: Test, Adjust, & Balance
Date: 05/02/2023

PROJECT
04-24-23 CULVERS - CAMDENTON, MO

Project: 04-24-23 CULVERS - CAMDENTON, MO

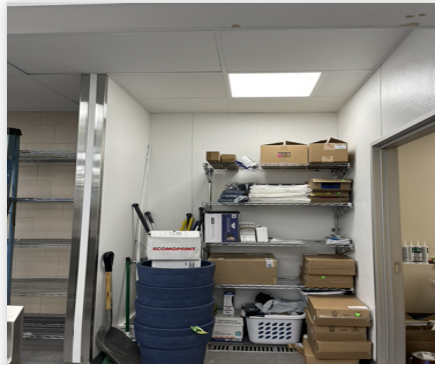
Exhaustfanmissing.jpe..
04/24/2023

Issue Name : EF1A not installed
Description : 75CFM Exhaust fan above the mop sink is not installed. GC notified.
Created By : National TAB **Assigned To :** National TAB - Jacob Davidson
Status : Open
Originated Date : 04/24/2023 - Jacob Davidson - National TAB

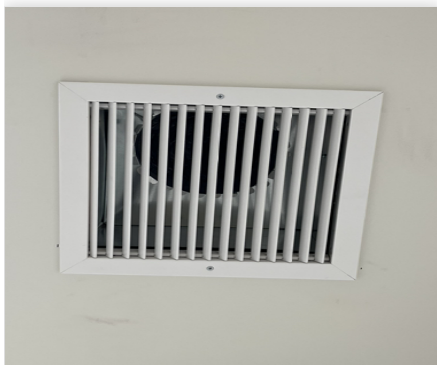
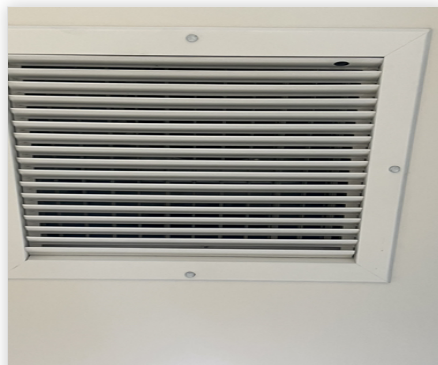
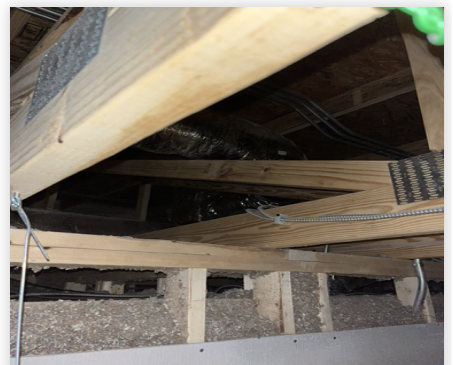
Issue Name : PRV1 employee restroom has no damper accessible
Description : PRV1 men and women restrooms have a face damper to adjust flow. The employee restroom does not have any damper visible. If there is a damper, it would have to be at the takeoff which is not accessible. Tech is unable to balance airflow without damper on diffuser in employee restroom.
