**Report: TAB REPORT**  
**Function: Test, Adjust, & Balance**  
**Date: 07/03/2025**  
**Completed By: National TAB**

**PROJECT**  
**06-30-25 CHIPOTLE #4957 MANOR, TX**

Project: 06-30-25 CHIPOTLE #4957 MANOR, TX

Project: 06-30-25 CHIPOTLE #4957 MANOR, TX  
Function: Test, Adjust, & Balance

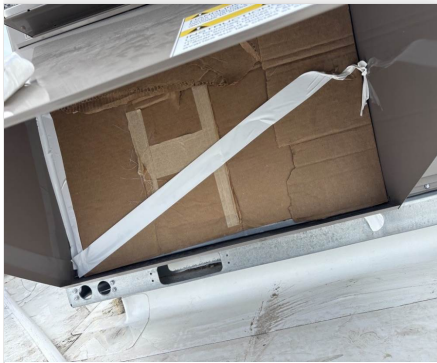
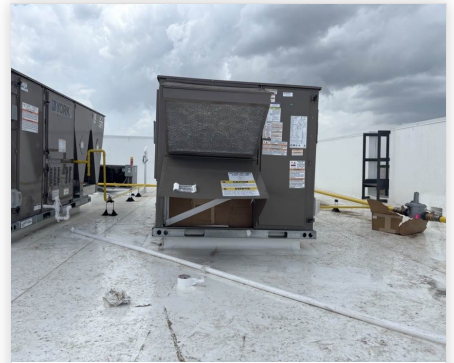
**Issue Name :** RTU Barometric Relief Dampers  
**Description :** Barometric relief dampers are installed incorrectly on the RTUs, allowing air to be pulled in through the outlet. This is causing a significant amount of outside to be pulled in and is pushing the building beyond pressure positive tolerance. Cardboard was placed over the outlet for testing. These dampers need to be installed correctly.  
**Created By :** National TAB      **Assigned To :** National TAB - Brianna Biggs  
**Status :** Open  
**Priority :** Urgent      **Asset Tag :**  
**Originated Date :** 07/02/2025 - Cavin Van - National TAB

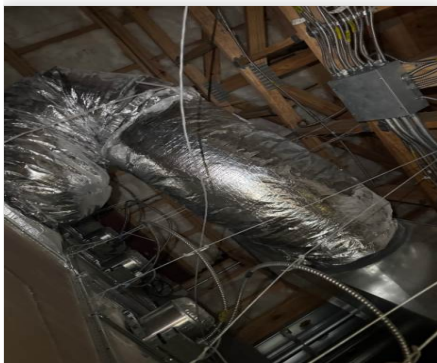
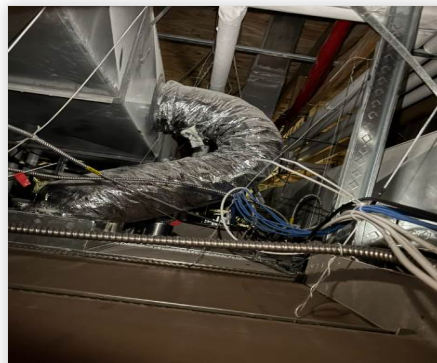
**Issue Name :** RTU-1 ductwork  
**Description :** Airflow is within design for the unit but the static pressure on the supply side is elevated (1.22") which appears to be due to restrictive flex duct installation.  
**Created By :** National TAB                      **Assigned To :** National TAB - Will Turnbough  
**Status :** Open  
**Priority :** InfoOnly                                      **Asset Tag :**  
**Originated Date :** 07/01/2025 - Cavin Van - National TAB

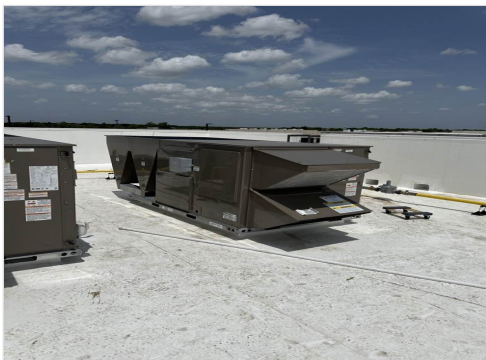
Asset: RTU1

Test Data		
	Design	Actual
SF CFM	4400	4080
SF RPM	-	1186
RA CFM	3900	3548
OA CFM	500	532
RL Voltage	-	210
RL Amperage	-	11.20/11.32/11.78
SF Rotation	-	CW
SF System SetPt	-	100

Performance Data		
	Design	Actual
MA Plenum SP	-	-0.53"
Fan Suction SP	-	-1.10"
Fan Discharge SP	-	1.17"
Total ESP	.80"	1.70"
Fan Total SP	-	2.27"

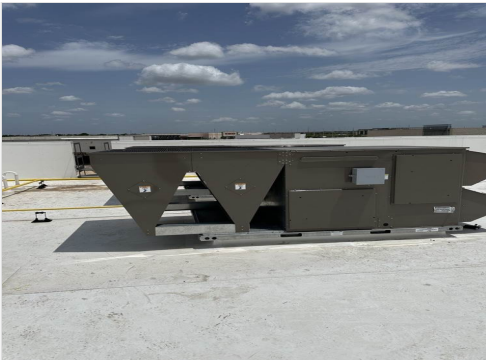
Asset: RTU2

Test Data		
	Design	Actual
SF CFM	4400	3887
SF RPM	-	1181
RA CFM	3400	2954
OA CFM	1000	933
RL Voltage	-	210
RL Amperage	-	11.6/11.99/12.35
SF Rotation	-	CW

Performance Data		
	Design	Actual
MA Plenum SP	-	-0.90"
Fan Suction SP	-	-1.35"
Fan Discharge SP	-	1.03"
Total ESP	.80"	1.93"
Fan Total SP	-	2.38"

**Issue Name :** RTU 2 Airflow  
**Description :** Airflow for the RTU is 88% of design. The static pressures indicate restriction in the ductwork although no major source could be located. Requires further investigation. Pressures: Mixed Air: -0.8718"; and Discharge: 1.0980".

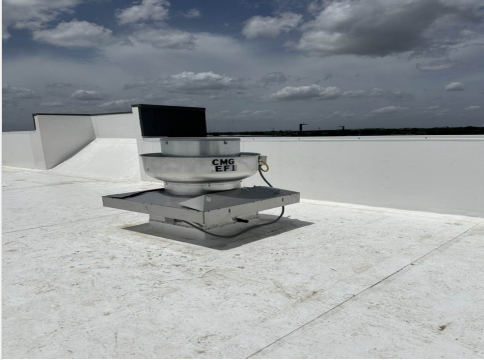
Asset: EF1

Test Data		
	Design	Actual
CFM	2550	2580
Fan RPM	-	955
Fan Rotation	-	CW
Motor RPM	-	955
System SetPt	-	49.0 HZ
RL Voltage	-	93
RL Amperage	-	4.6

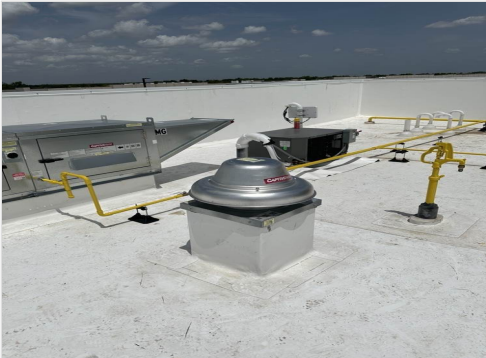
Asset: EF2

Test Data		
	Design	Actual
CFM	150	197
Fan RPM	-	303
Fan Rotation	-	CW
Motor RPM	-	303
System SetPt	-	20
RL Voltage	-	18.5
RL Amperage	-	0.11/0.12
Total ESP	.60"	0.0030"
Fan Inlet SP	-	0.0030"
Fan Discharge SP	-	ATM

**Issue Name :** EF-2 Airflow  
**Description :** EF-2 airflow is minimized at the speed controller but airflow is above design. The additional airflow is not anticipated to cause any issue.  
**Created By :** National TAB                      **Assigned To :** National TAB - Will Turnbough  
**Status :** Open  
**Priority :** InfoOnly                                      **Asset Tag :**  
**Originated Date :** 07/02/2025 - Cavin Van - National TAB

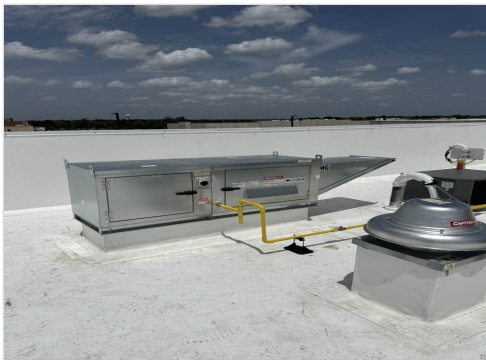
Asset: MUA1

Test Data		
	Design	Actual
CFM	1300	1319
SF RPM	-	1484
Motor RPM	-	1484
SF System SetPt	-	51.2 HZ
RL Voltage	-	138
RL Amperage	-	2.3
Total ESP	-	0.434

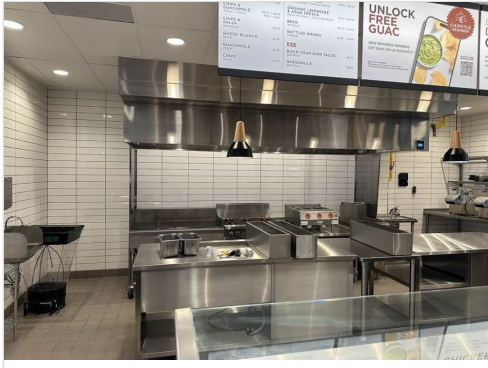
Asset: HD1

Test Data Supply		
	Design	Actual
Total Area	10.31	10.31
Kv factor (Vel)	.81	0.81
Num of Readings	-	9
Reading1 FPM	-	201
Reading2 FPM	-	171
Reading3 FPM	-	145
Reading4 FPM	-	145
Reading5 FPM	-	127
Reading6 FPM	-	175
Reading7 FPM	-	163
Reading8 FPM	-	136
Reading9 FPM	-	164
Ave FPM(corr)	-	158
CFM	1300	1319

Test Data Exhaust		
	Design	Actual
Filter Type	CAPTRATE SOLO FILTER	CAPTRATE SOLO FILTER
Filter Size 1	16X16	16X16
Filter Qty 1	9	9
Filter AK factor size 1	1.62	1.62
Filter Total AK Area	14.58	14.58
Filter1 FPM	-	151
Filter2 FPM	-	175
Filter3 FPM	-	182
Filter4 FPM	-	188
Filter5 FPM	-	193
Filter6 FPM	-	197
Filter7 FPM	-	187
Filter8 FPM	-	171
Filter9 FPM	-	157
Filter Ave FPM(corr)	-	177
CFM	2550	2580
