Report: TAB

Function: Test, Adjust, & Balance

**10-06-25 CHIPOTLE #5536 MODESTO, CA
(DALE & GREWAL)**

4602 DALE ROAD

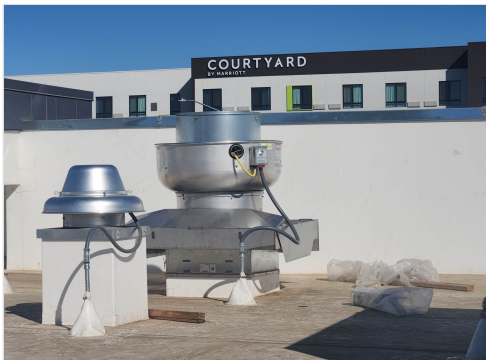
Unit Data - PHOTO LOG

Asset: EF1

AREA: KITCHEN HD

Unit Data		
	Design	Actual
MFG	CAPTIVE-AIRE	CAPTIVE-AIRE
Model Num	DU180HFA	DU180HFA
Serial Num	-	7628881
Type	UPBLAST	UPBLAST
Configuration	VERTICAL	VERTICAL

Test Data		
	Design	Actual
CFM	2550	2580
Fan RPM	1221	1047
Fan Rotation	-	CCW
Motor RPM	-	1047
System SetPt	-	53.7HZ
RL Voltage	-	164/164/164
RL Amperage	-	4.85/4.85/4.86
Total ESP	1.450"	1.13"
Fan Inlet SP	-	-1.13"
Fan Discharge SP	-	ATM
