Report: TAB

Function: Test, Adjust, & Balance

**10-06-25 CHIPOTLE #5536 MODESTO, CA
(DALE & GREWAL)**

Project: 10-06-25 CHIPOTLE #5536 MODESTO, CA (DALE & GREWAL)

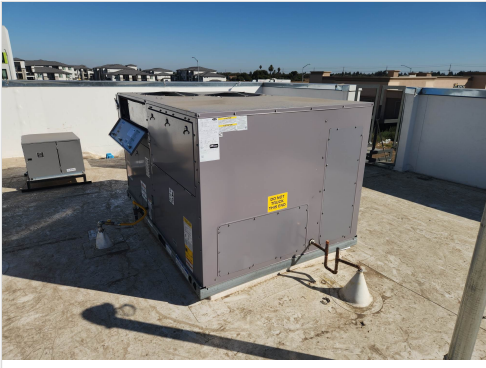
Asset: RTU1

AREA:KITCHEN

General	
	Actual
Fan Rotation Correct	YES
Unit Filters Clean	YES
Condensate Drain Installed	YES

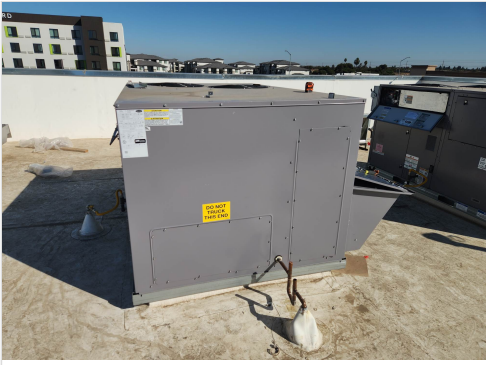
Asset: RTU2

AREA: DINING

General	
	Actual
Fan Rotation Correct	YES
Unit Filters Clean	YES
Condensate Drain Installed	YES

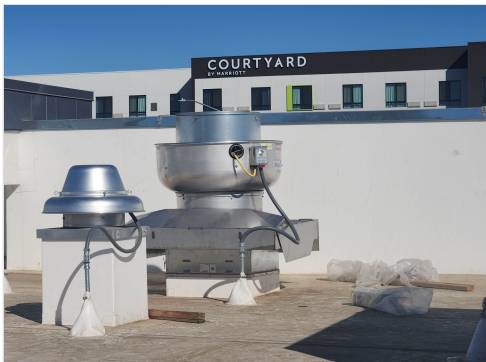
Asset: EF1

AREA: KITCHEN HD

Test Data		
	Design	Actual
CFM	2550	2580
Fan RPM	1221	1047
Fan Rotation	-	CCW
Motor RPM	-	1047
System SetPt	-	53.7HZ
RL Voltage	-	164/164/164
RL Amperage	-	4.85/4.85/4.86
Total ESP	1.450"	1.13"
Fan Inlet SP	-	-1.13"
Fan Discharge SP	-	ATM

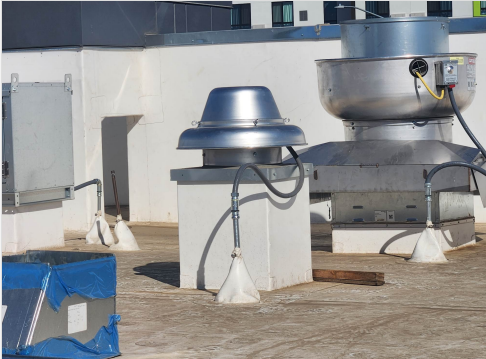
Asset: EF2

AREA:RESTROOM

Test Data		
	Design	Actual
CFM	150	153
Fan RPM	1282	1290
Fan Rotation	-	CCW
Motor RPM	-	1290
System SetPt	-	65%
RL Voltage	-	NA
RL Amperage	-	NA
Total ESP	0.600"	0.49"
Fan Inlet SP	-	-0.49"
Fan Discharge SP	-	ATM

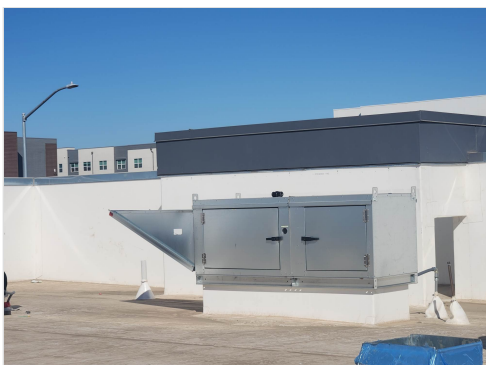
Asset: MAU1

AREA: KITCHEN HD

Gas Heat		
	Design	Actual
Heater Operates (y/n)	-	NO
Flame Status (pass/fail)	-	FAIL
Inlet Air Temp SetPt	55	55
Discharge Air Temp SetPt	60	60
Air Flow Switch SP Actual	-	0.47"

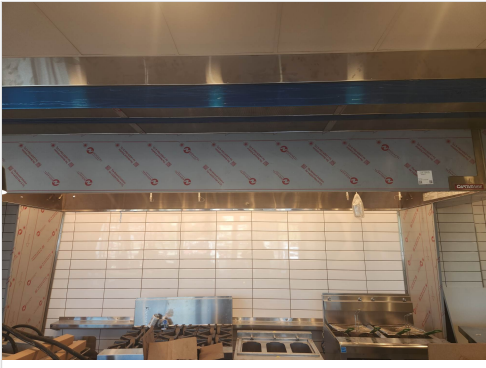
Asset: HD1

AREA: KITCHEN

Unit Data		
	Design	Actual
MFG	CAPTIVE-AIRE	CAPTIVE-AIRE
Model Num	5424 ND-2-ACPSP-F	5424 ND-2-ACPSP-F
Job / Serial Num	-	7164532
Type	TYPE 1 CANOPY	TYPE I CANOPY
Hood length	153"	153"
Hood Width	54"	54"
Supply Plenum Type	-	PERFORATED
Supply Plenum Width	9"	9"
Supply Plenum Length	165"	165"
