Report: TAB Report
Function: Test, Adjust, & Balance
Date: 10/28/2025
Completed By: National TAB

PROJECT
10-06-25 QT #1437 GLENDALE, AZ

Project: 10-06-25 QT #1437 GLENDALE, AZ

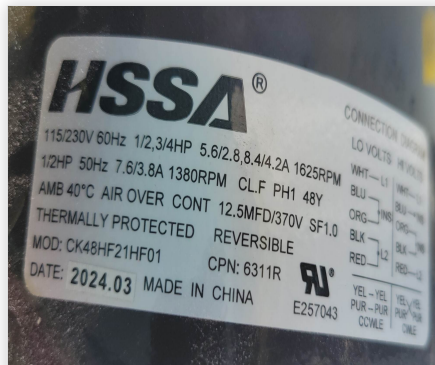
Issue Name : EF1 Exhaust above Design
Description : EF1 is almost 9% out of tolerance too high (887/750). Speed control has been turned to lowest setting (set w/ potentiometer, then knob replaced). Unit is running at FLA 8.4A.
Created By : National TAB **Assigned To :** National TAB - Dan Hertenstein
Status : Open
Priority : High **Asset Tag :** EF1
Originated Date : 10/09/2025 - Christine Weale - National TAB

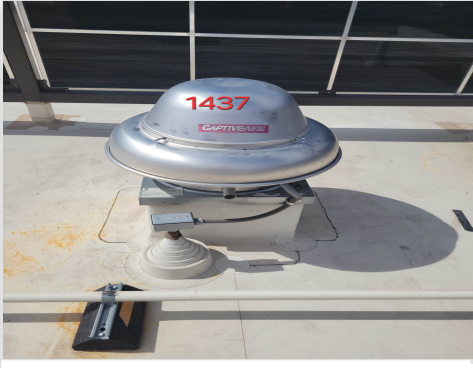
Test Data		
	Design	Actual
CFM	750	887
Fan RPM	-	NA
Fan Rotation	-	CCW
Motor RPM	-	NA
System SetPt	-	LOW @SPD CTRLR
RL Voltage	-	NA
RL Amperage	-	8.4
Total ESP	-	0.42
Fan Inlet SP	-	-0.42
Fan Discharge SP	-	ATMS
