**Report: TAB REPORT**  
**Function: Test, Adjust, & Balance**  
**Date: 10/14/2025**  
**Completed By: National TAB**

**PROJECT**  
**10-06-25 QT #1437 GLENDALE, AZ**

QUIKTRIP  
4705 SOUTH 129TH EAST AVENUE  
TULSA, OK 74134

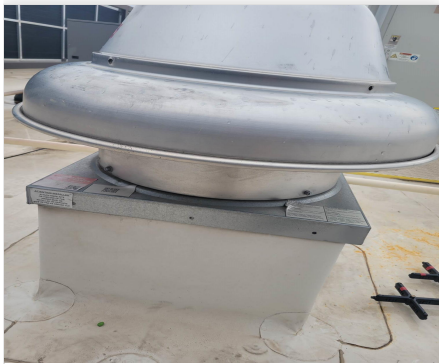
**Issue Name :** NO HINGEKIT ON EF1  
**Description :** No hinge kit installed on EF1  
**Created By :** National TAB                      **Assigned To :** National TAB - Dan Hertenstein  
**Status :** Closed  
**Priority :** InfoOnly                                      **Asset Tag :** EF1  
**Originated Date :** 10/10/2025 - Christine Weale - National TAB

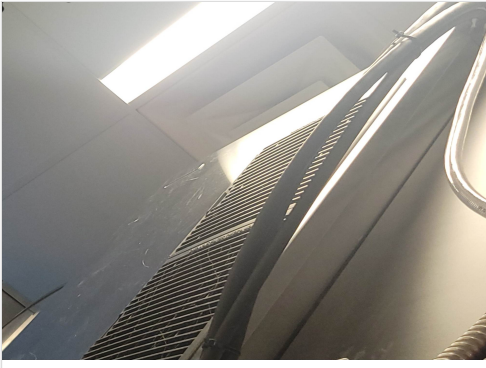
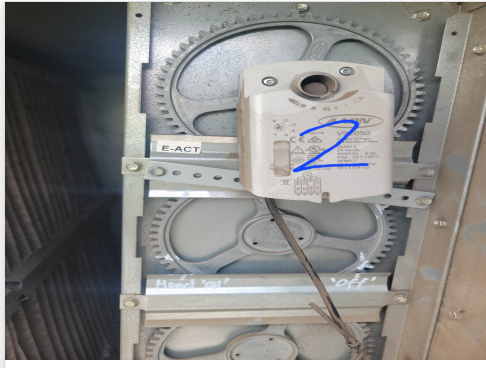
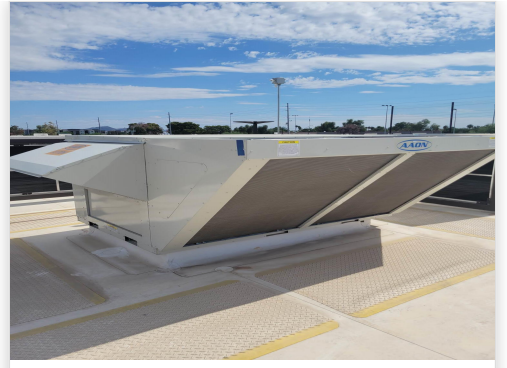
## Unit Data - PHOTO LOG

Pictures attached to show inaccessible diffuser #4, all air was diverted to measure, then the damper was opened for it at the end of balance.

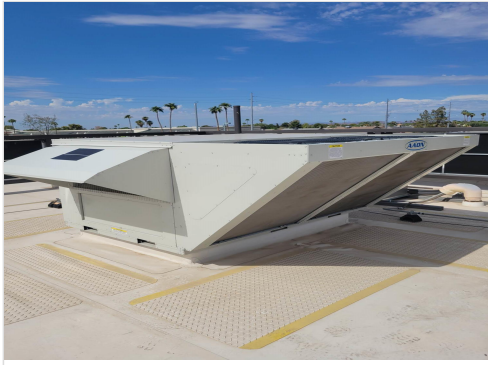
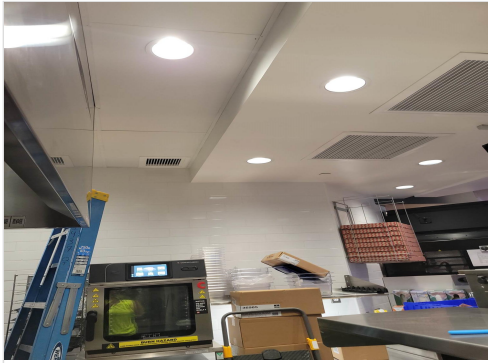
Pictures attached of inaccessible dampers, which caused slight imbalances. RTU3 -1 damper was opened, the only damper accessible. The oven could not be moved due to connections behind it.
