**Report: TAB REPORT**  
**Function: Test, Adjust, & Balance**  
**Date: 10/14/2025**  
**Completed By: National TAB**

**PROJECT**  
**10-06-25 QT #1437 GLENDALE, AZ**

QUIKTRIP  
4705 SOUTH 129TH EAST AVENUE  
TULSA, OK 74134

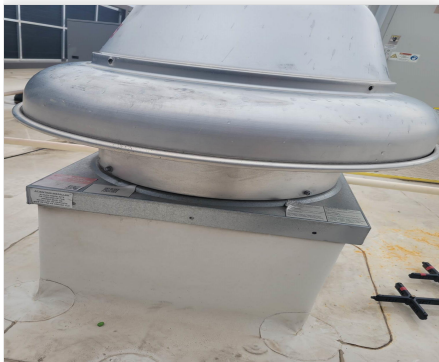
**Issue Name :** NO HINGEKIT ON EF1  
**Description :** No hinge kit installed on EF1  
**Created By :** National TAB                      **Assigned To :** National TAB - Dan Hertenstein  
**Status :** Closed  
**Priority :** InfoOnly                                      **Asset Tag :** EF1  
**Originated Date :** 10/10/2025 - Christine Weale - National TAB

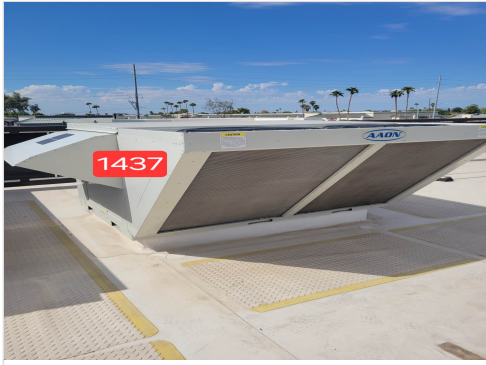
## Unit Data - PHOTO LOG

Unit Data		
	Design	Actual
MFG	NA	AAON
Serial Num	-	202205-ANEK24524
Model Num	NA	RN-013-8-0-EA0A-152
Type	-	RTU
Configuration	-	VERTICAL
Num OA Filters 1	-	1
OA Filter Size 1	-	45X22
Num Final Filter 1	-	2
Final Filter Size 1	-	46X19.5X2

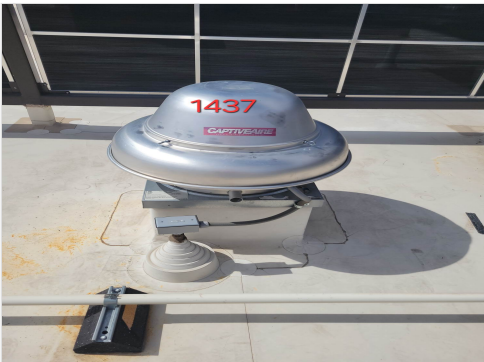
## Unit Data - PHOTO LOG

Unit Data		
	Design	Actual
MFG	NA	CAPTIVEAIRE
Model Num	NA	DR50HFA
Serial Num	-	5547376
Type	-	DOWNBLAST
Configuration	-	VERTICAL

Test Data		
	Design	Actual
CFM	750	887
Fan RPM	-	NA
Fan Rotation	-	CCW
Motor RPM	-	NA
System SetPt	-	LOW @SPD CTRLR
RL Voltage	-	NA
RL Amperage	-	8.4
Total ESP	-	0.42
Fan Inlet SP	-	-0.42
Fan Discharge SP	-	ATMS

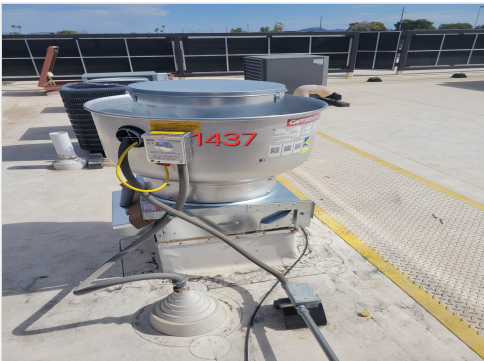
## Unit Data - PHOTO LOG

Unit Data		
	Design	Actual
MFG	NA	CAPTIVEAIRE
Model Num	NA	DU50HFA
Serial Num	-	7644879
Type	UPBLAST	UPBLAST
Configuration	VERTICAL	VERTICAL
