Report: TAB REPORT
Function: Test, Adjust, & Balance
Date: 10/14/2025
Completed By: National TAB

PROJECT
10-06-25 QT #1437 GLENDALE, AZ

Project: 10-06-25 QT #1437 GLENDALE, AZ

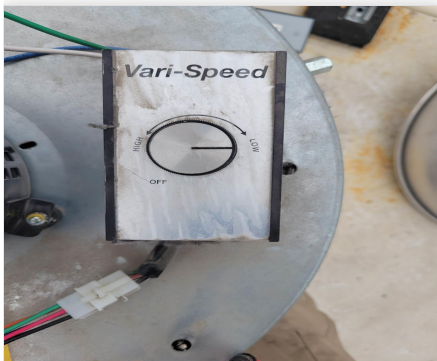
Issue Name : EF1 CFM TOO HIGH, ON LOWEST SETTING
Description : EF1 is almost 9% out of tolerance too high (887/750). Speed control has been turned to lowest setting (set w/ potentiometer, then knob replaced). I turned the other way slightly to make sure it wasn't backwards, and it increased. Unit is running at almost FLA 8.4A / 8.6A. Recommend checking installation, unit should not be at FLA on lowest setting.

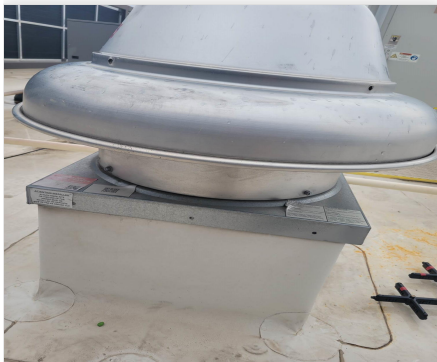
Issue Name : NO HINGEKIT ON EF1
Description : No hinge kit installed on EF1
Created By : National TAB **Assigned To :** National TAB - Dan Hertenstein
Status : Closed
Priority : InfoOnly **Asset Tag :** EF1
Originated Date : 10/10/2025 - Christine Weale - National TAB

No hinge kit installed on EF1.

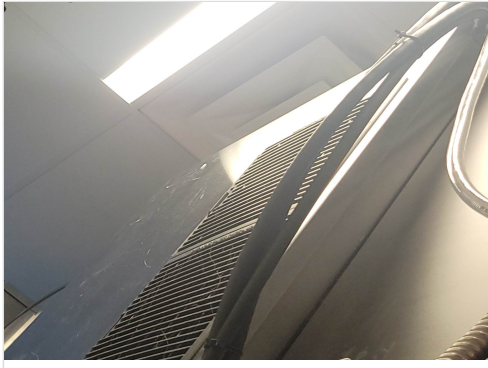
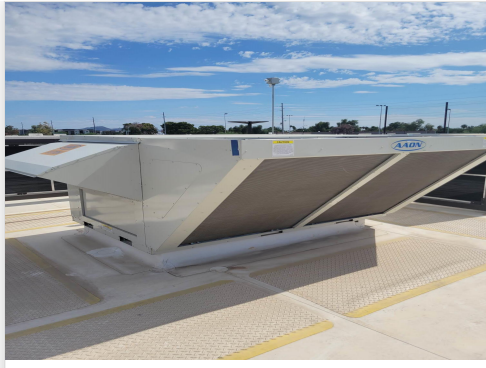
Unit Data - PHOTO LOG

Pictures attached to show inaccessible diffuser #4, all air was diverted to measure, then the damper was opened for it at the end of balance.

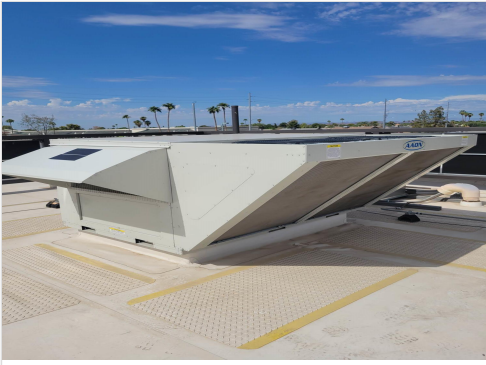
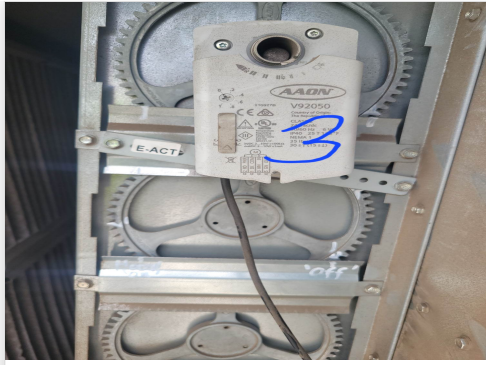
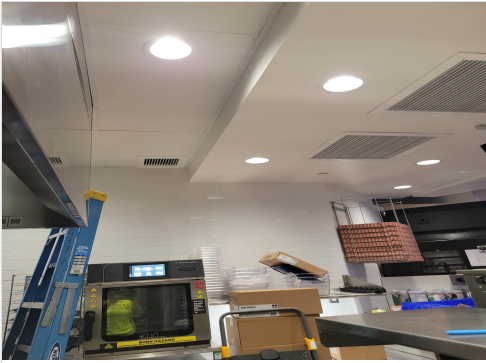
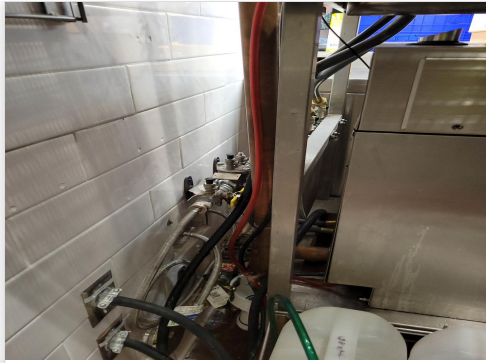
Unit Data - PHOTO LOG

Pictures attached of inaccessible dampers, which caused slight imbalances. RTU3 -1 damper was opened, the only damper accessible. The oven could not be moved due to connections behind it.

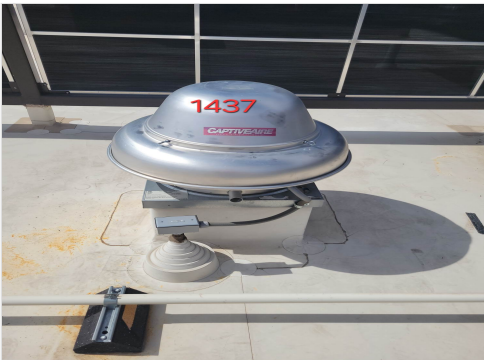
Unit Data - PHOTO LOG

Test Data		
	Design	Actual
CFM	750	887
Fan RPM	-	NA
Fan Rotation	-	CCW
Motor RPM	-	NA
System SetPt	-	LOW @SPD CTRLR
RL Voltage	-	NA
RL Amperage	-	8.4
Total ESP	-	0.42
Fan Inlet SP	-	-0.42
Fan Discharge SP	-	ATMS

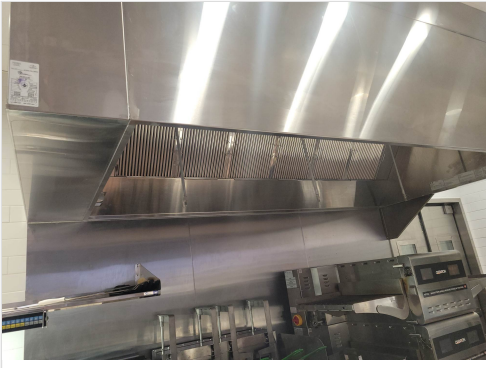
Unit Data - PHOTO LOG

Notes:
SMOKE TEST FAILED AT 20% OVER DESIGN CFM. LEFT FAN SPD W/I 10% TOLERANCE.
