Report: TAB

Function: Test, Adjust, & Balance

Date: 04/14/2025

**04-07-25 CAVA PHOENIX, AZ (99TH &
MCDOWELL)**

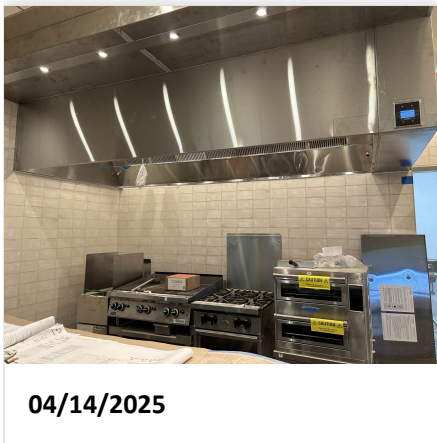
Issue Name : HOOD END PANEL NOT INSTALLED
Description : Hood vertical end panel not yet installed at the time of TAB. Recommend installing for increased smoke capture efficiency. Please refer to M6.5 on Mechanical plans.
Created By : National TAB **Assigned To :** National TAB - Brianna Biggs
Status : Open
Priority : Low **Asset Tag :**
Originated Date : 04/14/2025 - David Nicolas Sanchez - National TAB

End panels are installed Fail

In process of being installed.
