Report: TAB

Function: Test, Adjust, & Balance

04-07-25 CAVA PHOENIX, AZ (99TH & MCDOWELL)

Project: 04-07-25 CAVA PHOENIX, AZ (99TH & MCDOWELL)

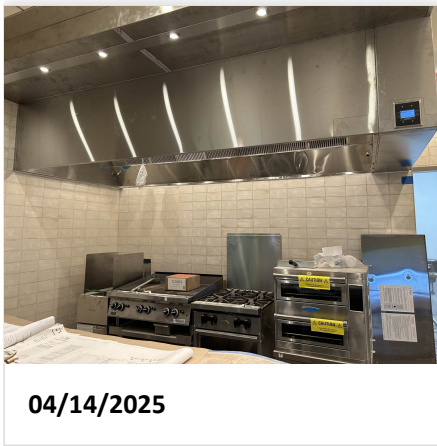
Issue Name : HOOD END PANEL NOT INSTALLED
Description : Hood vertical end panel not yet installed at the time of TAB. Recommend installing for increased smoke capture efficiency. Please refer to M6.5 on Mechanical plans.
Created By : National TAB **Assigned To :** National TAB - Brianna Biggs
Status : Open
Priority : Low **Asset Tag :**
Originated Date : 04/14/2025 - David Nicolas Sanchez - National TAB

End panels are installed Fail

In process of being installed.

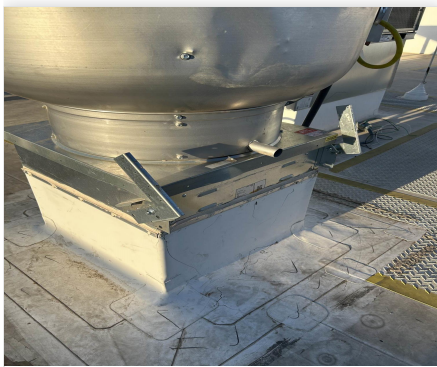
Issue Name : KEF GREASE CUPS NOT INSTALLED
Description : KEF-1 grease cups are not installed. Recommend installing grease cups to the base of the fan to prevent grease from spilling on the roof. Refer to M6.7 on Mechanical plans.
Created By : National TAB **Assigned To :** National TAB - Brianna Biggs
Status : Open
Priority : Low **Asset Tag :**
Originated Date : 04/14/2025 - David Nicolas Sanchez - National TAB

Grease cups are properly installed and connected to the fan base grease drain to prevent spilling outside of the grease cup

Fail

In process of being installed.

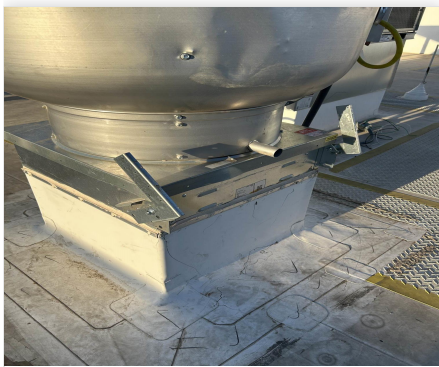
Issue Name : KEF HINGE NOT INSTALLED
Description : KEF-1 fan hinge is not installed. Recommend finishing hinge install by connecting hinge to the base of the fan. Refer to M6.7 on mechanical plans.
Created By : National TAB **Assigned To :** National TAB - Brianna Biggs
Status : Open
Priority : Low **Asset Tag :**
Originated Date : 04/14/2025 - David Nicolas Sanchez - National TAB

Fan is properly hinged and supported when hinged fully back for grease duct access (for Halton fans, ensure the base mounted disconnect is not hitting the fan base/curb when fully hinged back)

Fail

In process of being installed.
